Nottingham Fire Company

Fire Engine #17

Feasibility Study

Fire Station # 17, Nottingham District 7 – Audit

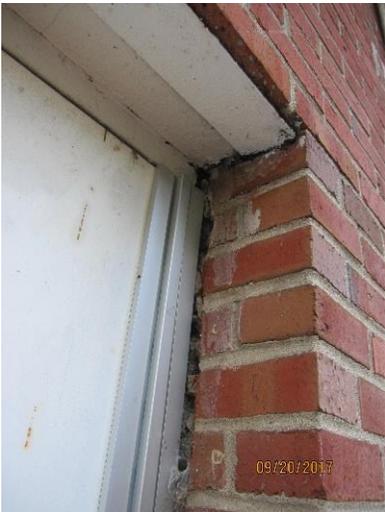
VISIBLE VOID BETWEEN MASONRY & DOOR FRAME

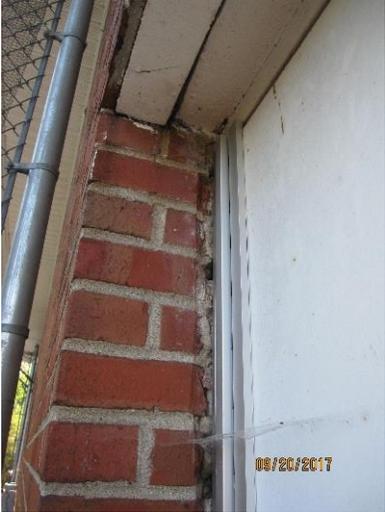
VISIBLE VOID BETWEEN MASONRY & DOOR FRAME

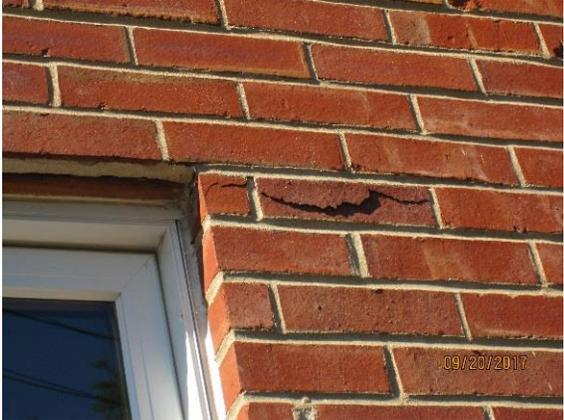
SPALLED BRICK

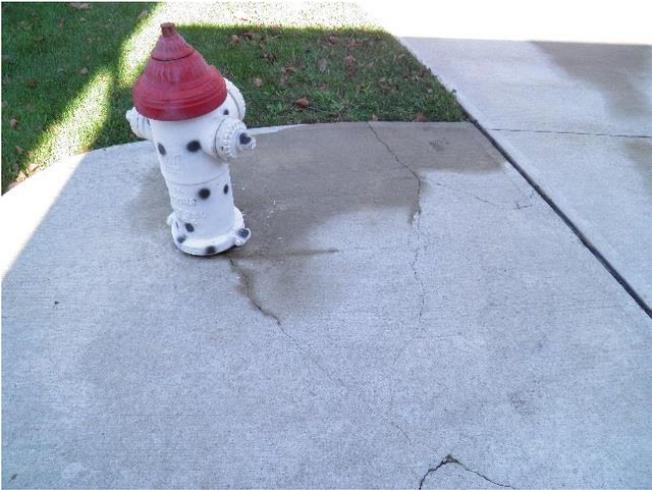
VISIBLE CRACK IN THE CONCRETE PAVERS

<u>Work Item</u>	<u>Estimated Cost Opinion</u>
A. <u>Site</u>	
i. Repair the concrete apron at the truck entrance	\$17,000
ii. Replace the concrete apron curb	\$12,000
iii. Repair the concrete sidewalk	\$8,500
iv. Repair the parking lot asphalt paving	\$55,000

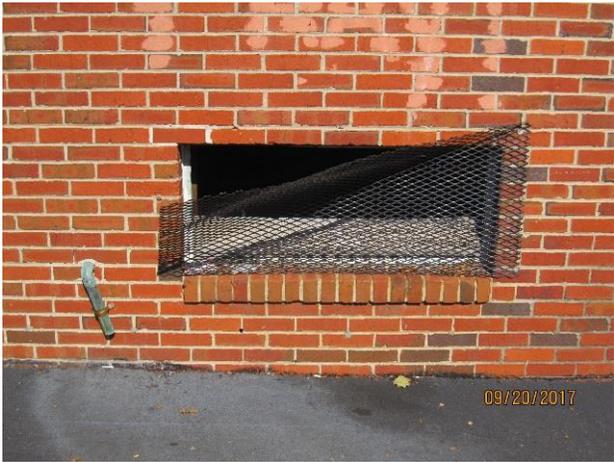
- v. There is one louver on this facade that is damaged and covered with a metal security screen.
 - vi. There is an abandoned opening on this façade that most likely contained a window or louver and is covered with a damaged metal security screen.

DAMAGED METAL SCREEN

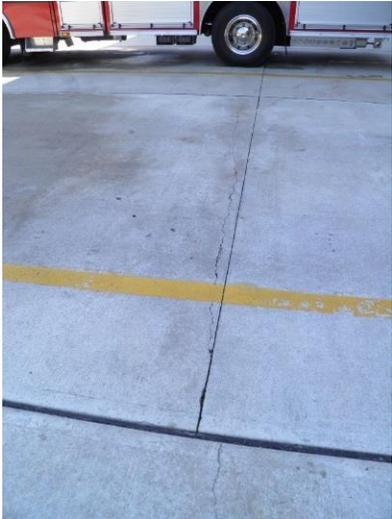
VISIBLE CRACK IN THE CONCRETE PAVERS

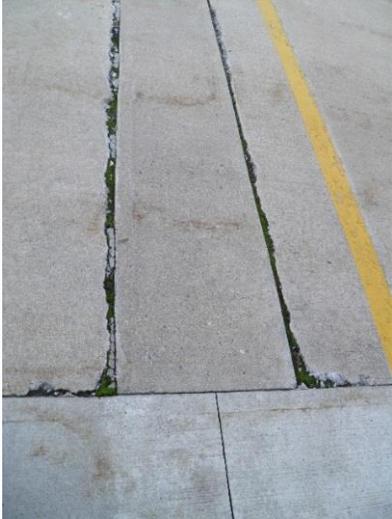
ERODED CONCRETE JOINT

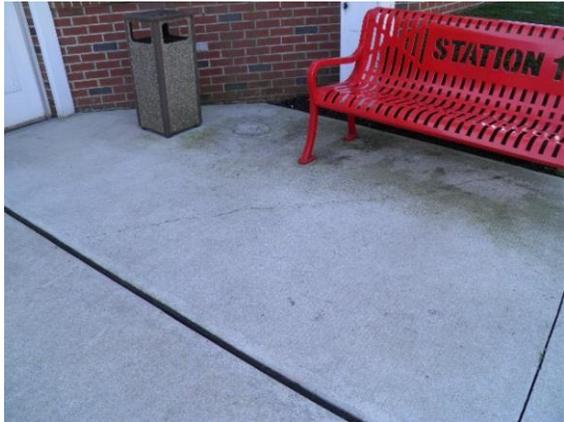
VISIBLE CRACK IN THE CONCRETE PAVERS

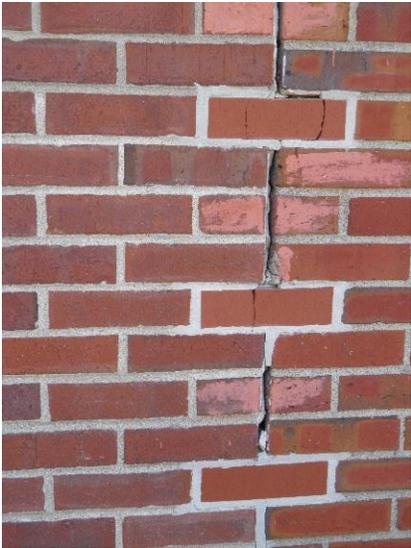
VISIBLE CRACK IN THE BRICK WALL

v. Provide the additional handrail at the side entrance steps	\$3,500
B. <u>Facades</u>	
i. Replace the sealant at the expansion joints	\$5,000
ii. Repair the vertical brick crack	\$5,500

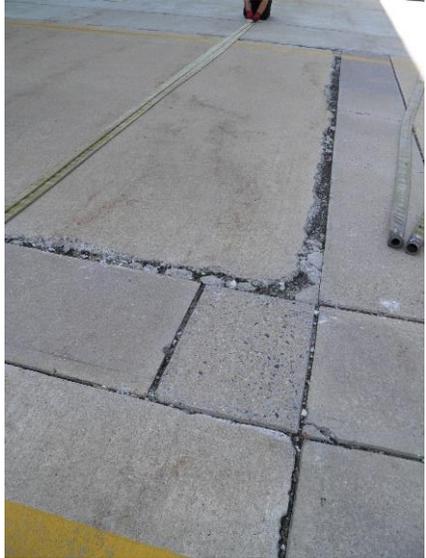
VISIBLE CRACK IN THE CONCRETE PAVERS

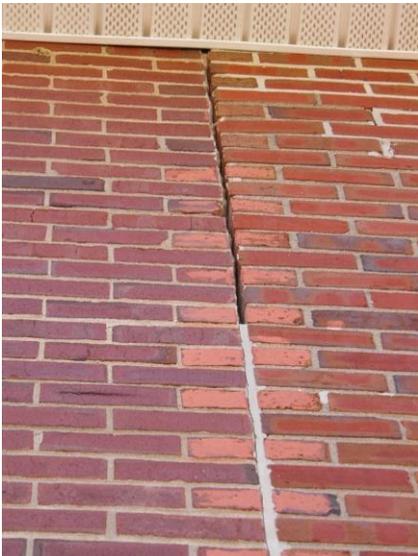
VISIBLE CRACK IN THE BRICK WALL

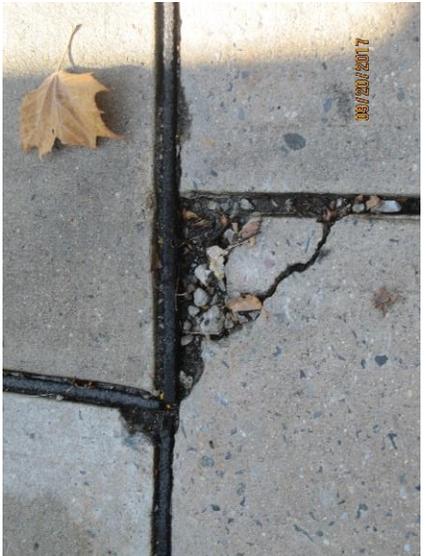
VISIBLE CRACK IN THE CONCRETE PAVERS

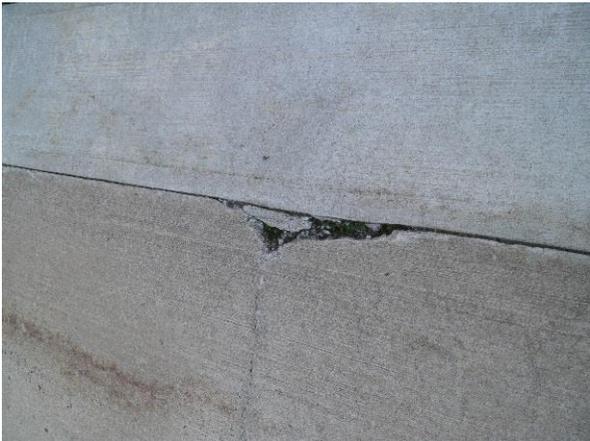
VISIBLE CRACK IN THE CONCRETE PAVERS

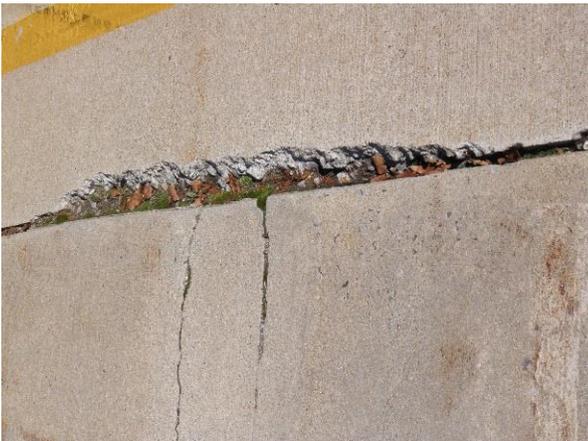
VISIBLE CRACK IN THE CONCRETE PAVERS

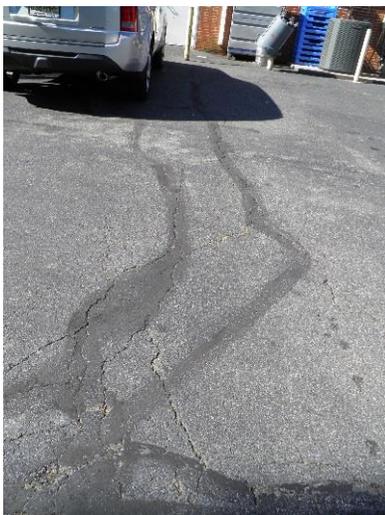
VISIBLE CRACK THE PARKING LOT

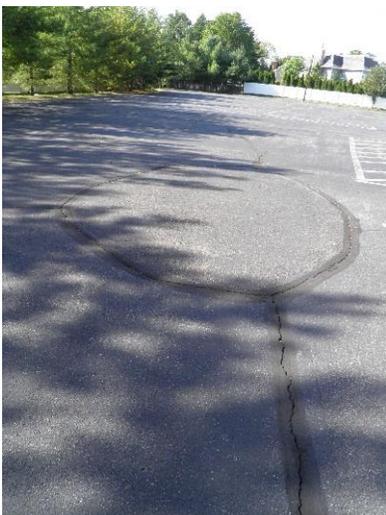
VISIBLE CRACK THE PARKING LOT

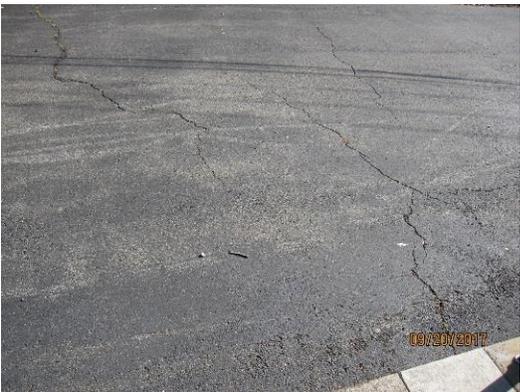
VISIBLE CRACK THE PARKING LOT

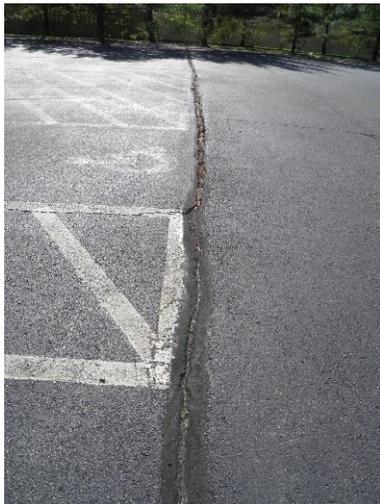
VISIBLE CRACK THE PARKING LOT

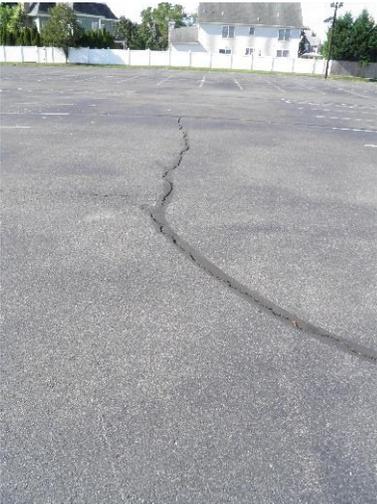
VISIBLE CRACK THE PARKING LOT

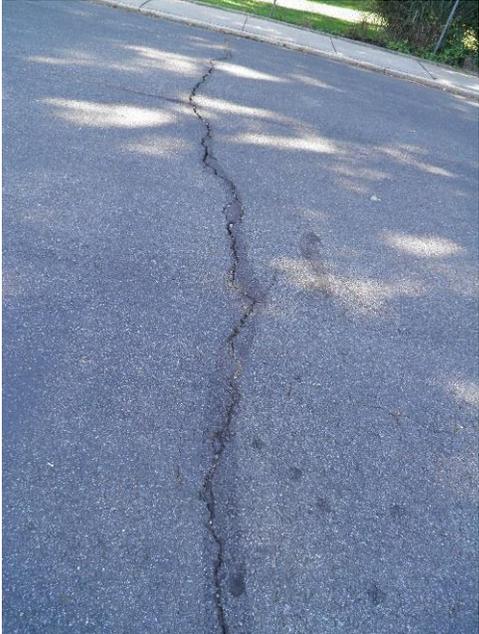
VISIBLE CRACK THE PARKING LOT

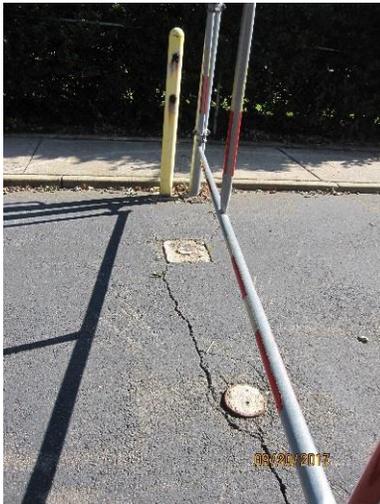
VISIBLE CRACK THE DRIVEWAY

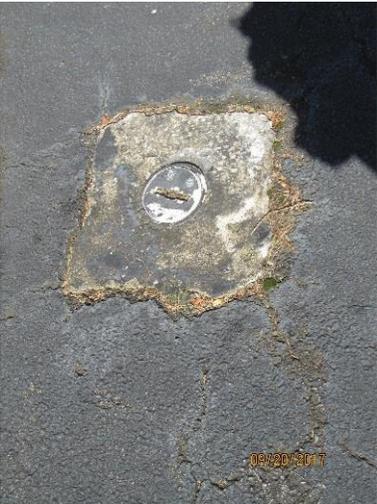
VISIBLE CRACK THE DRIVEWAY

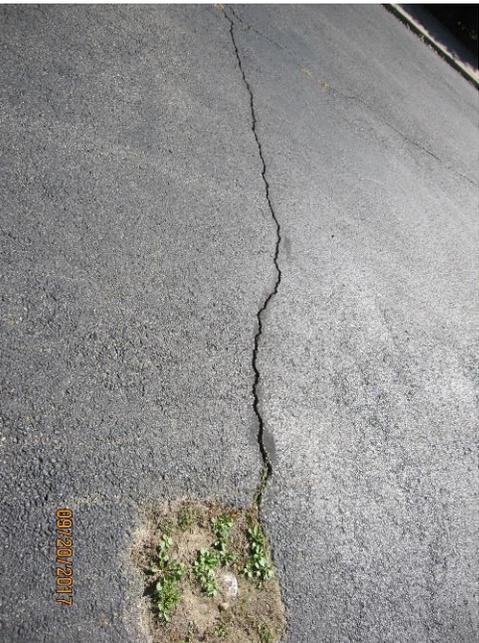
VISIBLE CRACK THE PARKING LOT

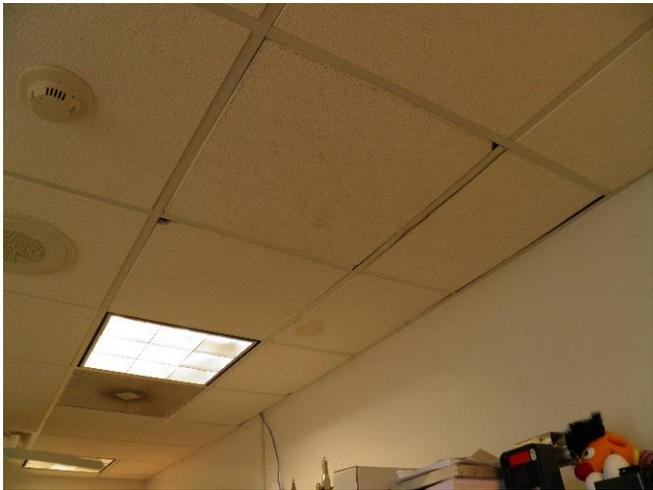
DIRTY AND DAMAGED CEILING TILES

v. Replace the kitchen counters	\$12,000
vi. Replace the cabinets at the watch desk/control room	\$15,000
vii. Repair quarry floor tiles in the kitchen	\$3,500
viii. Replace damaged acoustical ceiling tiles and grids from roof leaks	\$10,000

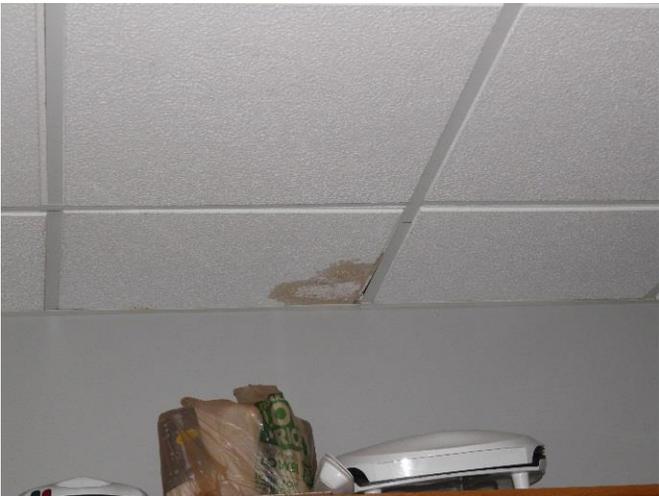
STAINED CEILING TILE PROBABLY FROM PREVIOUS PIPE LEAK

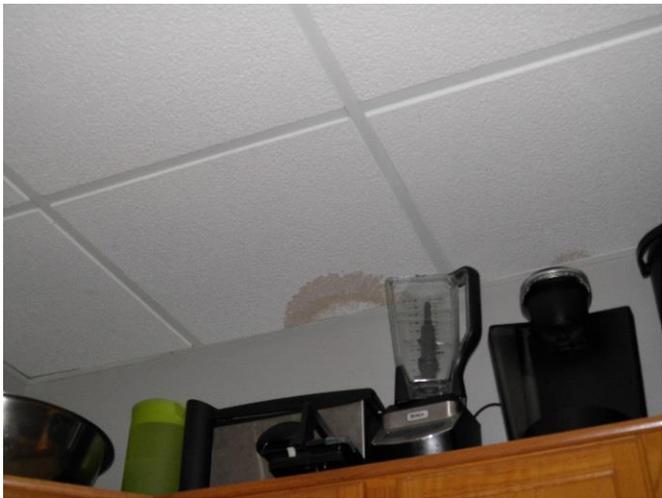
STAINED CEILING TILE PROBABLY FROM PREVIOUS PIPE LEAK

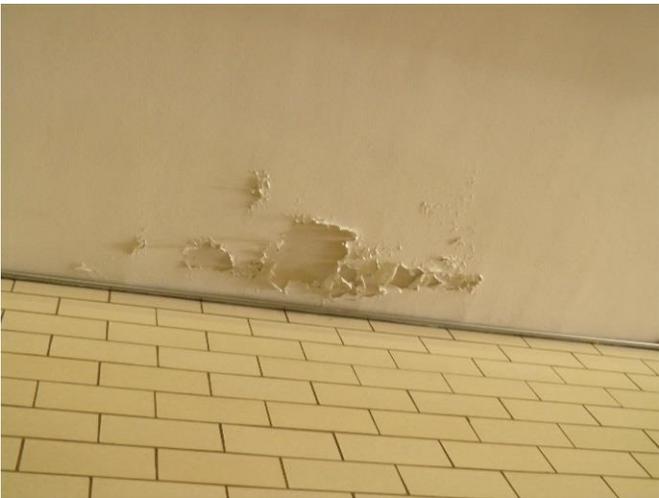
PAINT PEELING OF FROM THE CEILING

C. <u>Roofs</u>	
N/A	
D. <u>Interior</u>	
i. Repair the scratch and hairline cracks in the engine/apparatus Room	\$4,500
ii. Repair the outside gypsum board wall corner in the engine/apparatus room	\$600
iii. Repair the glazed CMU at a door jamb in the engine/apparatus room	\$3,500
iv. Repaint the gypsum ceiling in the engine/apparatus Room	\$40,000

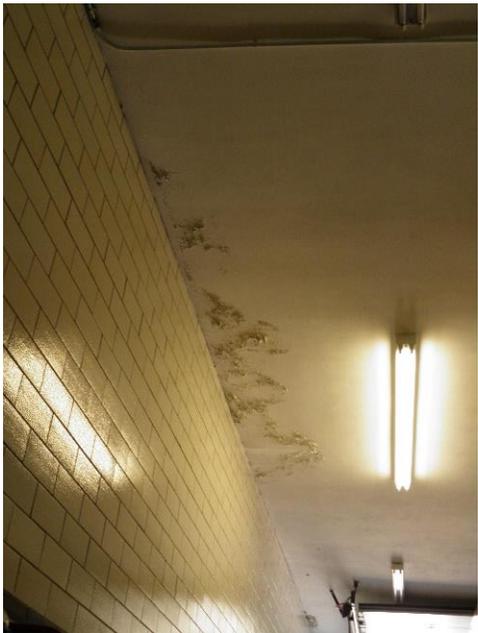
PAINT PEELING OF FROM THE CEILING

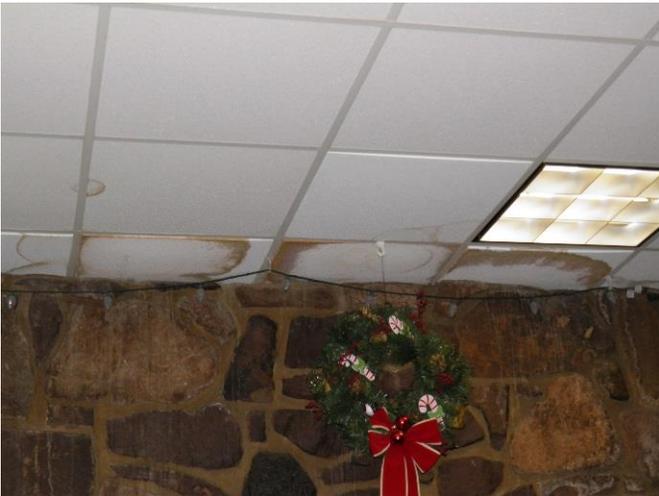
SIGNS OF WATER DAMAGE ON THE CEILING TILES

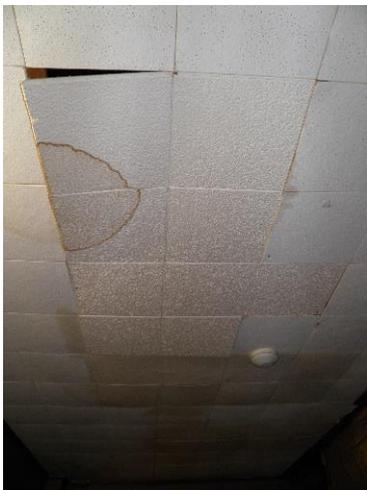
DIRTY AND DAMAGED CEILING TILES

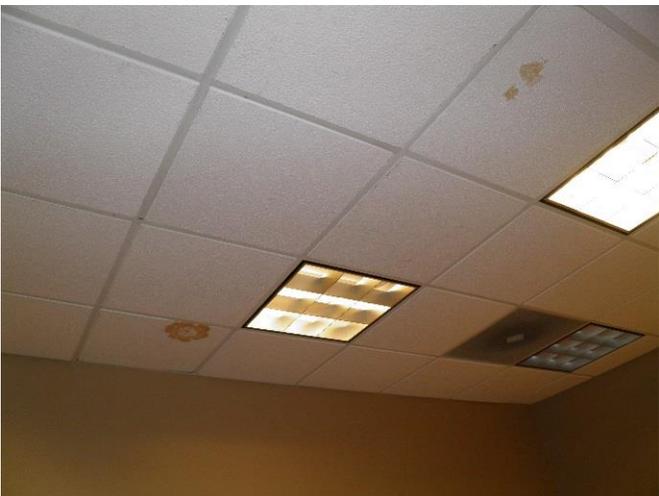
STAINED CEILING TILE PROBABLY FROM PREVIOUS PIPE LEAK

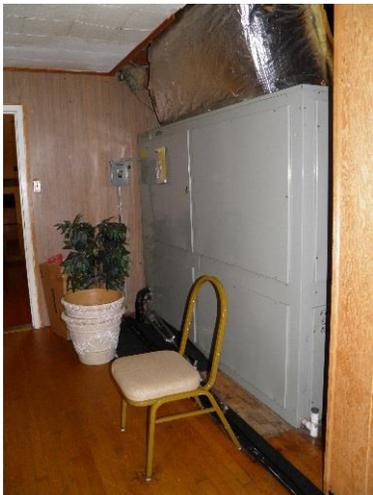
SIGNS OF WATER DAMAGE IN THE CEILING & ON THE FLOOR

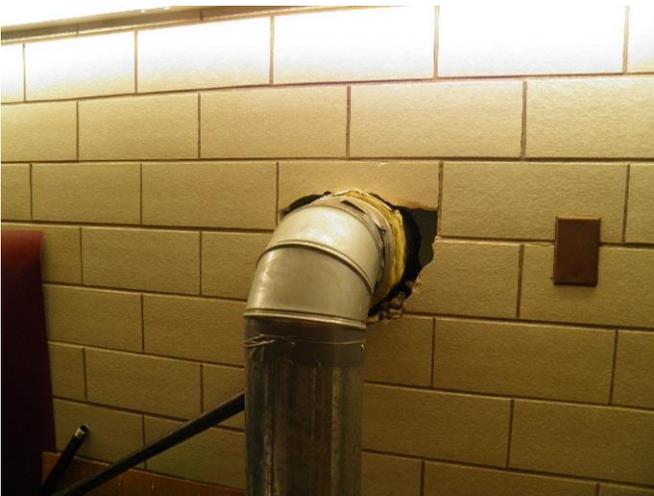
MISSING SEAL AROUND WALL PENETRATION

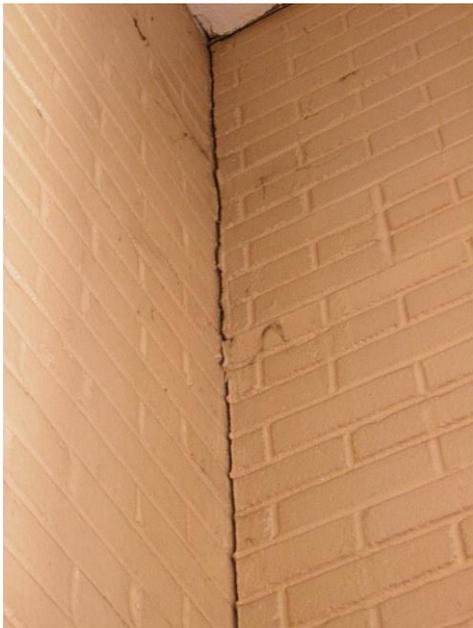
VISIBLE CRACK AT WALL JOINT

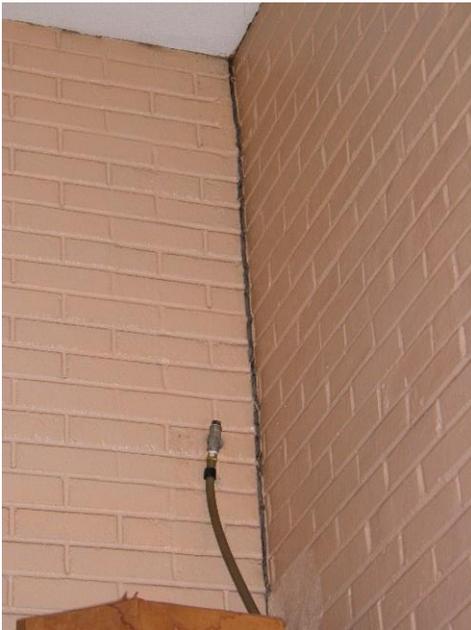
VISIBLE CRACK AT WALL JOINT

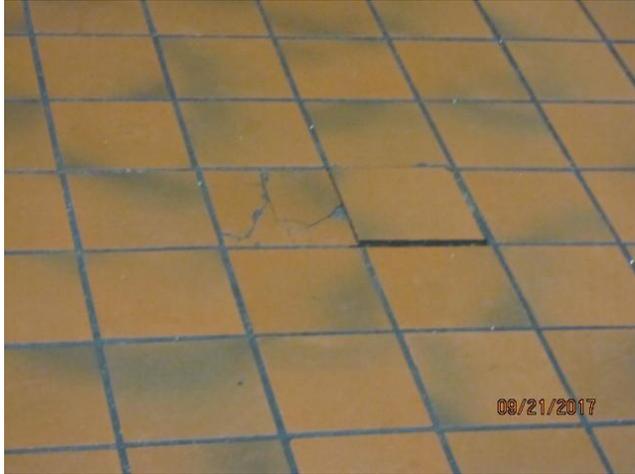
CRAKED FLOOR TILES

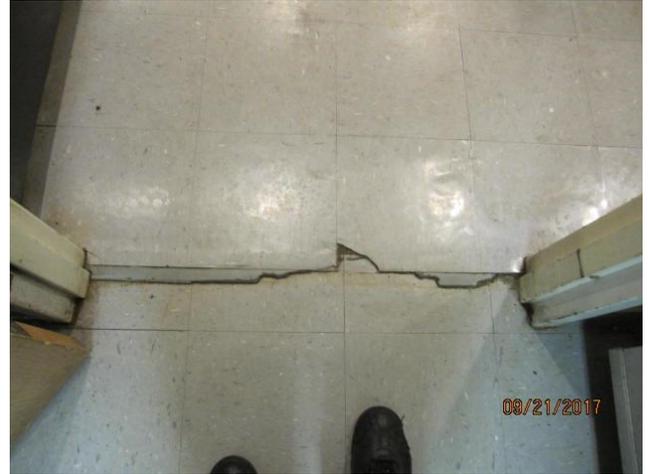
CRACK IN THE VCT FLOOR TILES

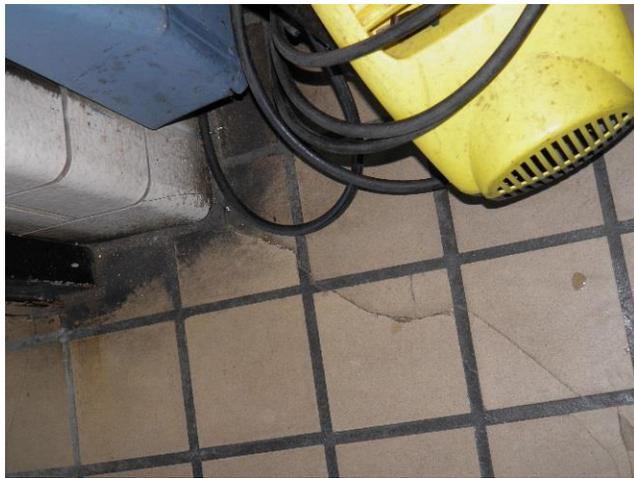
CRAKED FLOOR TILES

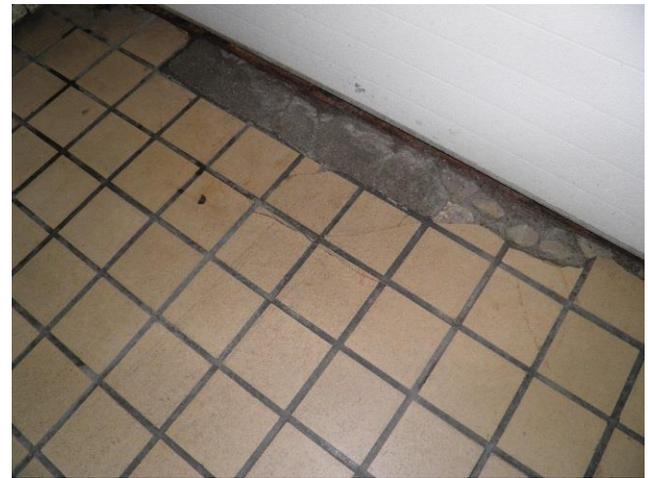
VISIBLE DAMAGE TO FLOOR TILES

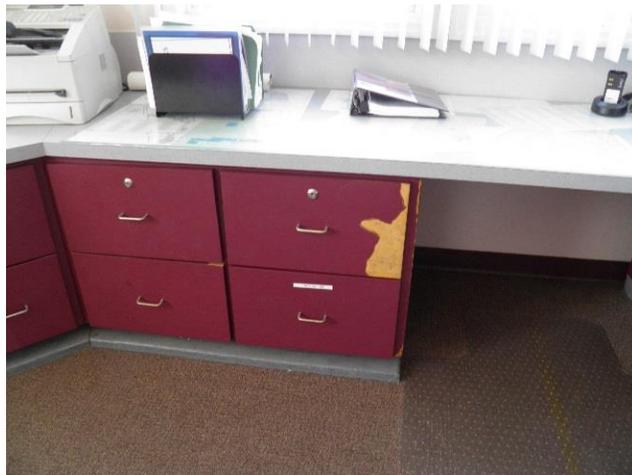
VISIBLE DAMAGE TO MILLWORK

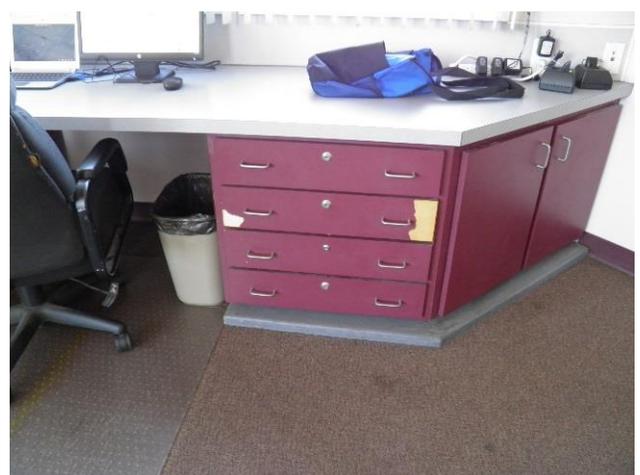
VISIBLE DAMAGE TO MILLWORK

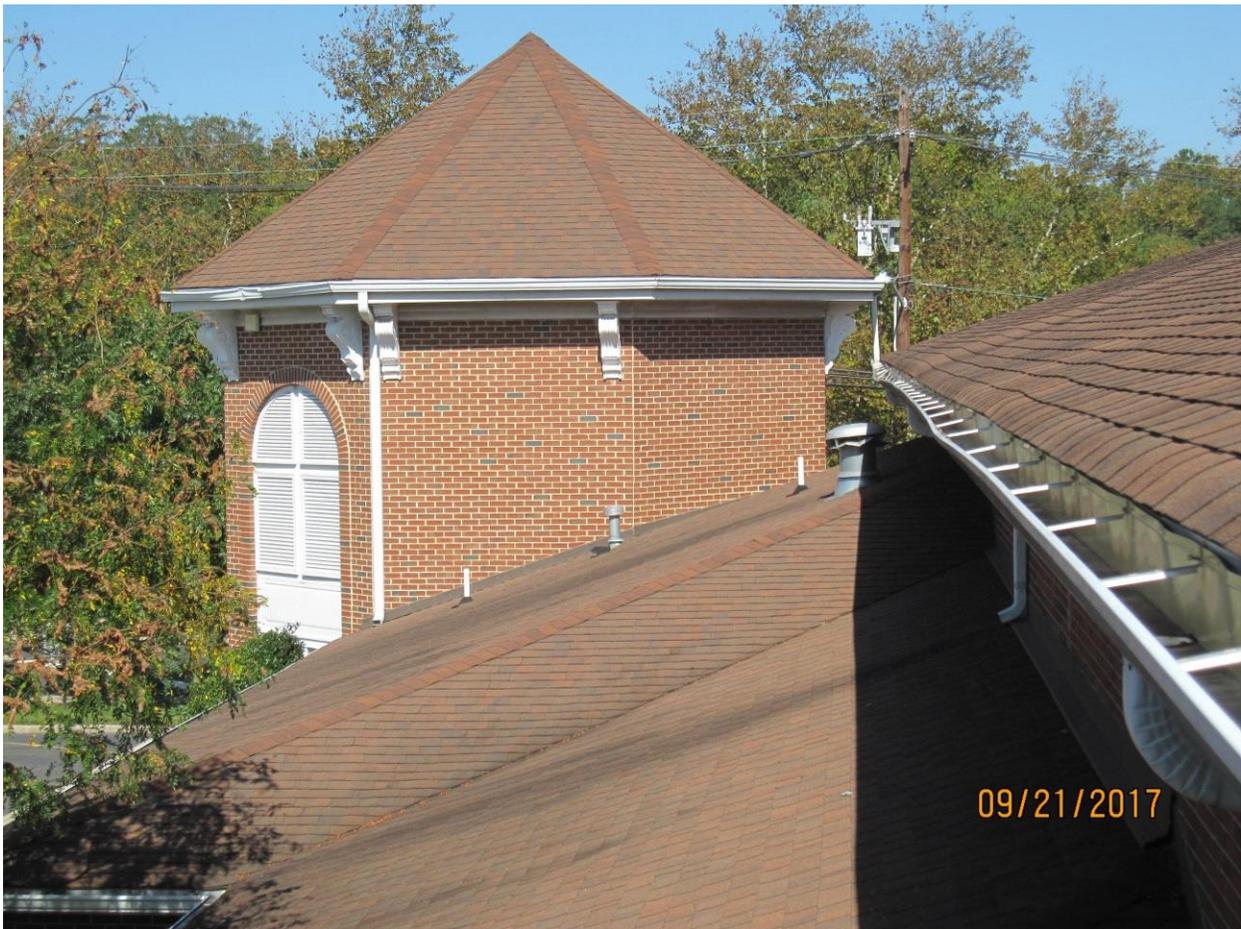
ASPHALT SHINGLE ROOF APPEARS TO BE IN GOOD CONDITION.
NO MAJOR ISSUES OBSERVED
