Colonial Fire Company  
Fire Engine #18  
81 Kuser Road, Hamilton, NJ 08619

## Feasibility Study

December 7, 2017

## **Fire Station # 18, Colonial District 8 – Audit**

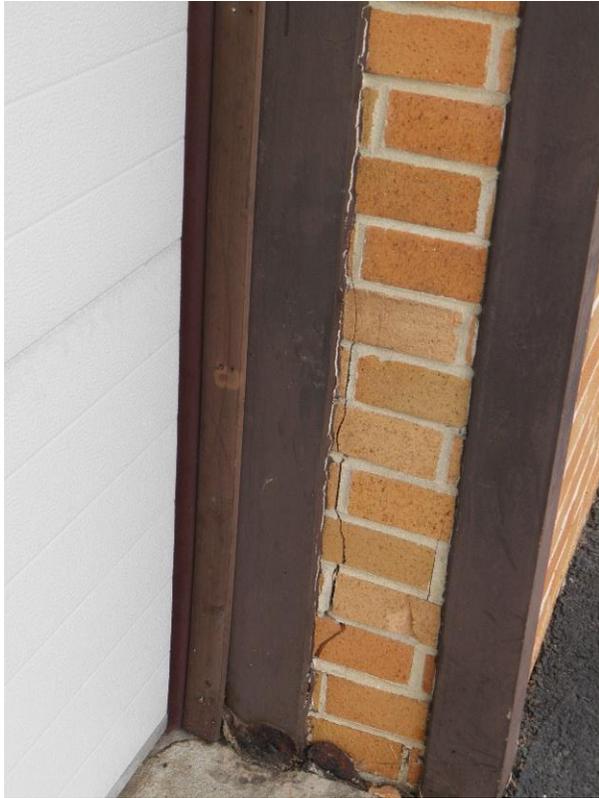
VISIBLE CRACK IN BRICK WALL

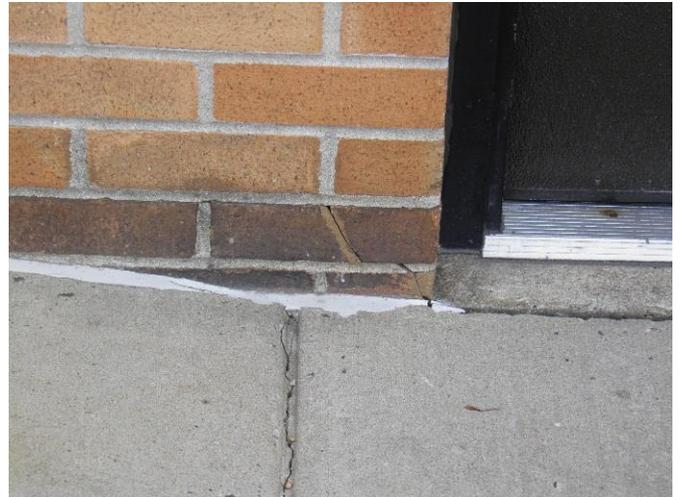
VISIBLE CRACK IN BRICK WALL AND CONCRETE PAVERS

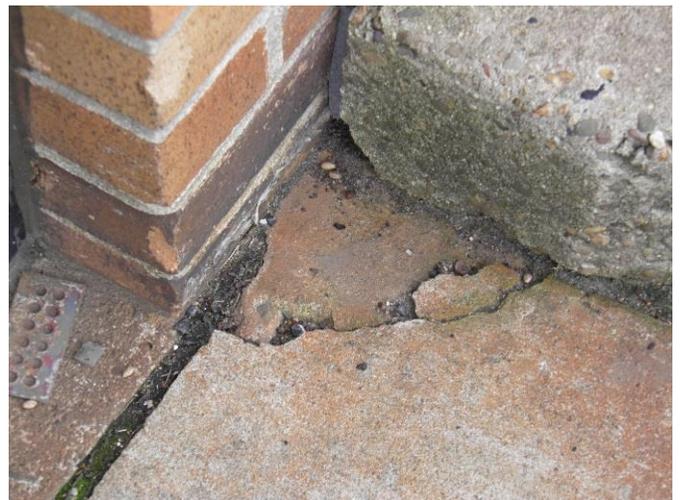
DAMAGED CONCRETE PAVER

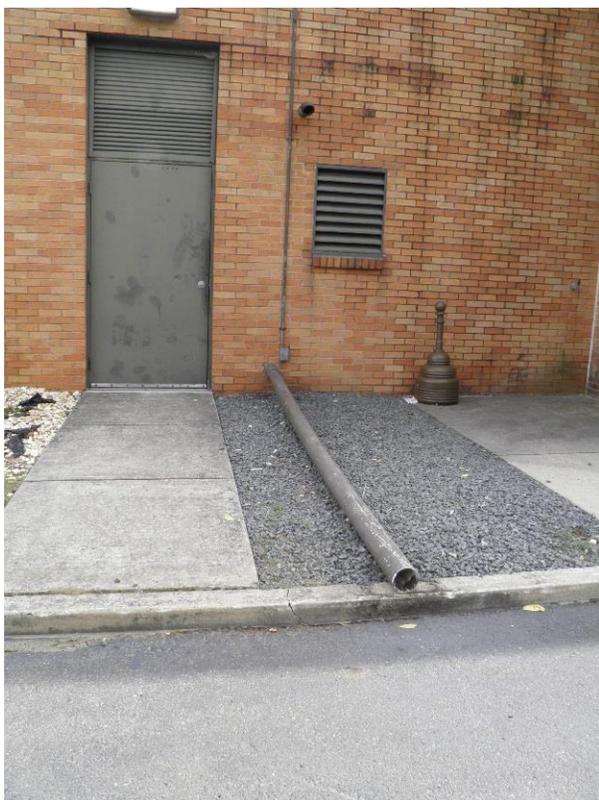
EXPOSED DRAIN PIPE IS A POTENTIAL TRIPPING HAZARD

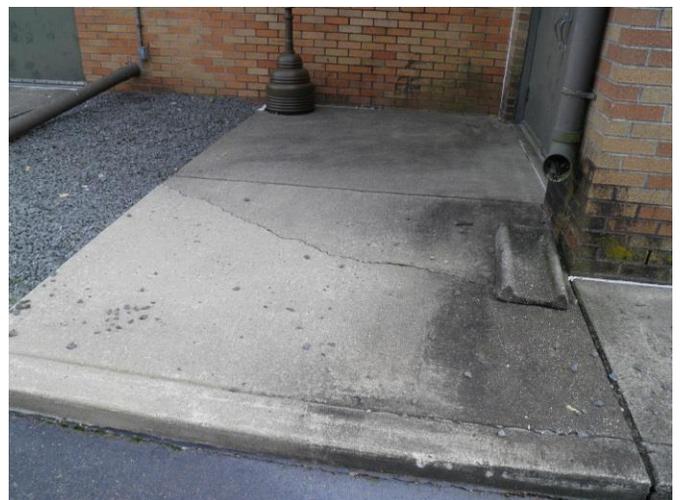
VISIBLE CRACK IN THE CONCRETE PAVERS & SIGNS OF MOSS GROWTH ON WALL

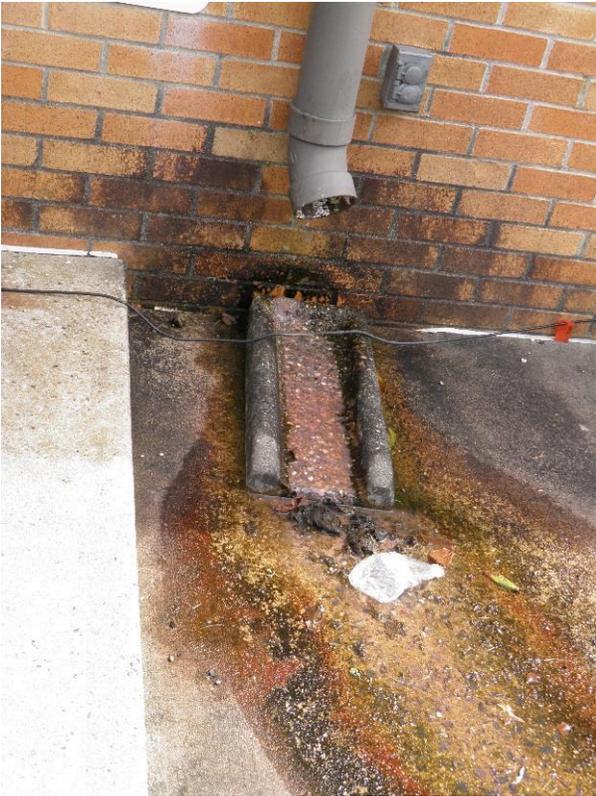
VISIBLE STAIN ON BRICK WALL & GROUND FROM ROOF RUNOFF

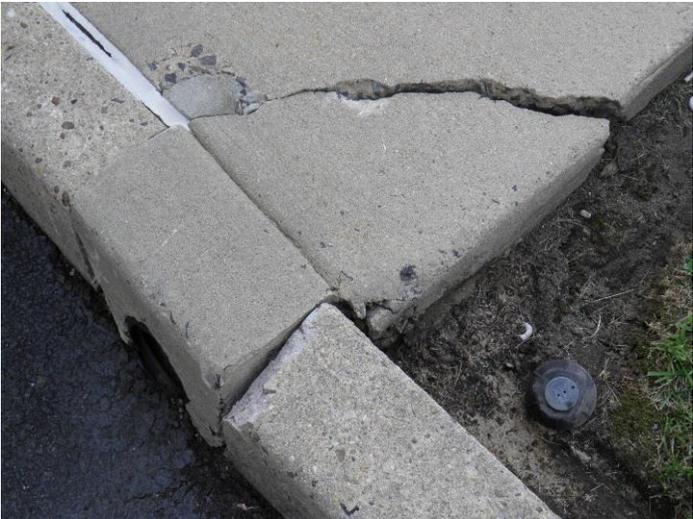
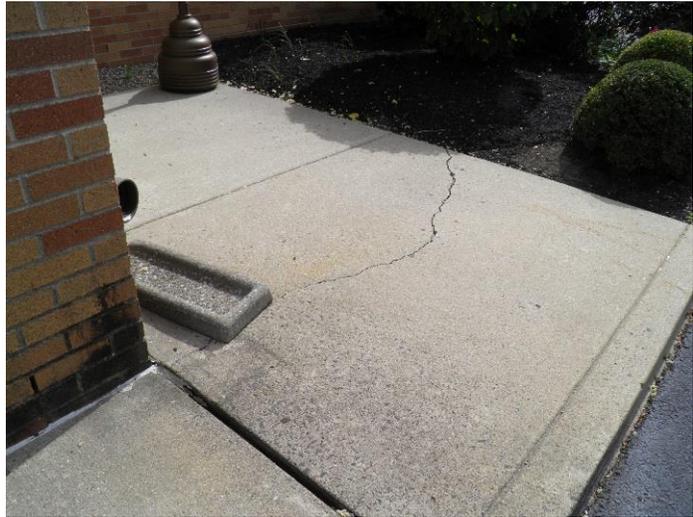
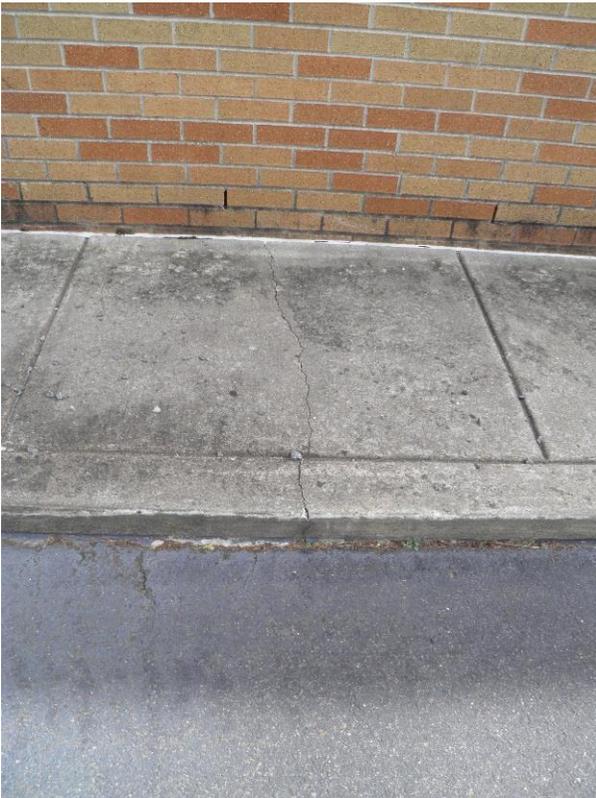
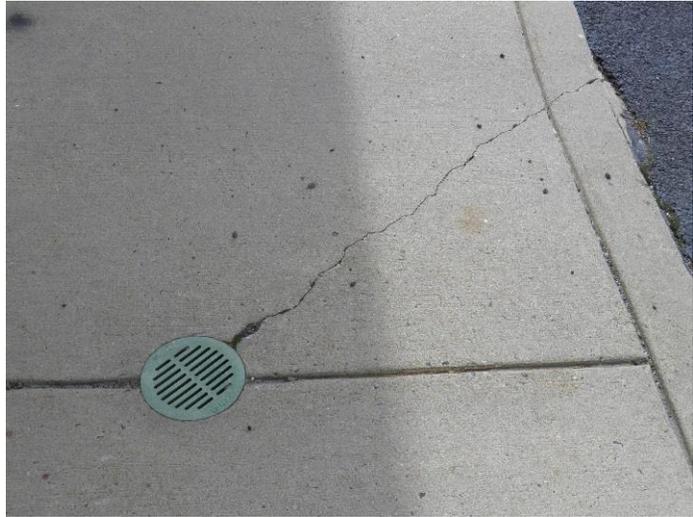
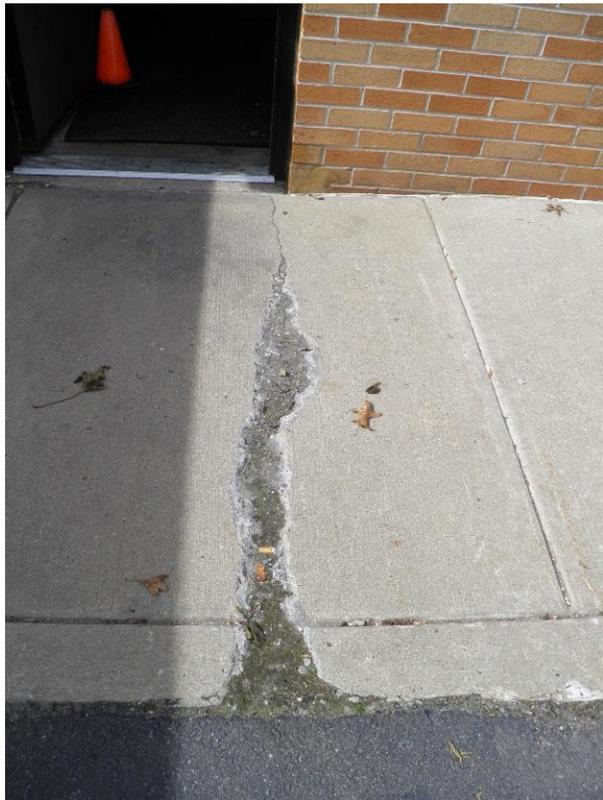
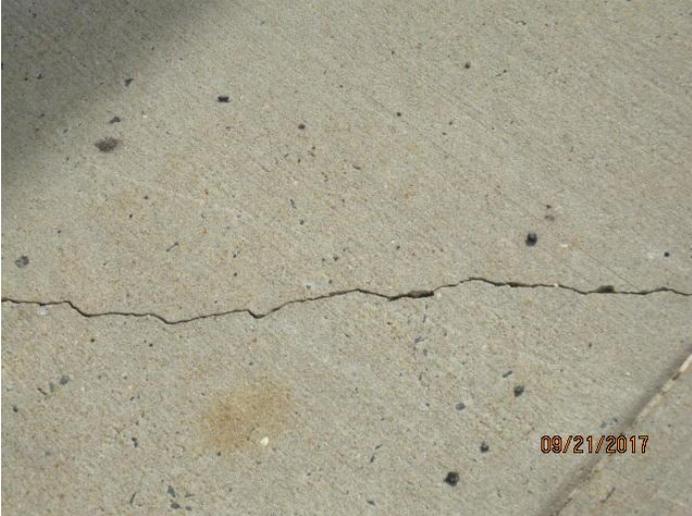
- E. The concrete sidewalks around the building are in poor condition with many cracks and spalls.
- F. The parking lot is in poor condition with many pot holes and cracks.

VISIBLE CRACK IN THE CONCRETE SIDEWALK

| <u>Work Item</u> | <u>Estimated Cost Opinion</u> |
|--|---|
| iv. Replace the concrete sidewalks around the building | \$50,000 |

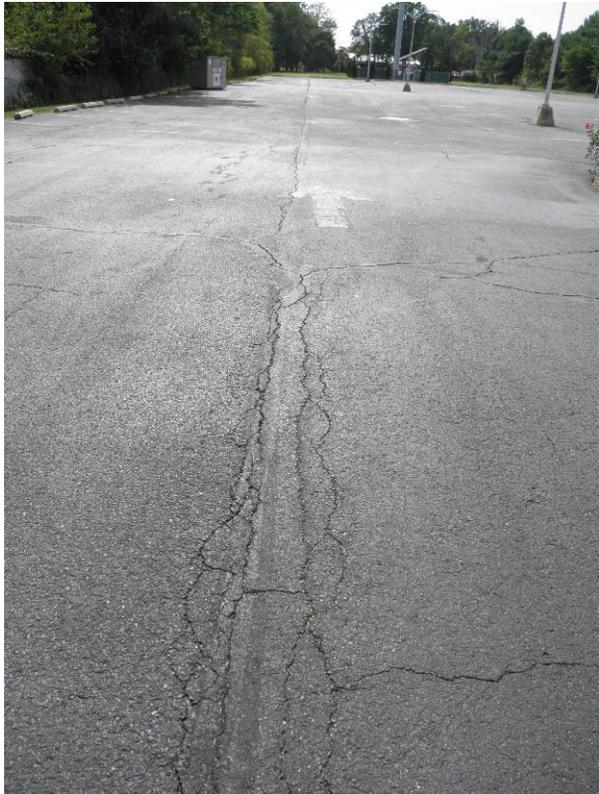
- A. The station does have adequate fire truck maneuverability and turn-around space.
- B. The asphalt driveway between the truck concrete apron and street is in poor condition with several cracks.

VISIBLE CRACKS IN THE DRIVEWAY

| <u>Work Item</u> | <u>Estimated Cost Opinion</u> |
|--|---|
| i. Replace the asphalt driveway in front of the truck apron | \$240,000 |

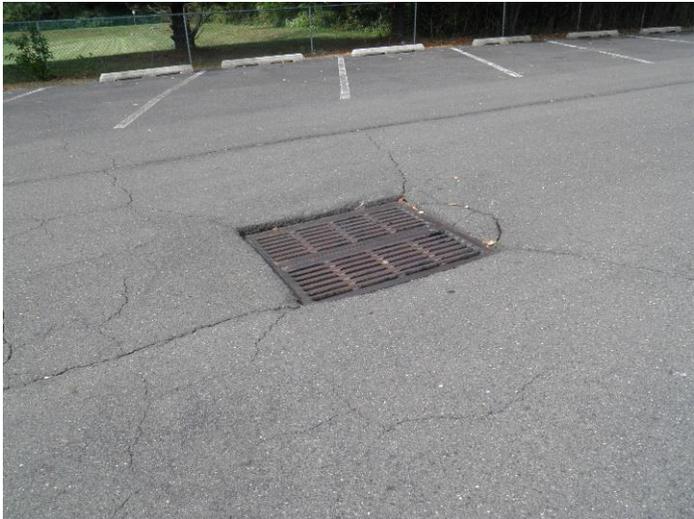
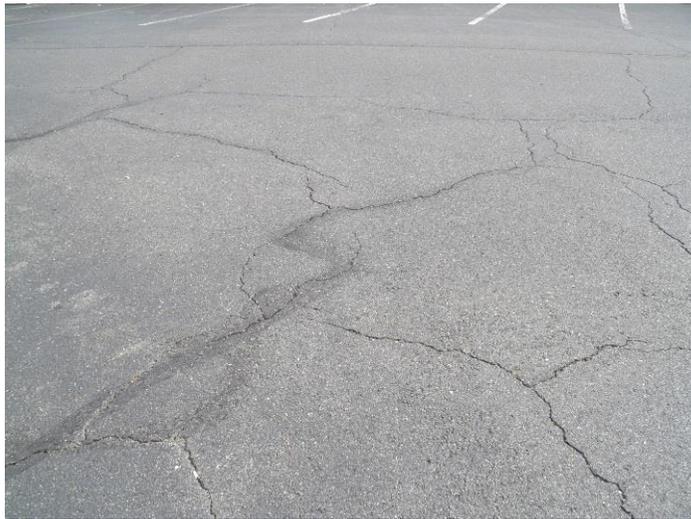
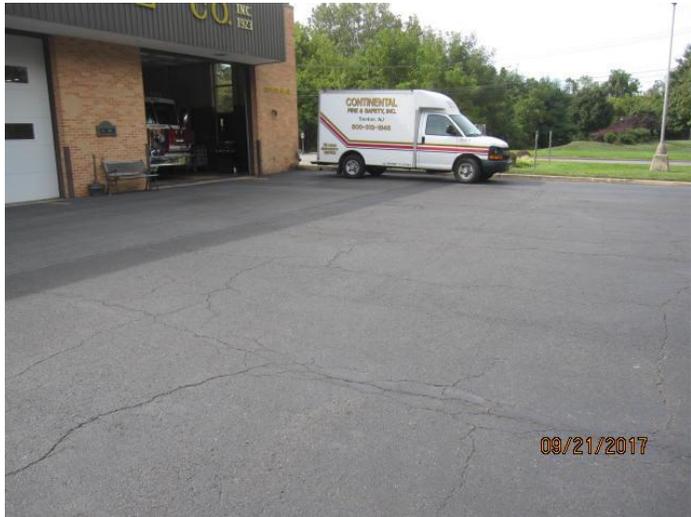
VISIBLE CRACKS IN THE PARKING LOT

| <u>Work Item</u> | <u>Estimated Cost Opinion</u> |
|--|---|
| v. Replace the parking lot | \$2,000,000 |

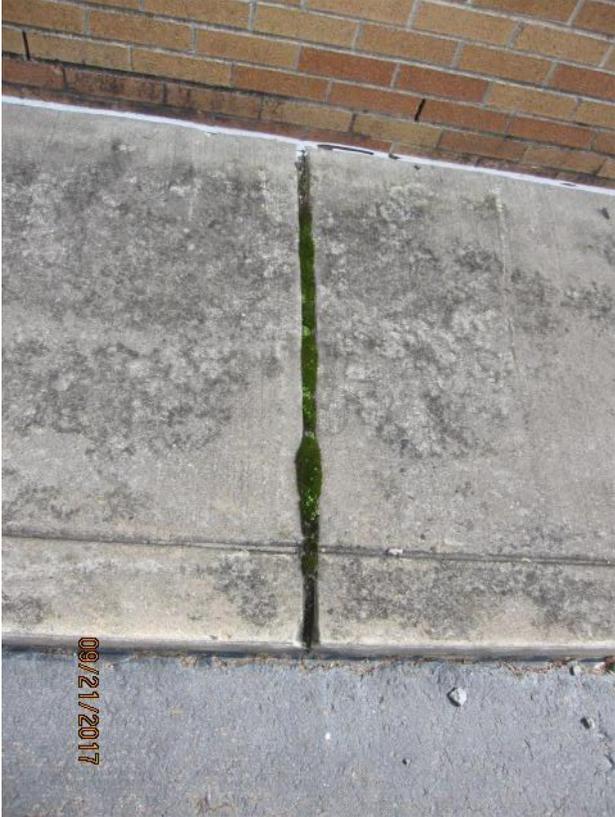
MOSS GROWTH IN CONCRETE SIDEWALK JOINT

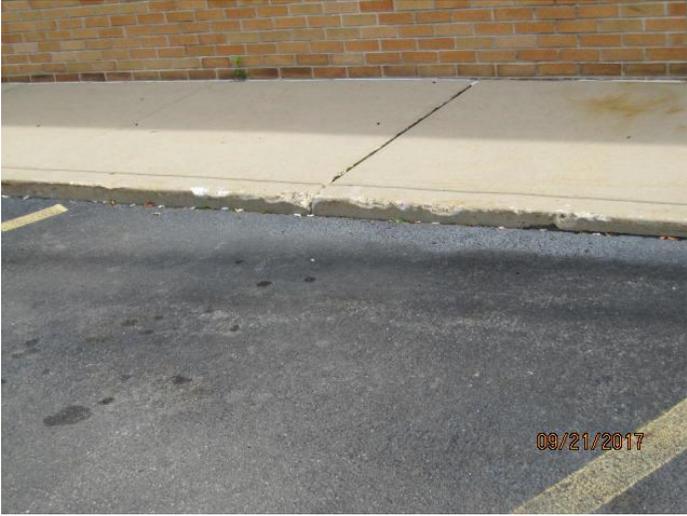
- C. The concrete curb located between the asphalt apron and street is in poor condition containing many spalls and cracks.
- D. There are several cracks and eroded mortar joints in the freestanding brick building sign.

VISIBLE DAMAGE TO THE CONCRETE CURB

| <u>Work Item</u> | <u>Estimated Cost Opinion</u> |
|--|---|
| ii. Replace the concrete curb located between the asphalt apron and street | \$15,500 |

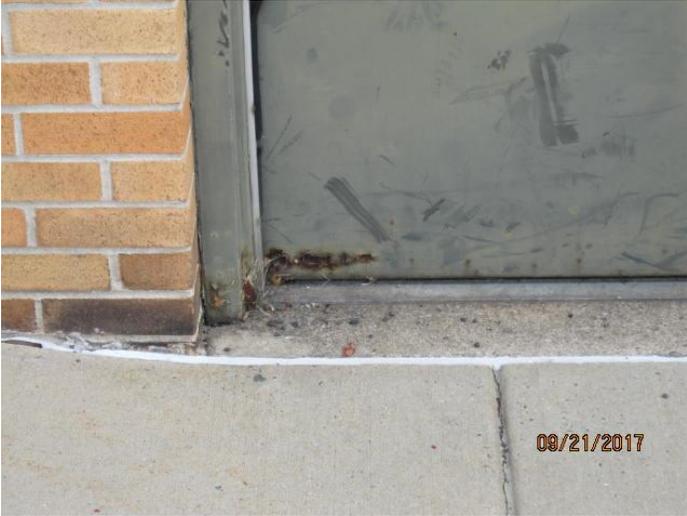
SIGNS OF CORROSION AT DOOR & FRAME

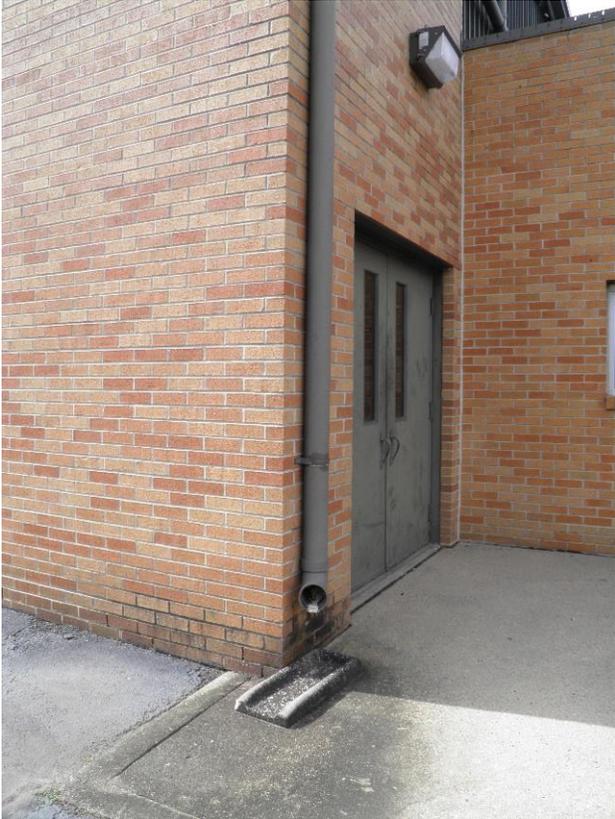
SIGNS OF CORROSION AND WATER DAMAGE AT WALL AND SIDEWALK

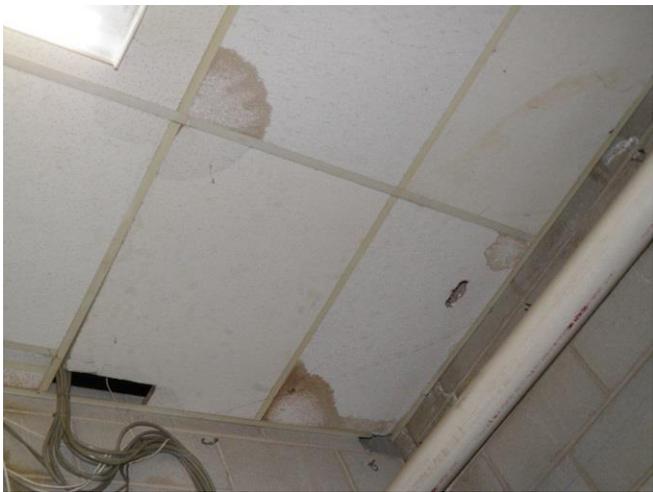
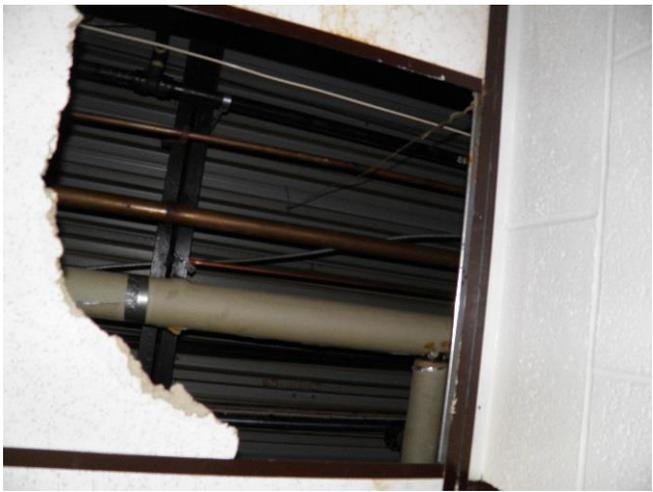
DIRTY AND DAMAGED CEILING TILES

| <u>Work Item</u> | <u>Estimated Cost Opinion</u> |
|--|---|
| ii. Replace acoustical ceiling tiles and grid | \$10,000 |

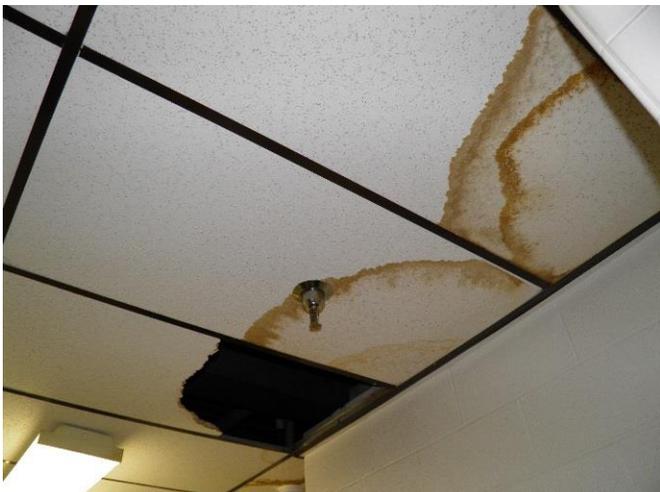
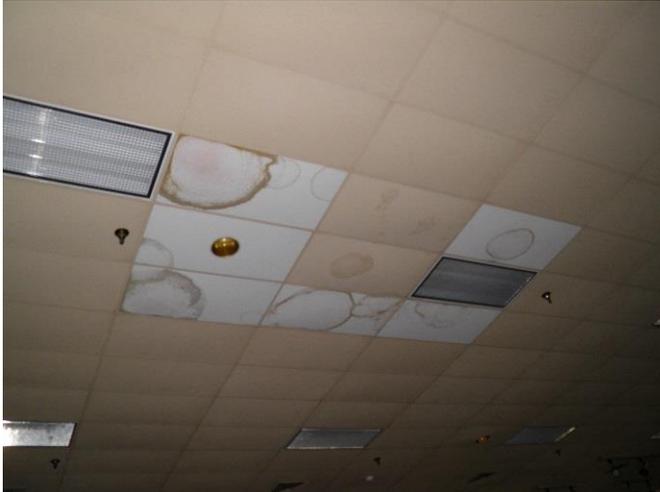
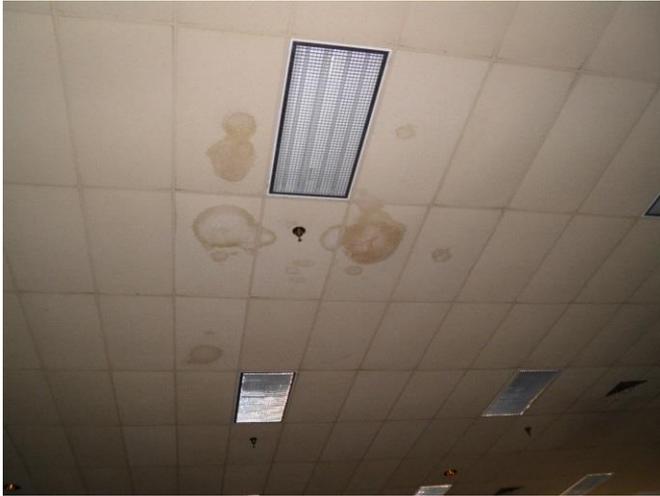
SIGNS OF WATER DAMAGE ON THE CEILING TILES

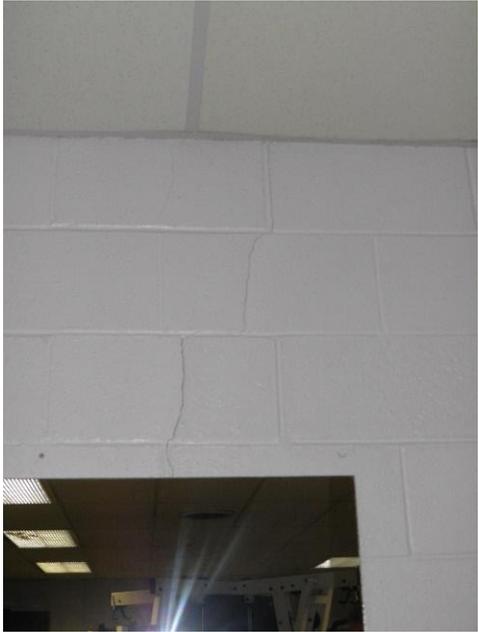
1. The banquet hall has an attached commercial kitchen which is also used by the fire fighters when on a shift. The kitchen, and pantry are in fair condition.
2. The halls maximum occupancy 590 with tables and chairs.
3. There are mens and womens non barrier free bathrooms located off the banquet hall which are in fair condition.
4. There is one unisex bathroom located within the kitchen area which is in fair condition.
5. There are several vertical crack in the concrete masonry unit (CMU) hall walls.
6. There are several damaged acoustical ceiling tiles in the general storage room.
7. There are several cracks in the CMU walls of the general storage room.

VISIBLE CRACK IN MASONRY WALL

| <u>Work Item</u> | <u>Estimated Cost Opinion</u> |
|--|---|
| i. Repair the vertical cracks in the CMU hall and general storage room walls | \$9,500 |

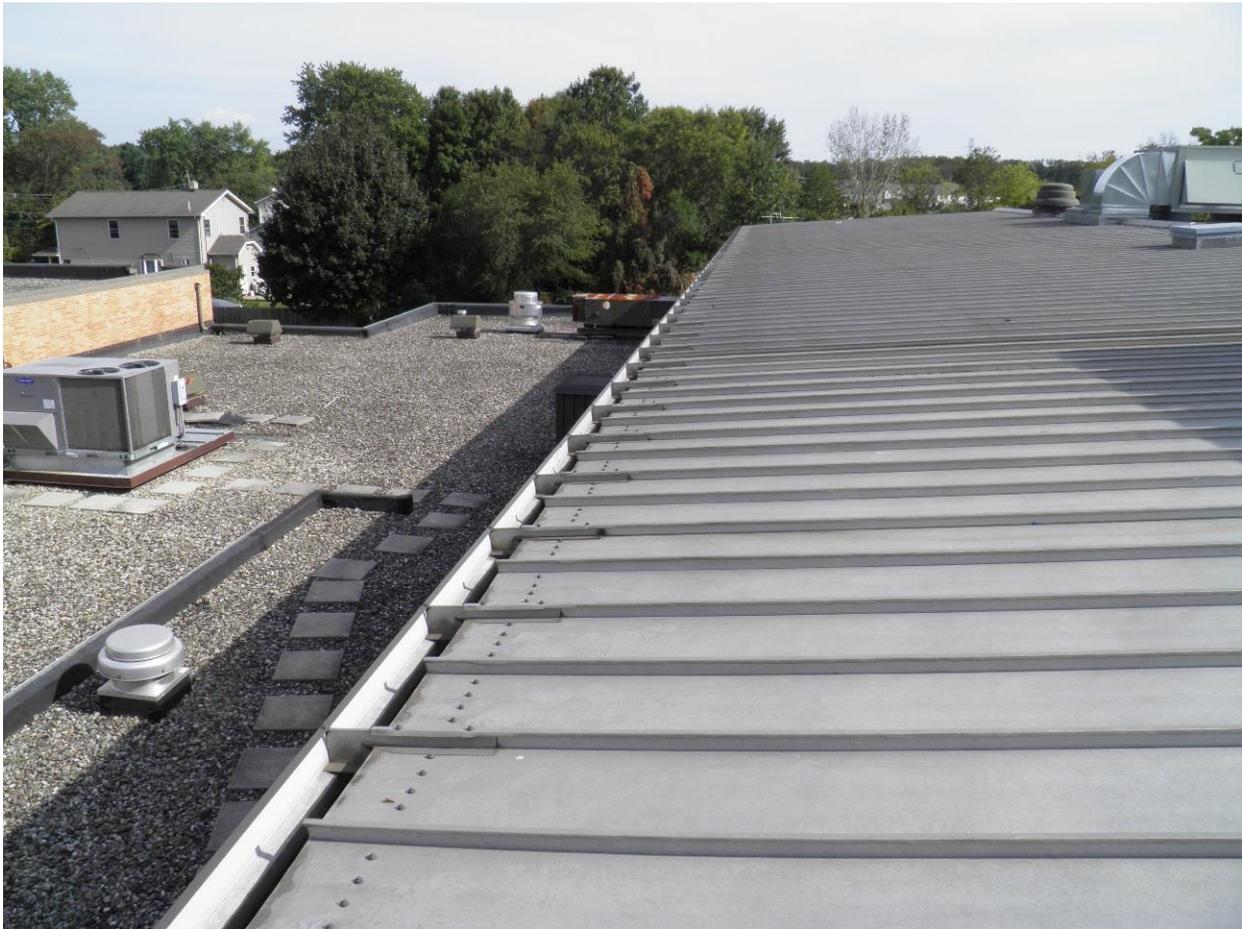
PART FLAT ROOF AND PART METAL ROOF  
ROOF APPEARS TO BE IN GOOD CONDITION.  
NO MAJOR ISSUES OBSERVED
