Groveville Fire Company  
Fire Engine #19  
4201 Crosswicks Hamilton Square Road  
Hamilton, NJ 08691

## Feasibility Study

December 7, 2017

## **Fire Station # 19, Groveville District 9 – Audit**

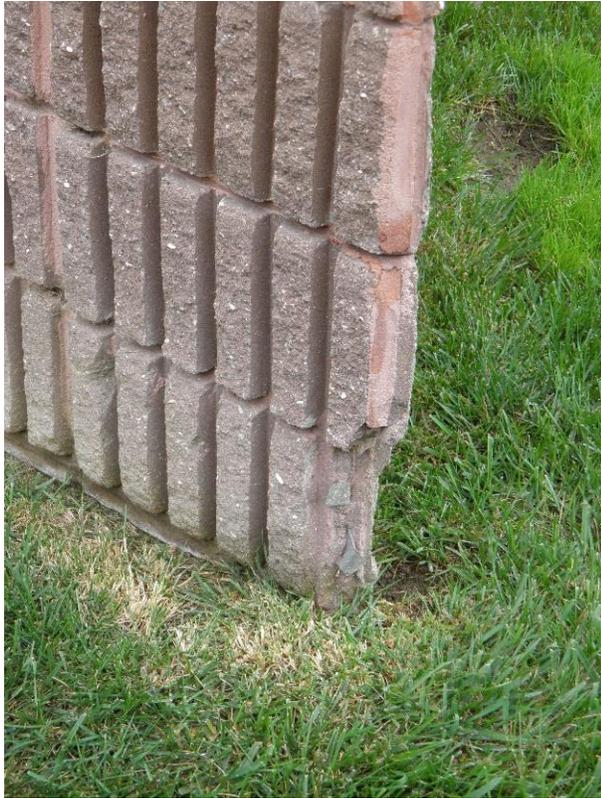
- A. Building Façade Conditions
  - 1. Crosswicks Hamilton Square Road. Elevation (South Elevation)
    - i. The overhead truck bay doors all operate properly and in fair condition.
    - ii. The split rib concrete masonry units at the base of the column at the main building entrance is damaged.

VISIBLE DAMAGE TO MASONRY WALL

i. Repair the split rib concrete masonry units (CMU) at the base of the column at the main building entrance	\$1,200
ii. Reattach the section of weathersitipping at base of overhead door	\$750
iii. Replace the hollow metal doors and frame	\$3,000
iv. Replace the aluminum windows	\$6,500

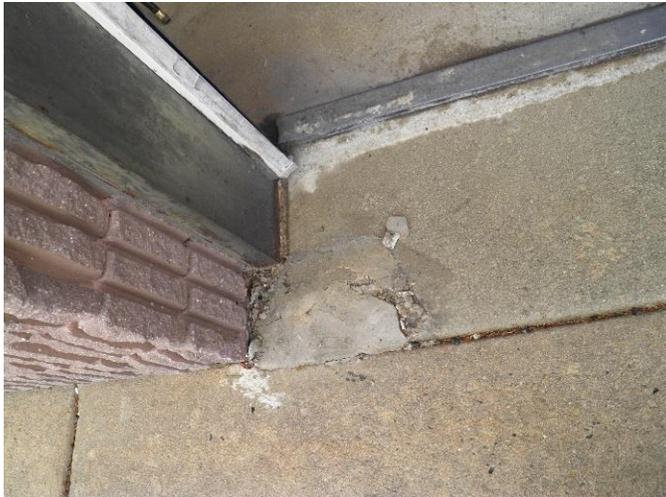
- A. The station does have adequate fire truck maneuverability and turn-around space.
- B. The concrete truck aprons are in in poor condition with several cracks and spalls.

VISIBLE PATCHES IN DAMAGED CONCRETE

<u>Work Item</u>	<u>Estimated Cost Opinion</u>
<b>A. <u>Site</u></b>	
i. Replace the concrete truck apron	\$75,000
ii. Replace the asphalt pavement between the street and the concrete truck apron	\$200,000
iii. Repair the concrete sidewalks around the building	\$5,500
iv. Replace the parking lot	\$1,200,000

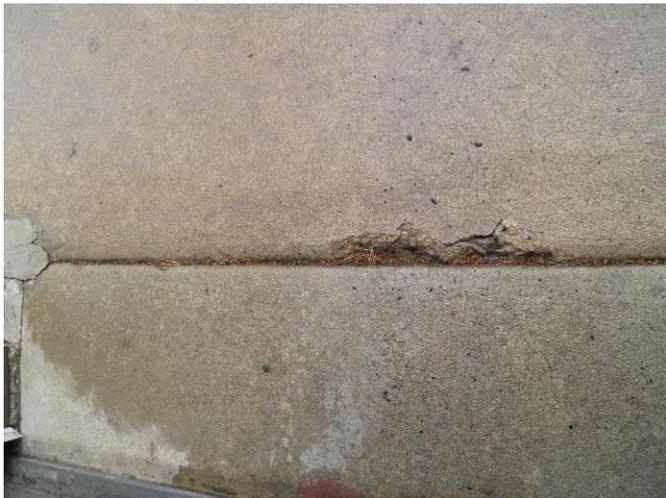
DAMAGED CONCRETE PAVER

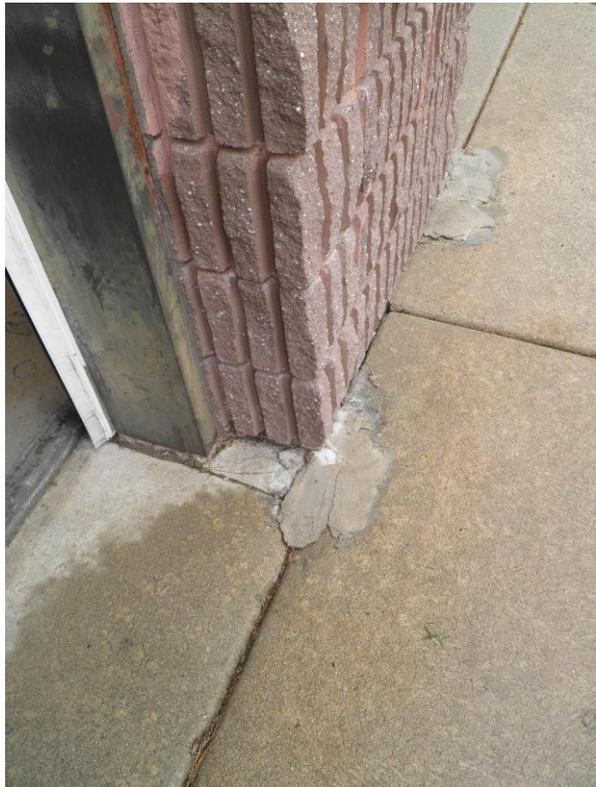
VISIBLE PATCHES IN DAMAGED CONCRETE

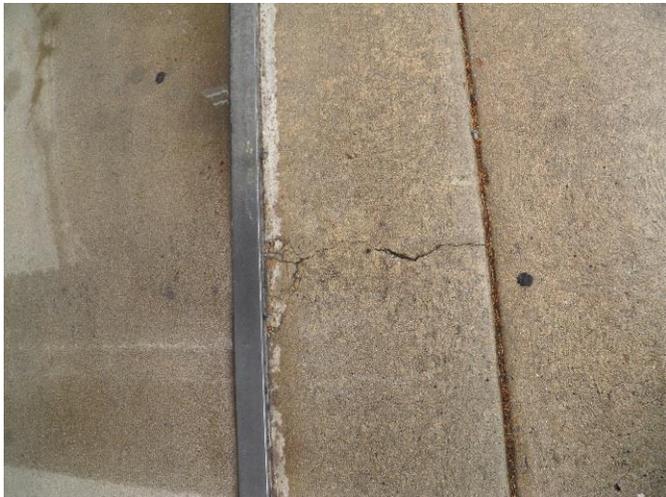
VISIBLE CRACK IN THE CONCRETE PAVERS

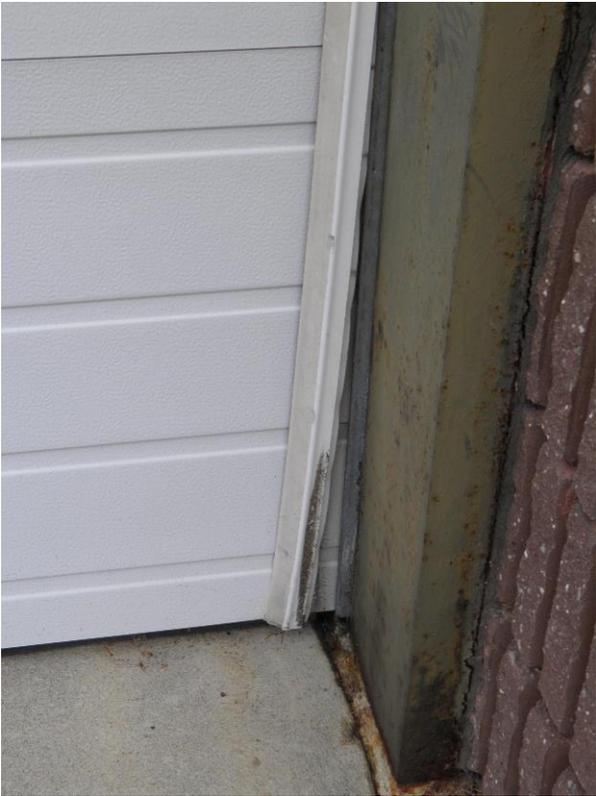
- v. The aluminum storefront doors and frame are in fair condition.
2. East Elevation
- i. There are no overhead truck bay doors on this elevation.
  - ii. The hollow metal doors and frame are in poor condition and rusting at the door sill and bottom of the door frame.

VISIBLE RUST ON DOOR FRAME AND DAMAGE TO THE DOOR SEAL

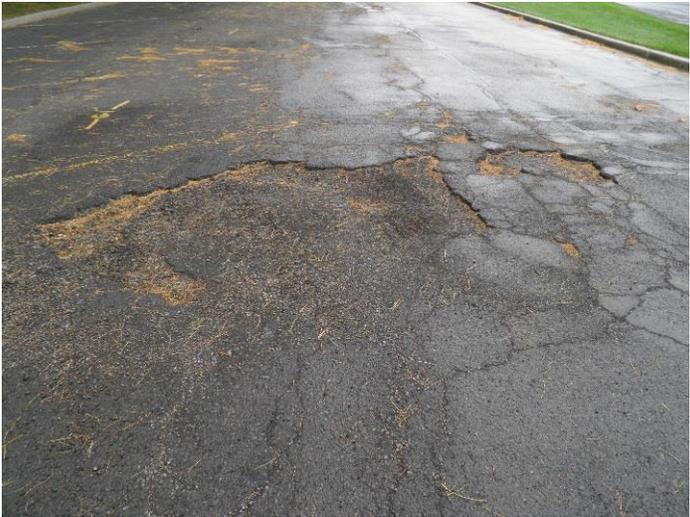
- E. The parking lot is in poor condition with many pot holes and cracks.
- H. There is a drainage issue at the northwest corner of the parking lot where the existing grass swale is emptying onto the pavement and causing extensive flooding on the parking lot.

VISIBLE CRACKS THE PARKING LOT

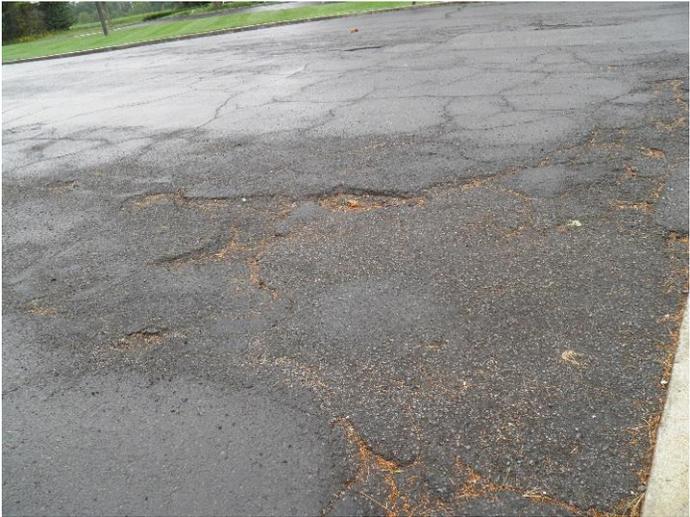
VISIBLE CRACKS THE PARKING LOT

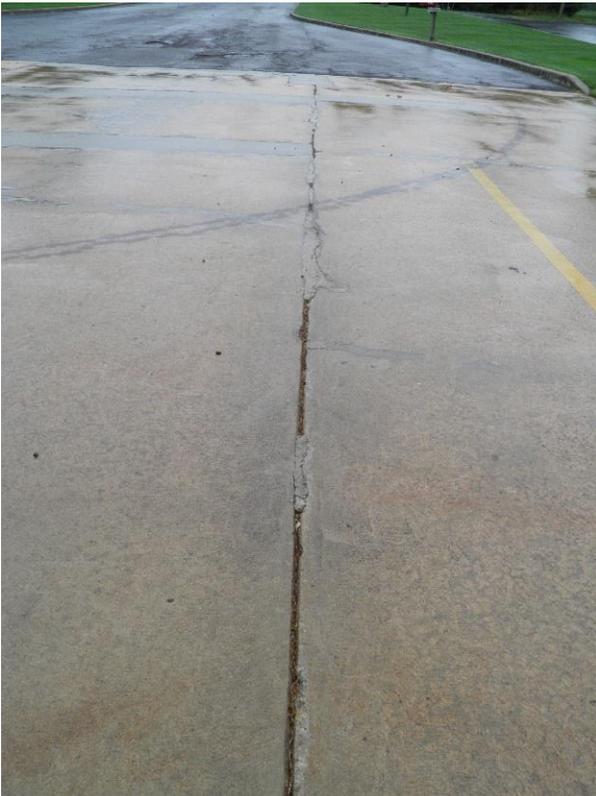
VISIBLE DAMAGE TO THE JOINT THE CONCRETE DRIVEWAY

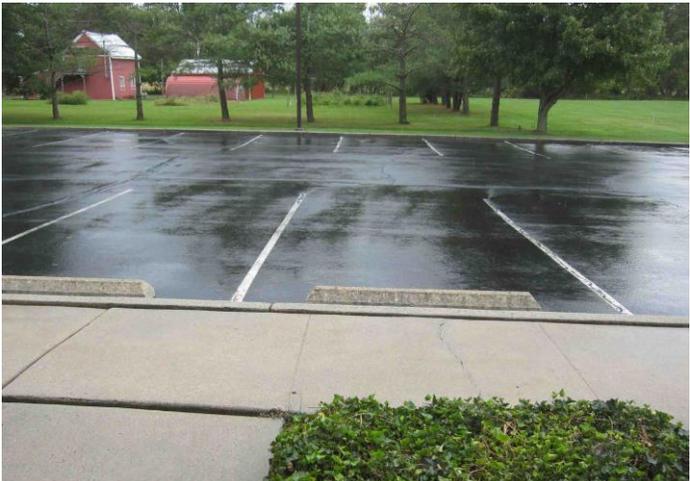
- C. The asphalt pavement between the street and the concrete truck apron is in poor condition containing many potholes and cracks.
- D. The concrete sidewalks around the building are in fair condition with a few cracks and spalls.

VISIBLE CRACKS IN THE CONCRETE SIDEWALK AND THE PARKING LOT

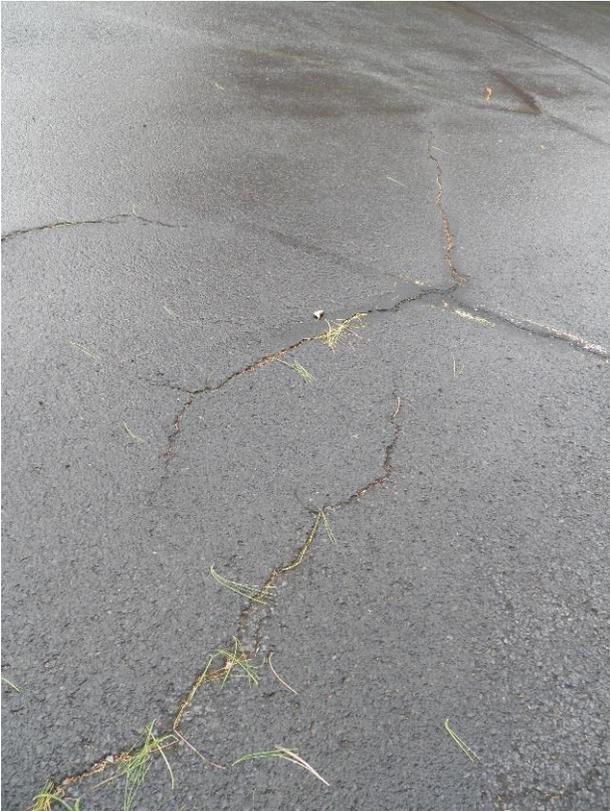
VISIBLE CRACKS IN THE DRIVEWAY

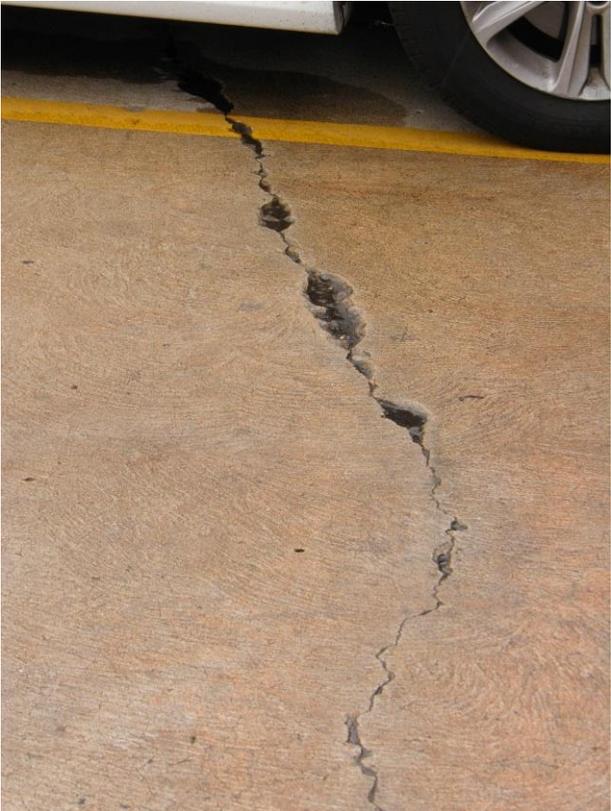
VISIBLE CRACKS IN THE CONCRETE DRIVEWAY

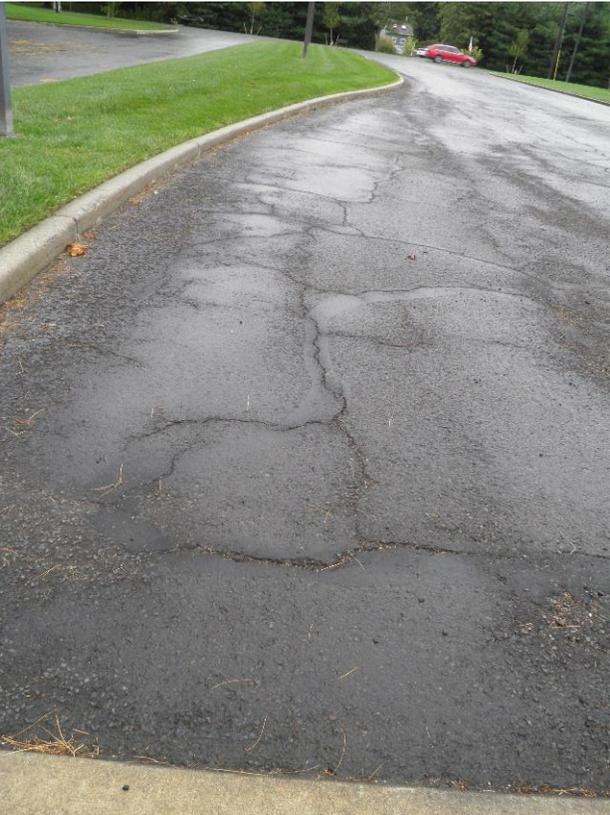
VISIBLE CRACK IN THE CONCRETE DRIVEWAY

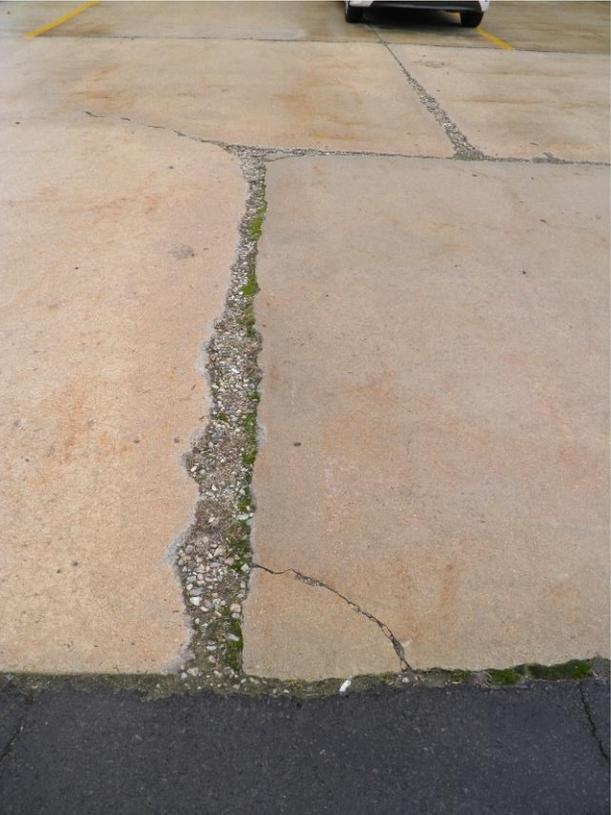
VISIBLE CRACKS IN THE CONCRETE DRIVEWAY

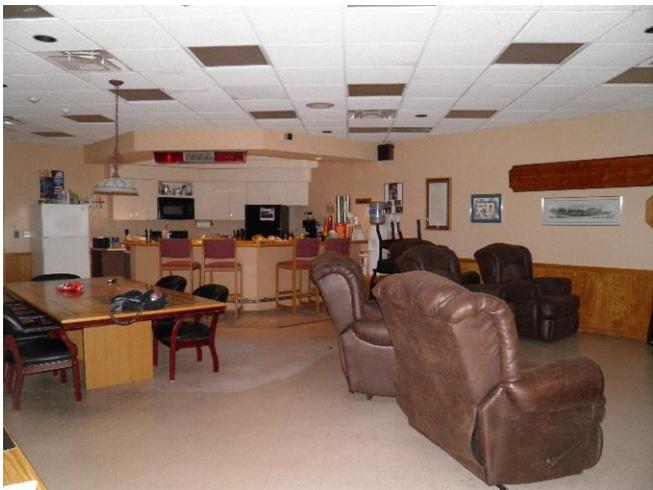
4. There are many acoustical ceiling tiles that are curling upward and the metal ceiling grid is starting to rust in several locations
5. The wall covering within one of the skylight wells in the corridor that is starting to sag.

SIGNS OF WATER DAMAGE ON THE CEILING TILES

v. Replace acoustical ceiling tiles and replace ceiling grid	\$5,500
vi. Repair the wall covering within the skylight well	\$600
vii. Replace the kitchen counters and cabinets	\$15,500
viii. Install a beveled termination piece at the differing floor finish locations	\$800
ix. Replace the VCT floor finish in the lounge area	\$2,500

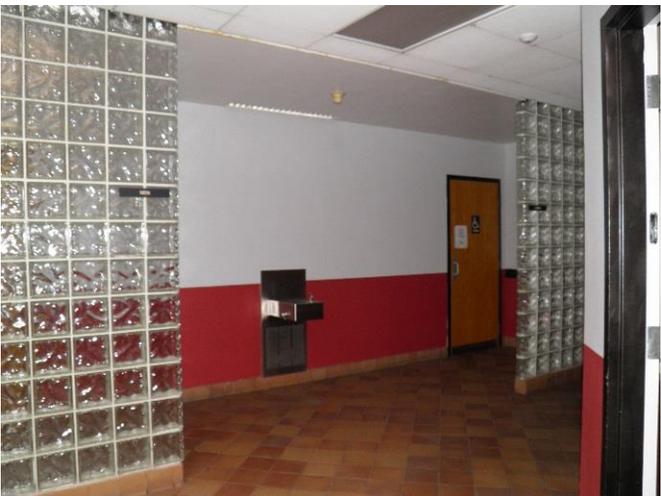
SIGNS OF RUST ON THE CEILING RUNNER FROM WATER LEAK

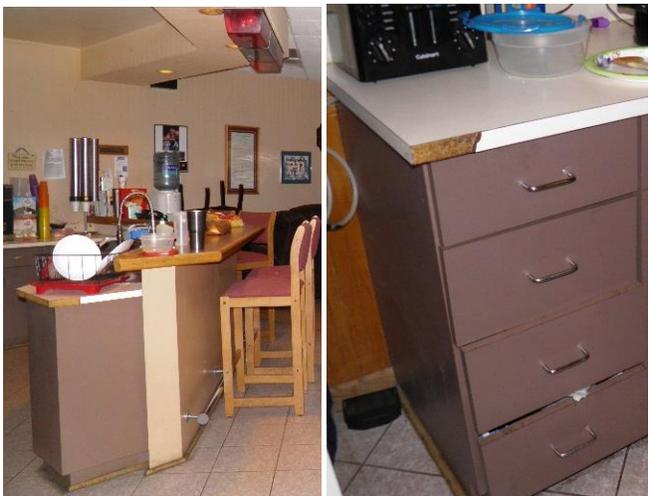
6. The kitchen is in fair condition, however the counters are in poor condition and the plastic laminate has delaminated or is missing in several locations. The kitchen appliances are old and in poor condition. The bottom shelf inside the kitchen cabinet is damaged and warping. There is an unbeveled edge at raised floor tile around the kitchen counter island which is a potential tripping hazard.

DAMAGED TO MILLWORK

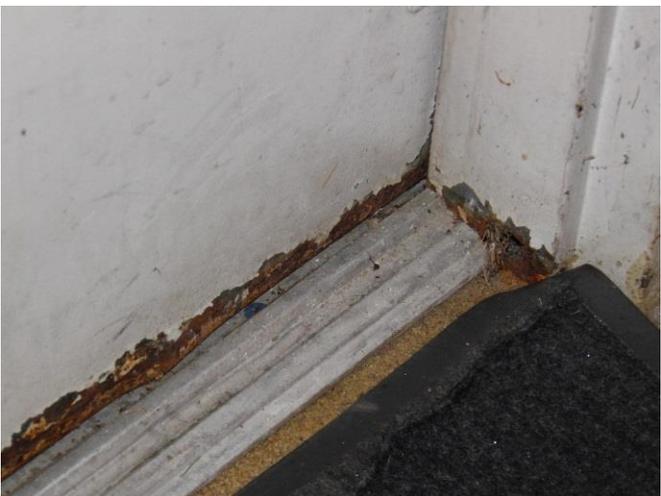
- iii. The paint on the underside of the metal roof deck is in poor condition and is peeling in many locations.
  - iv. There is a pair of hollow metal doors and door frame which are rusting.

RUSTED DOOR AND FRAME

i. Repair the epoxy coated floor finish Engine/Apparatus Room	\$2,500
ii. Repair the vertical crack in the (CMU) walls	\$3,500
iii. Install a suspended acoustical ceiling within the Engine/Apparatus Room	\$30,000
iv. Replace the pair of hollow metal doors and frame	\$6,500

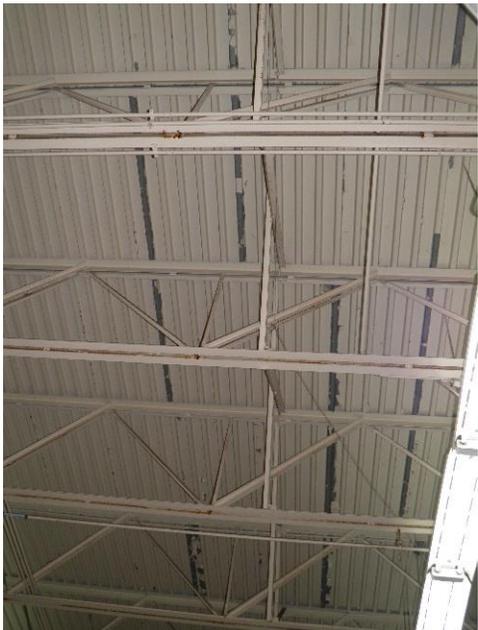
PAINT PEELING OFF ROOF METAL DECK

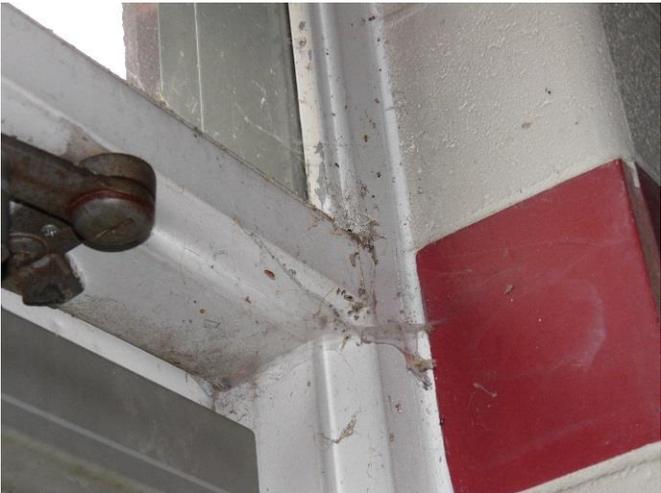
DIRT AND SPIDER WEB ON DOOR FRAME

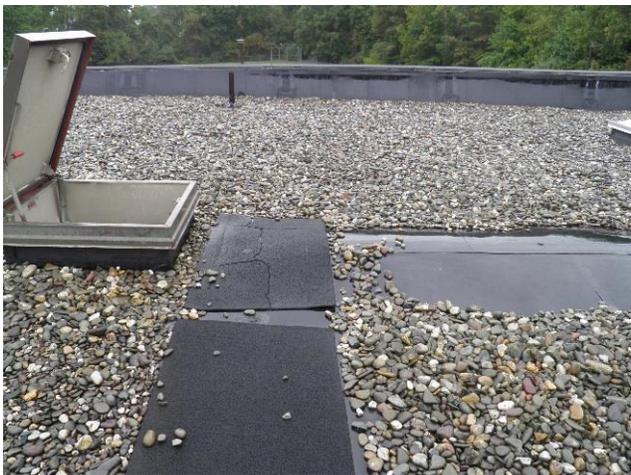
- v. The precast concrete panel joint sealant material is alligating and oxidizing causing it to split open.
- B. Roofs
- i. An original single ply membrane roofing system with ballast is on all the roofs and all are in poor condition and require frequent maintenance to keep them water tight,

DISPLACED GRAVEL EXPOSING ROOF MEMBRANE AND CRACKED WALK PADS

v. Replace the sealant at the expansion joints	\$2,000
<b>C. <u>Roofs</u></b>	
i. Replace the single ply membrane roofing system with a built-up roofing system	\$470,000
<b>D. <u>Interior</u></b>

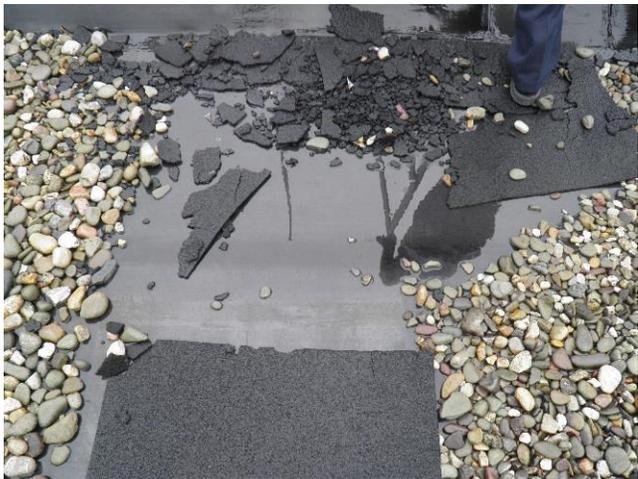
DISPLACED GRAVEL EXPOSING ROOF MEMBRANE AND DAMAGED WALK PADS

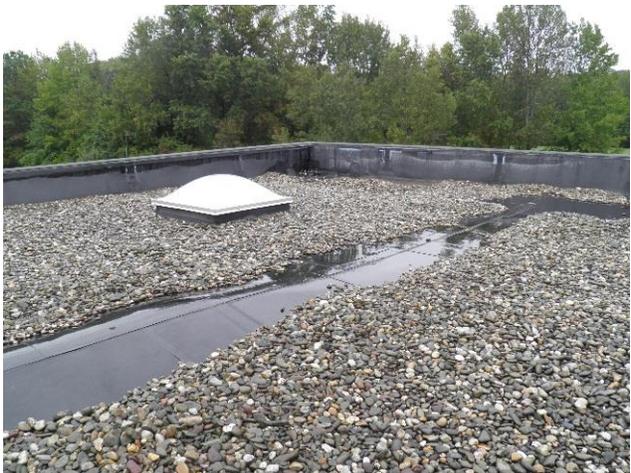
DISPLACED GRAVEL EXPOSING ROOF MEMBRANE

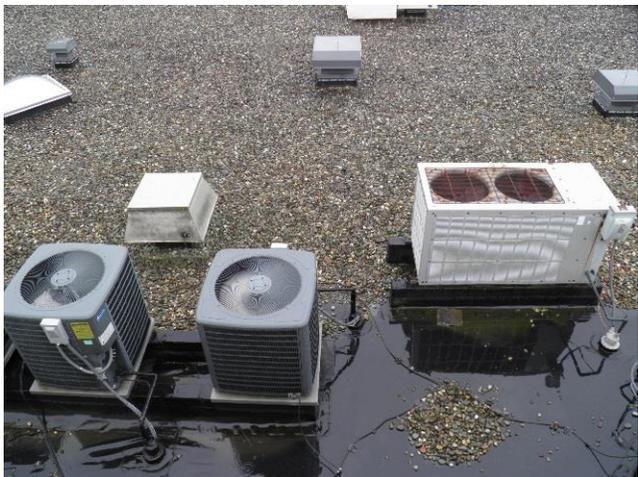
EXPOSED ROOF MEMBRANE AND WATER PONDING

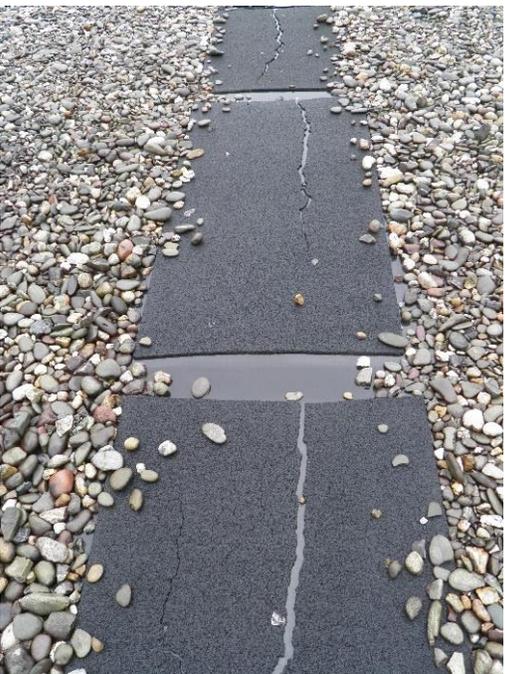
DAMAGED AND CRACKED WALK PADS

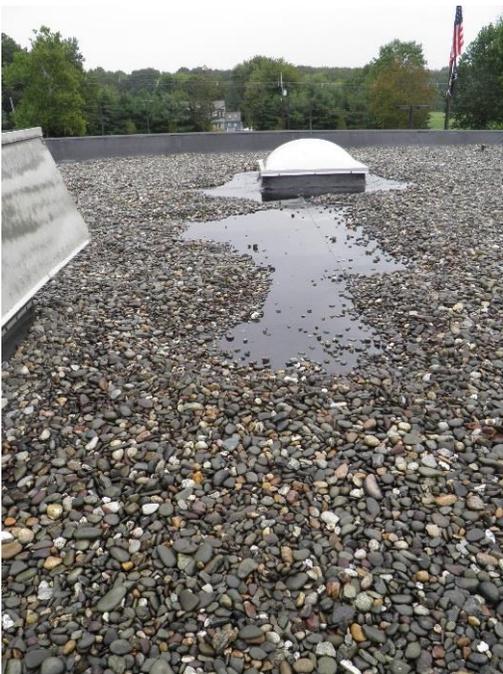
EXPOSED ROOF MEMBRANE AND WATER PONDING
