Mercerville Fire Company  
Fire Engine #12  
2711 Nottingham Way, Hamilton, NJ 08619

## Feasibility Study

December 7, 2017

## **Fire Station # 12, Mercerville District 2 – Audit**

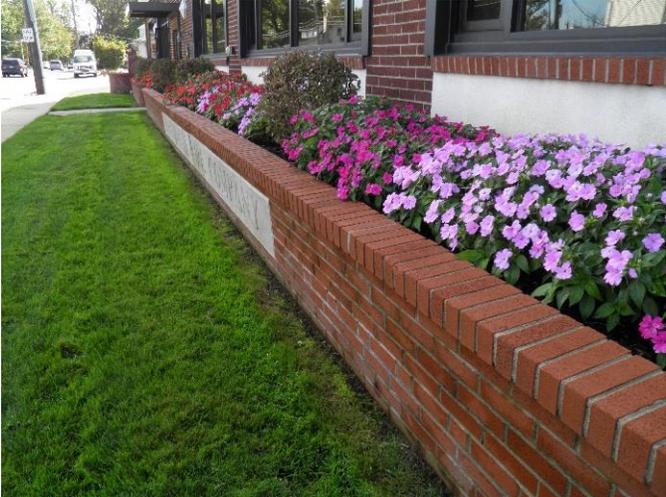
- M. The landscaping area brick walls located on Nottingham Way are in poor condition and have several severe stepped cracks which are bowing outward.
- N. The vertical sealant joint between the landscaping brick wall and the brick façade located at the corner of Nottingham Way and Whitehorse Avenue is alligating and oxidizing causing it to split open.

PLANTER WALL IS DISPLACED AND SHOWS SEVERE SIGNS OF CRACKING

x. Replace the landscaping area brick walls and provide weep holes to allow water to escape behind these walls.	\$17,000
xi. Reseal the joint between the landscaping brick wall and the brick façade	\$600

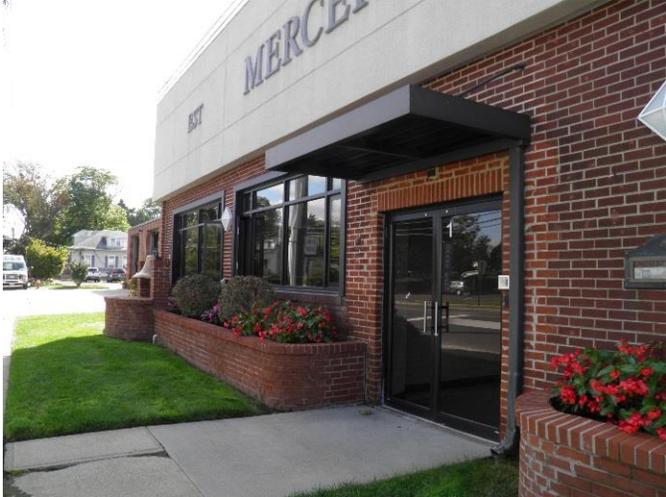
VISIBLE DAMAGE TO THE SIDEWALK AND SIGNS OF REPAIRS TO THE BRICK

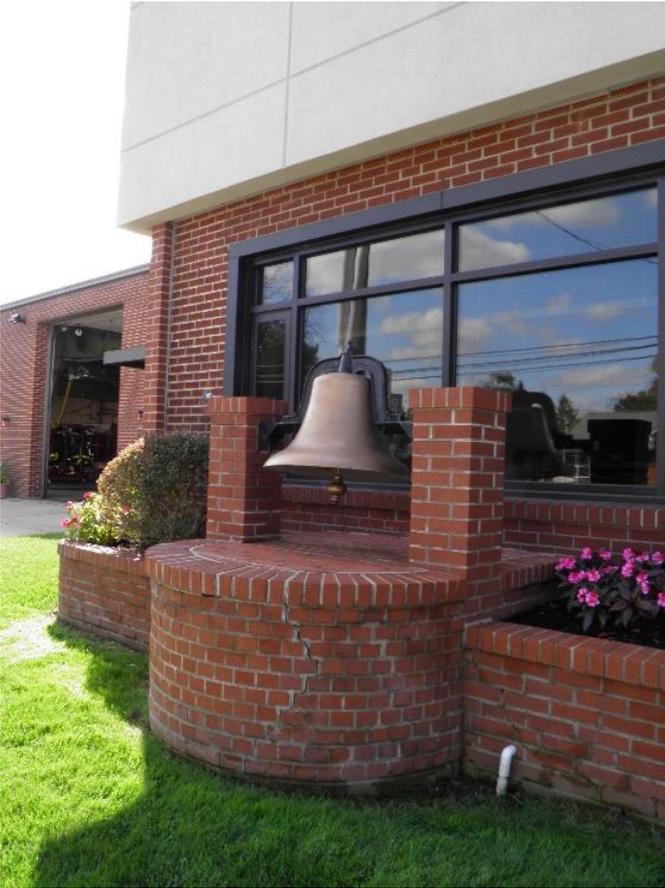
SEVERE CRACKS TO THE PLANTER BRICK WALL AND THE BELL PEDESTAL

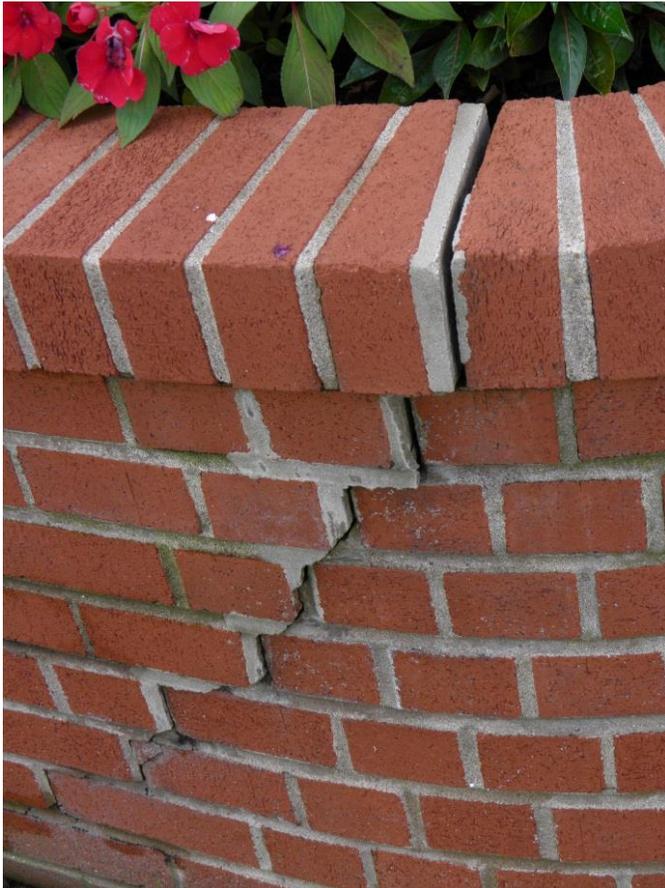
SEVERE CRACKS TO THE PLANTER BRICK WALL

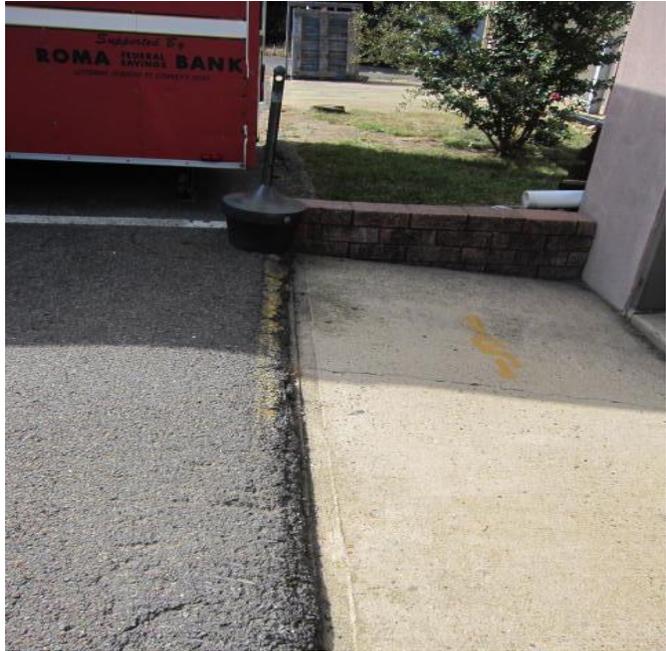
- D. One corner of the concrete landing at the personnel door leading into the side truck room entrance is raised higher than the surrounding asphalt pavement.

UNEVEN TRANSITION BETWEEN ASPHALT TOP AND CONCRETE PAVERS

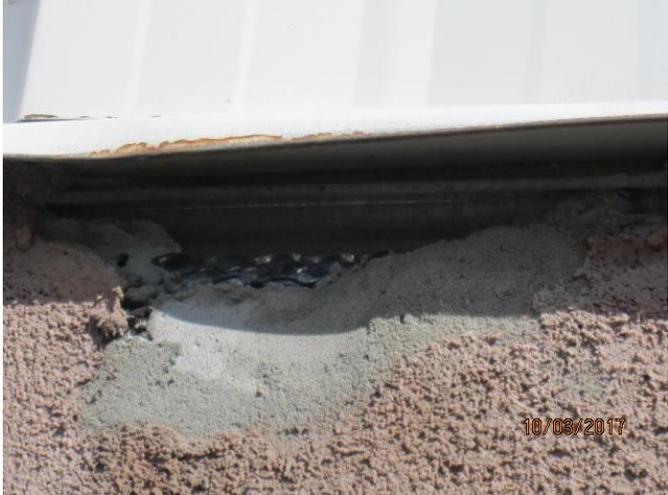
RUST IN THE METAL PANEL SIDING VISIBLE DAMAGE TO THE STUCCO FINISH

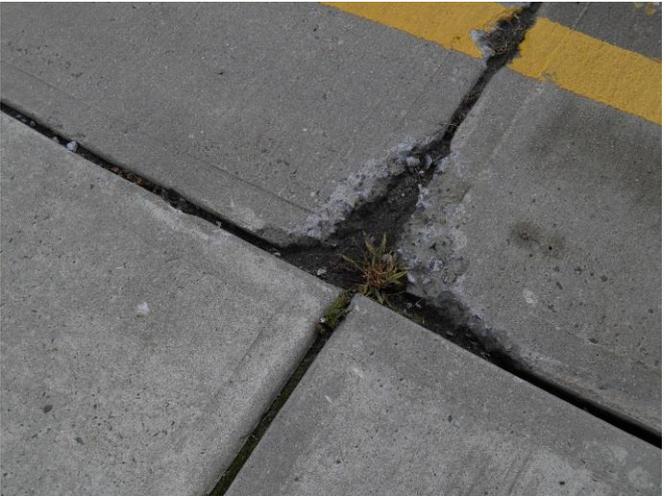
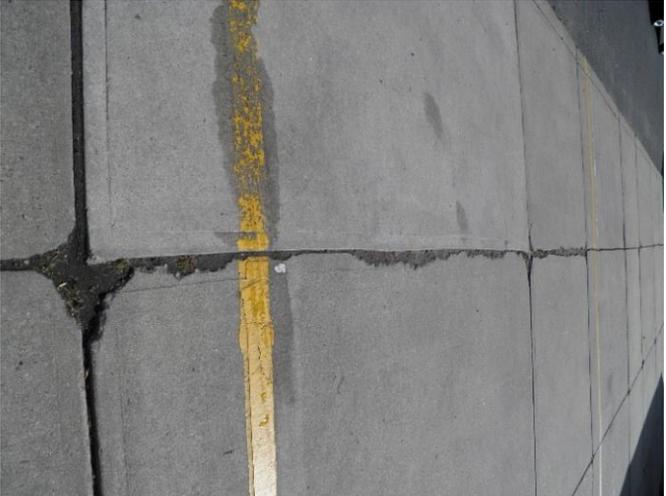
VISIBLE SIGNS OF EROSION IN THE CONCRETE SIDEWALK

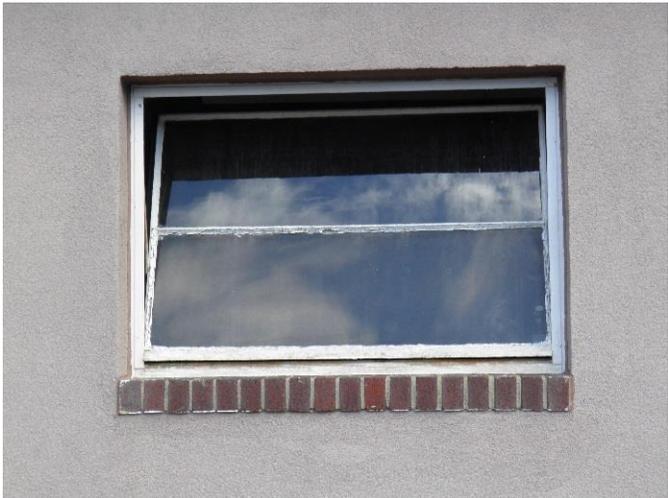
SIGNS OF RUST IN THE WINDOW FRAME AND BLISTERING IN THE GLASS SEALANT

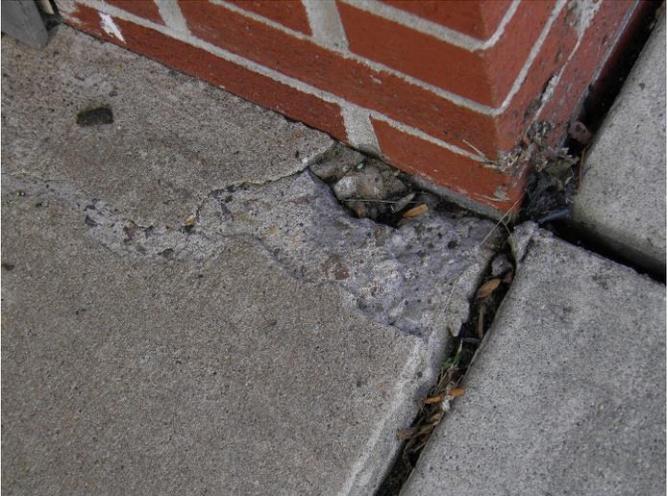
SPALLING IN THE CONCRETE SIDEWALK

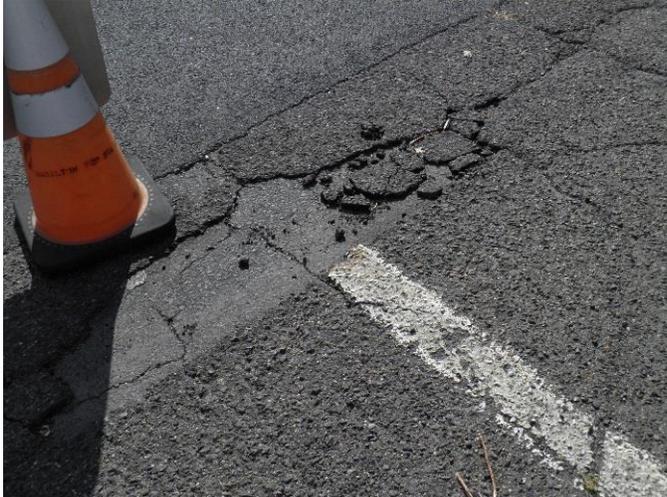
- A. The station has adequate fire truck maneuverability and turn-around space.
- B. The parking lot located off Nottingham Way and in the rear of the facility are in poor condition with multiple cracks and pothole areas.

VISIBLE CRACKS IN THE PARKING LOT

<u>Work Item</u>	<u>Estimated Cost Opinion</u>
A. <u>Site</u>	
i. Replace the asphalt paving base and top wearing course throughout the parking lot.	\$200,000
ii. Replace the concrete apron in front of the overhead side door truck entrance and re-pitch it away from the building.	\$4,500
iii. Raise the adjacent area drain accordingly.	\$850
iv. Repair the concrete apron spalls and cracks	\$10,000

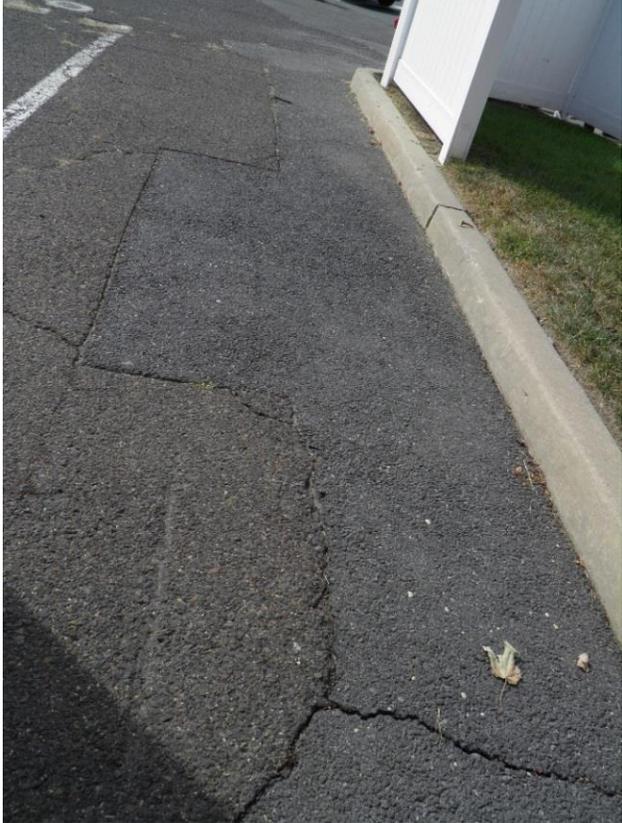
VISIBLE CRACKS IN THE PARKING LOT

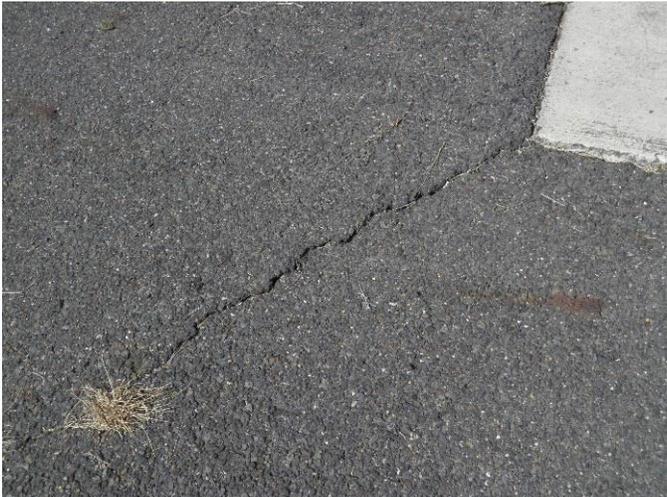
VISIBLE CRACKS IN THE PARKING LOT

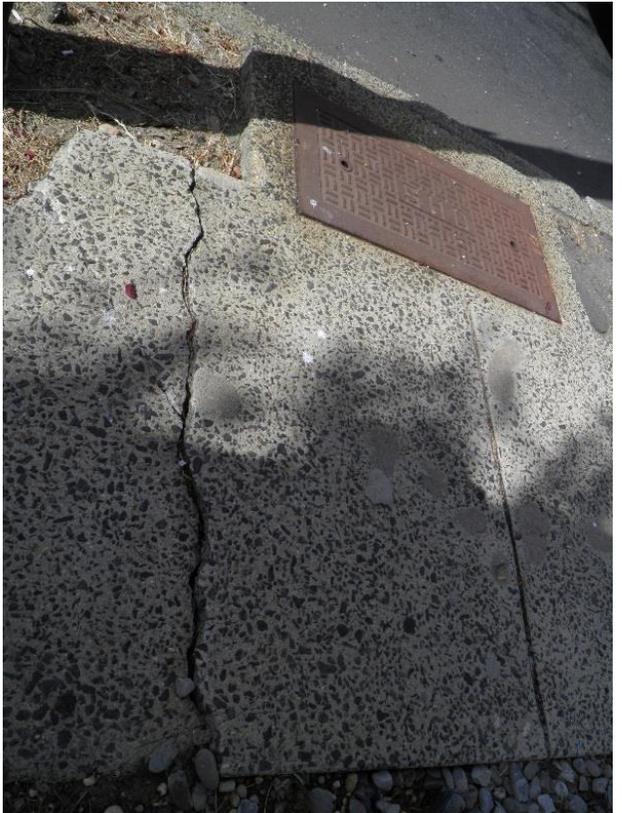
VISIBLE CRACKS IN THE PARKING LOT

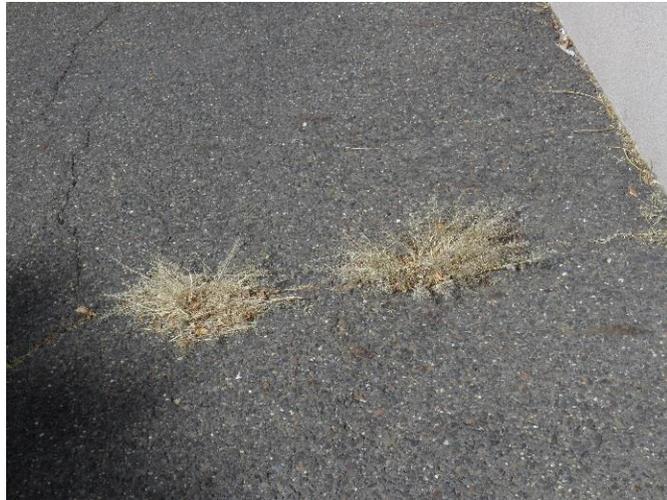
VISIBLE CRACKS IN THE PARKING LOT

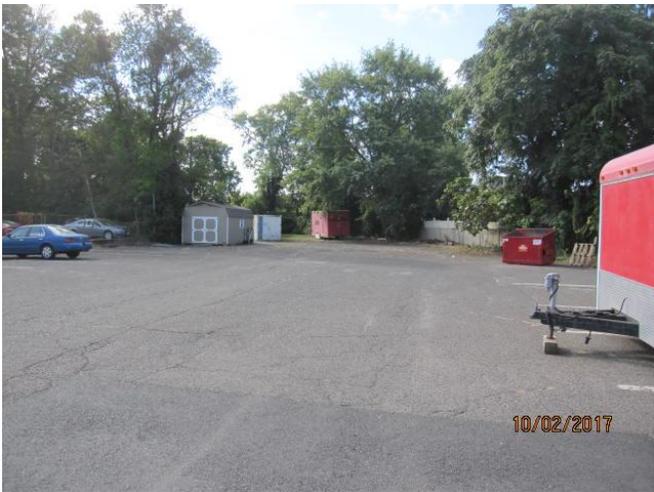
SEVERAL CRACKS ARE VISIBLE IN THE PARKING AREAS

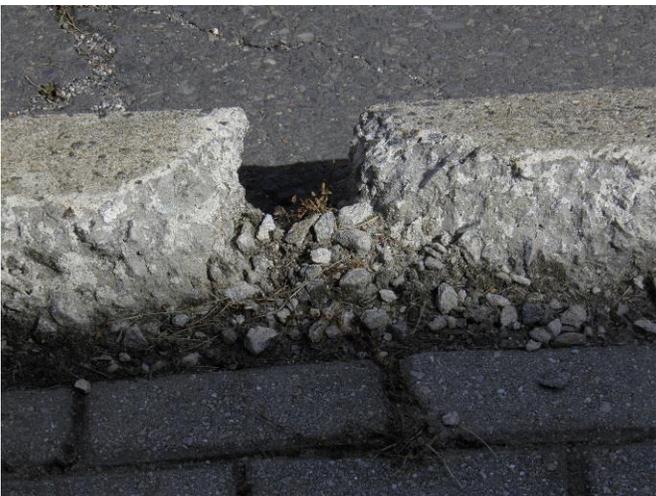
BROKEN CURB AT THE SIDEWALK

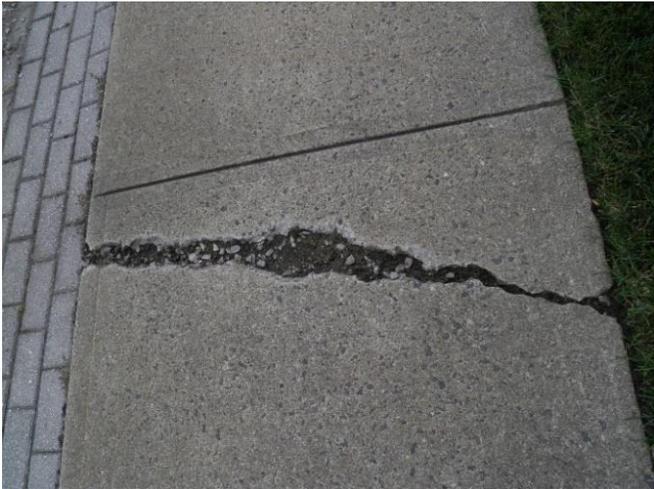
VISIBLE CRACK IN THE CONCRETE WALKWAY

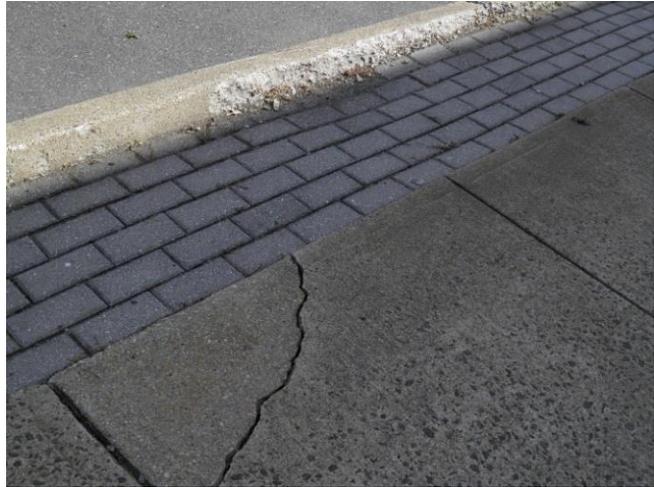
VISIBLE CRACK IN THE CONCRETE WALKWAY

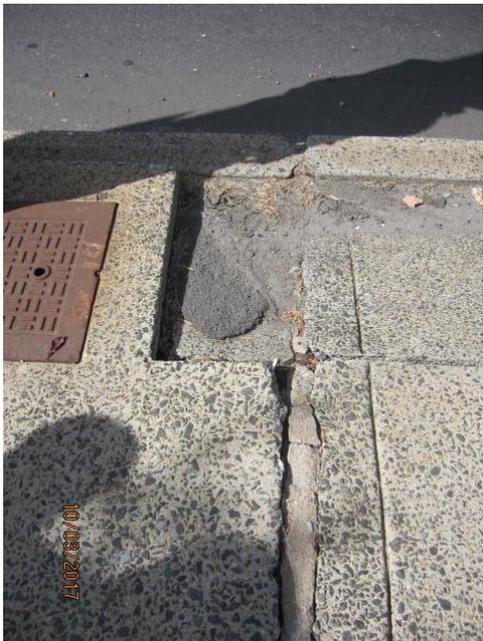
TRIPPING HAZARD. DEPRESSION IN THE CONCRETE WALKWAY

v. Replace the damaged and cracked sidewalk sections	\$7,500
vi. Repaint the bollards surrounding the generator	\$1,500
vii. Repair the crack in the concrete generator pad	\$1,200
viii. Seal the voids in the annular space around the metal pipe railing posts located along the perimeter of the concrete ramp	\$800
ix. Replace the sunken sections of sidewalk	\$750

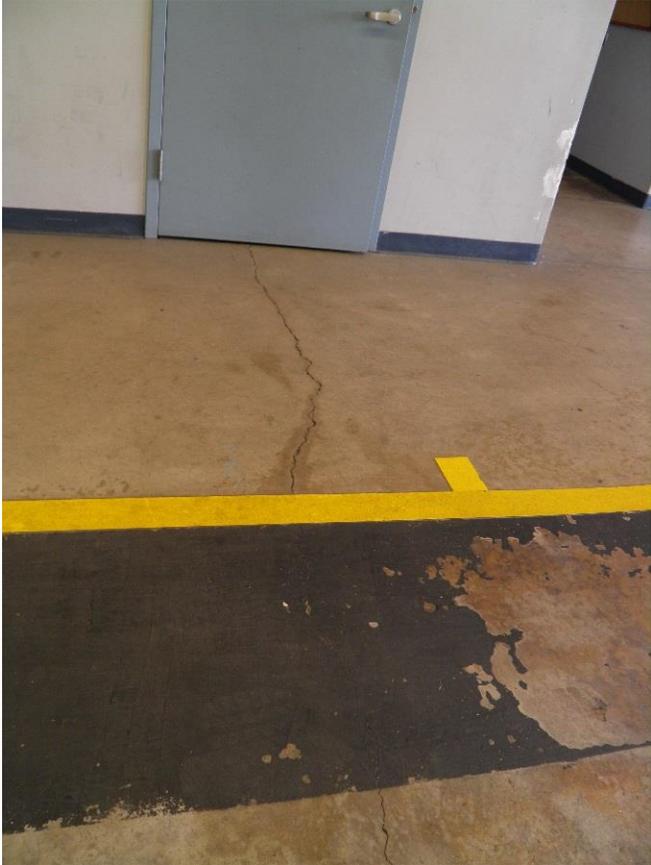
SEVERE CRACK AND SURFACE DAMAGE IN THE CONCRETE FLOOR

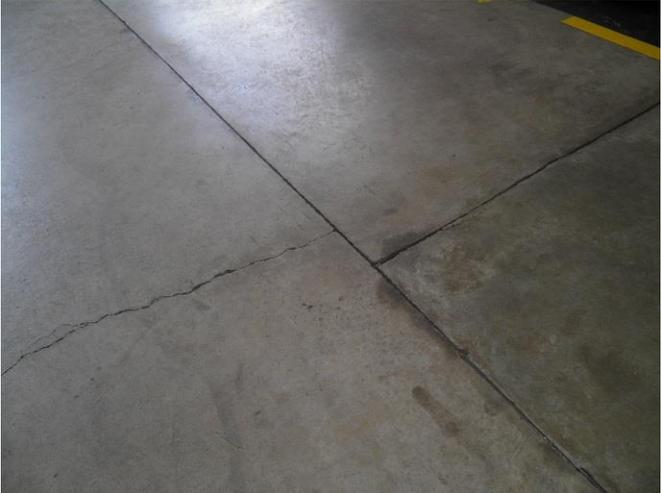
VISIBLE CRACKS IN THE CONCRETE FLOOR

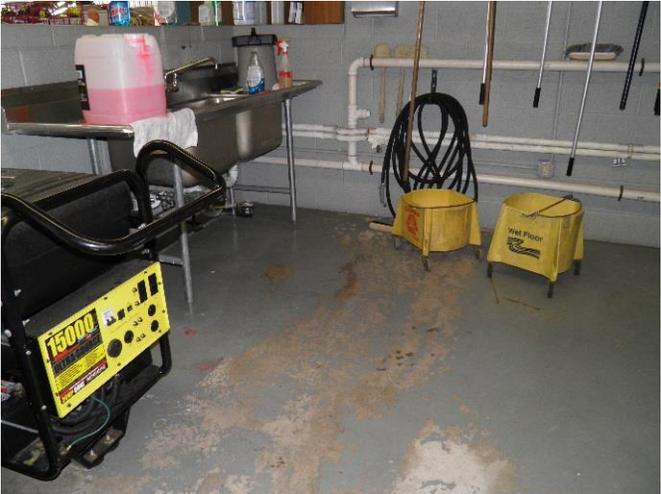
DETERIORATED FLOOR SEALER

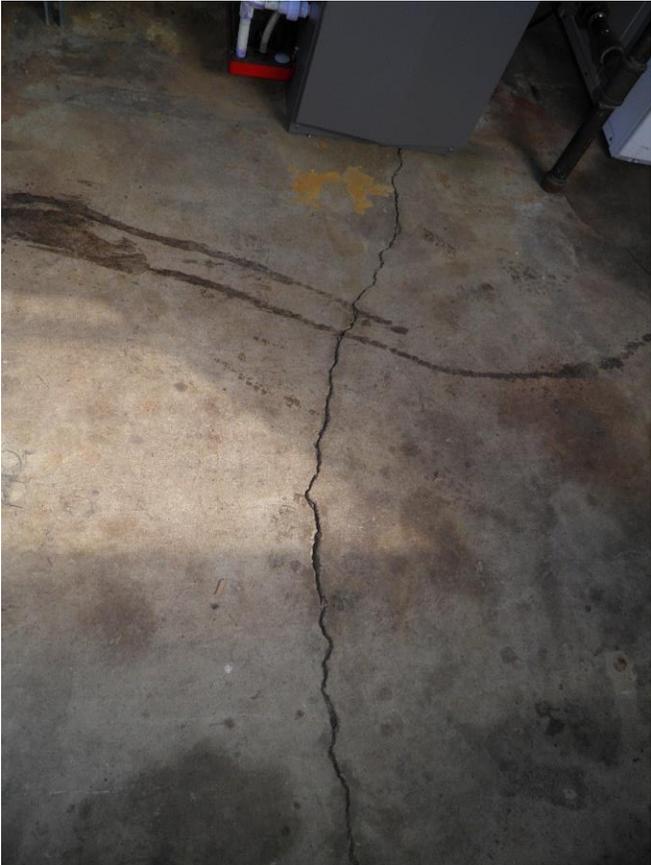
SEVERE CRACK IN THE CONCRETE FLOOR

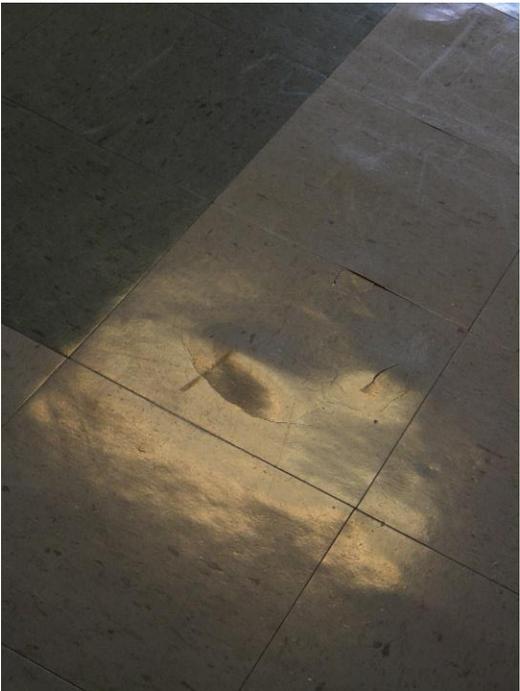
7. The gypsum board ceiling in the SCBA room is damaged.
8. The Storage Room and Common Workroom contains VCT floor tiles which appear to be damaged and several are lifting up.

DAMAGED FLOOR TILES

v.	Replace the VCT floor tiles	\$3,000
E.	<u>Interior Accessibility of Station (*)</u>	
i.	Provide access to provide access to the basement Volunteers Meeting/Lounge Room	\$17,000
ii.	Provide a barrier free bathroom located in the basement	\$10,500

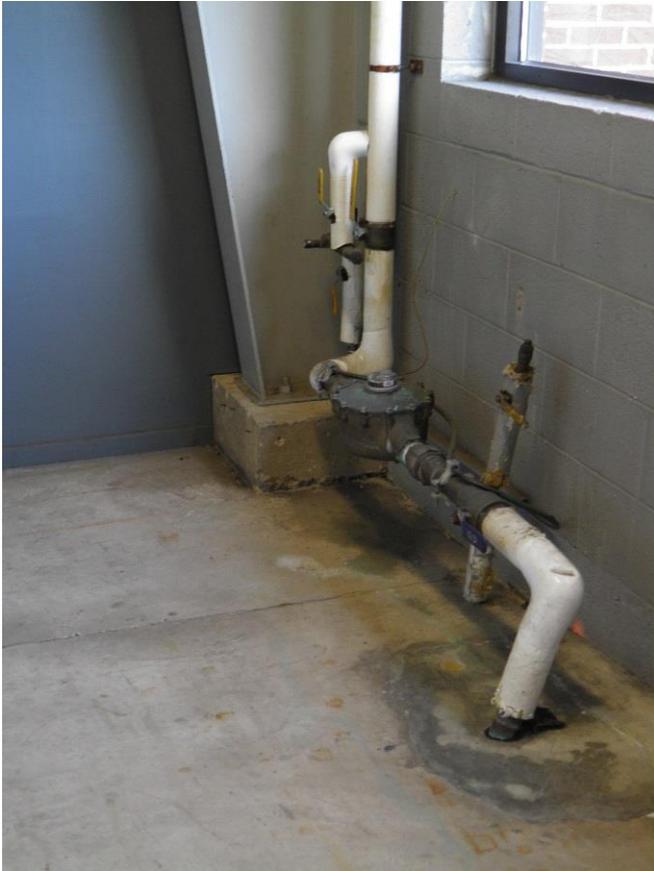
SIGNS OF WATER LEAKAGE ON THE FLOOR

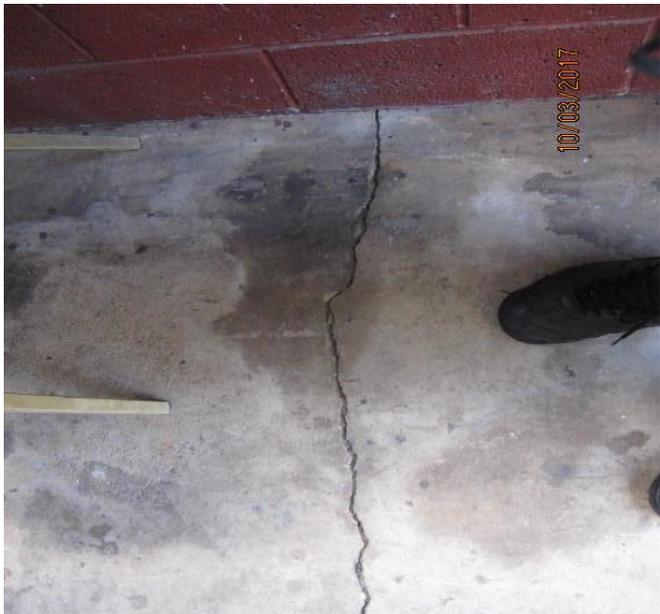
VISIBLE CRACK IN CONCRETE FLOOR

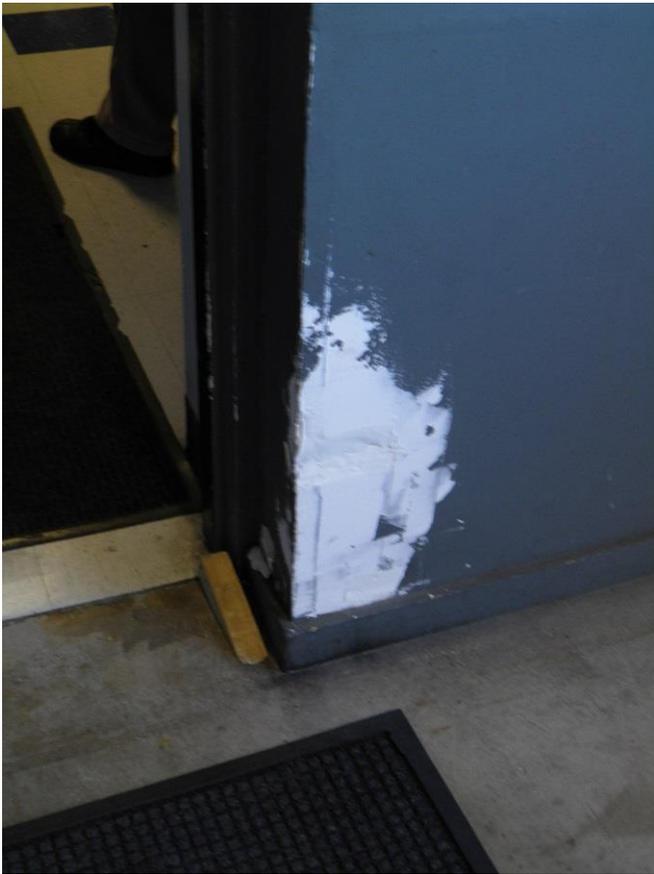
REPAIR ATTEMPT AT DAMAGED WALL

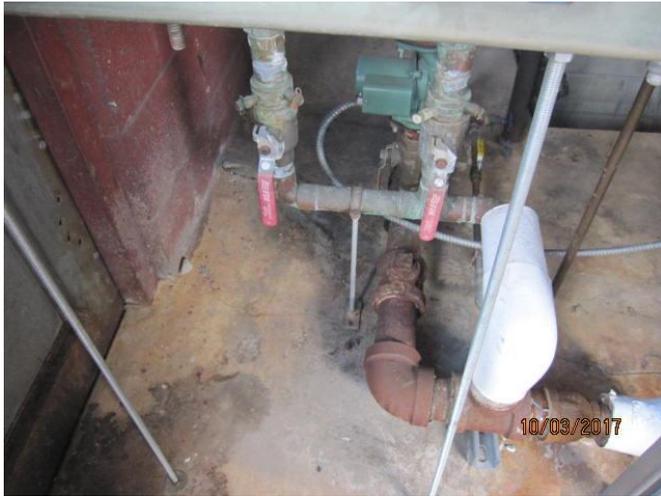
SIGNS OF WATER LEAKAGE ON THE FLOOR

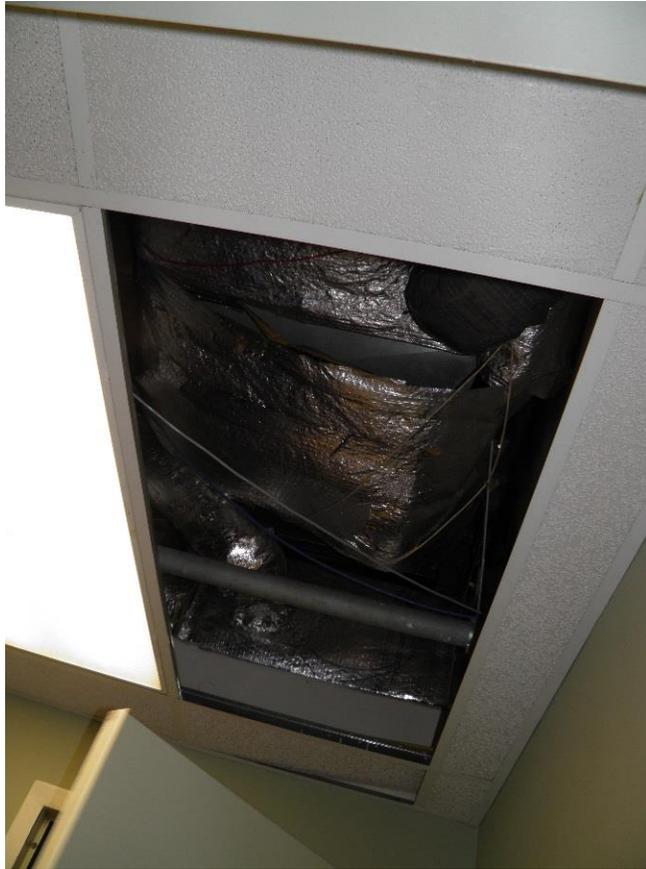
MISSING CEILING TILE

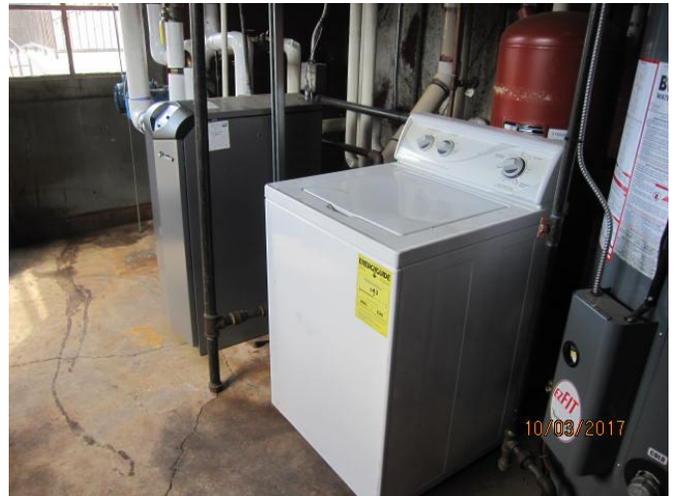
VISIBLE CRACK IN CONCRETE FLOOR

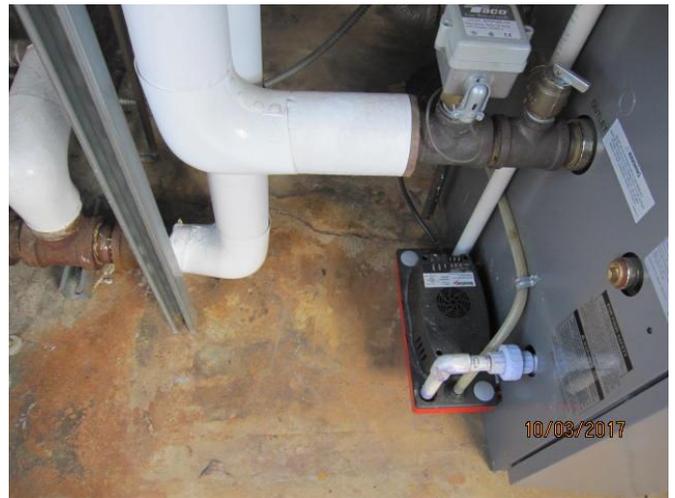
VISIBLE CRACK IN CONCRETE AND SIGNS OF LEAKAGE ON THE FLOOR

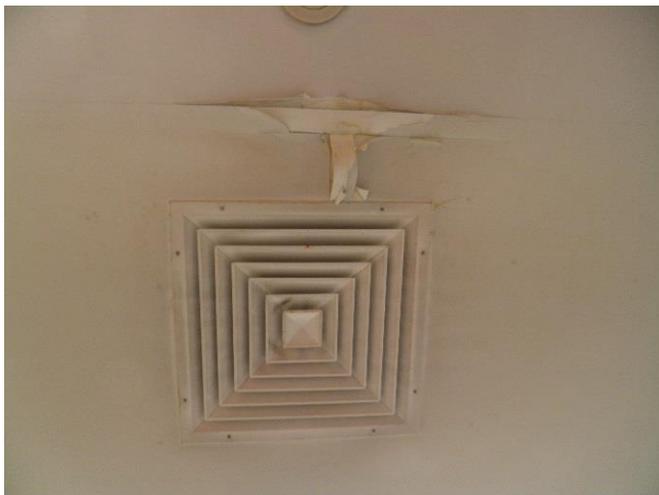
VISIBLE DAMAGE TO THE CEILING

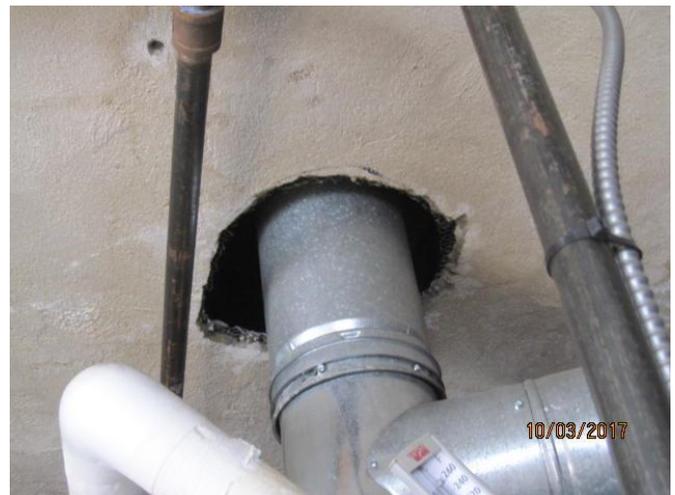
LACK OF SEALANT AROUND CEILING PENETRATION

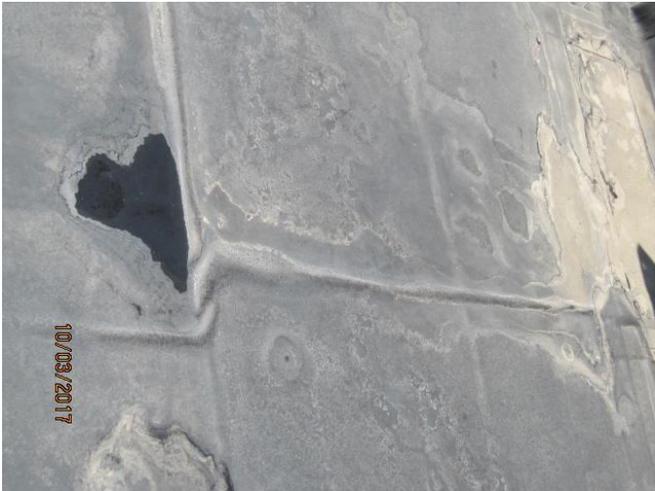
SIGNS OF WATER PONDING

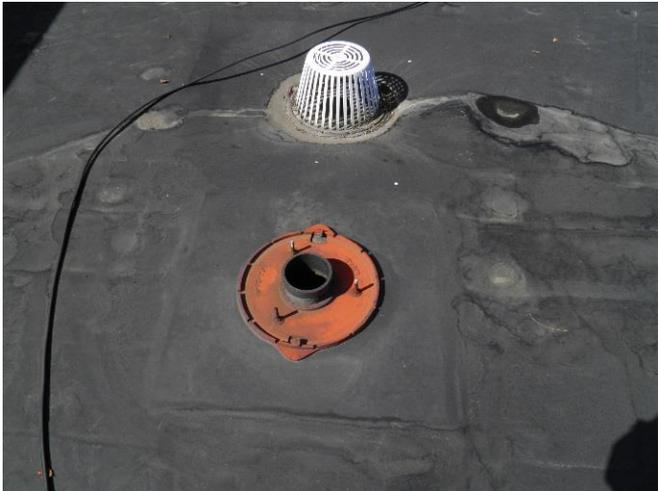
MISSING DRAIN COVER

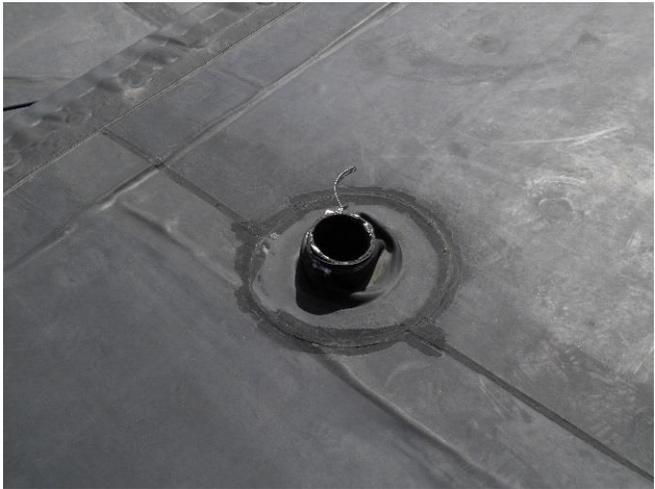
MISSING VENT PIPE

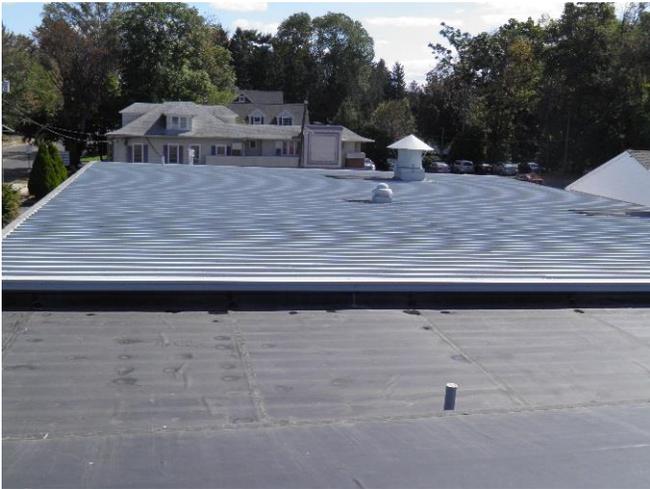
THE ROOF IS PART EPDM AND PART STANDING SEAM METAL ROOF

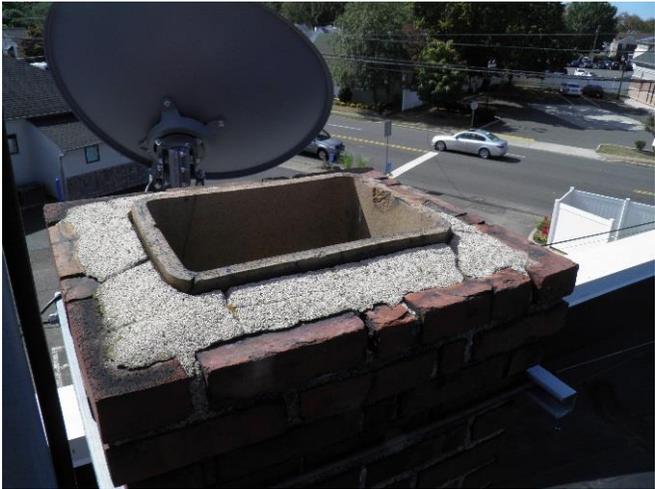
VISIBLE CRACKS IN THE CHIMNEY STACK

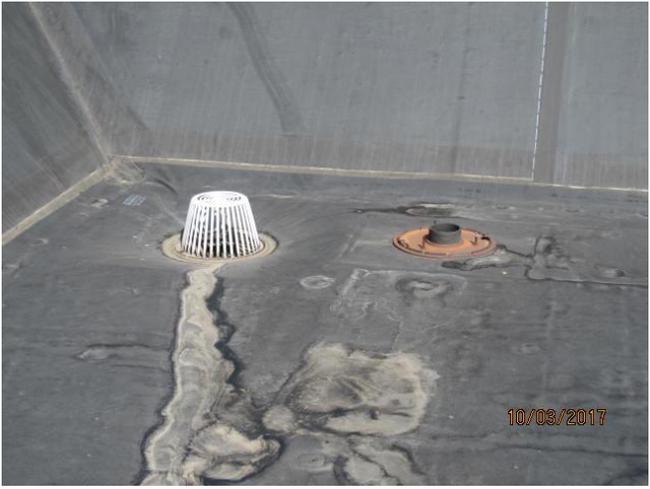
MISSING DRAIN COVER AND SIGNS OF WATER PONDING

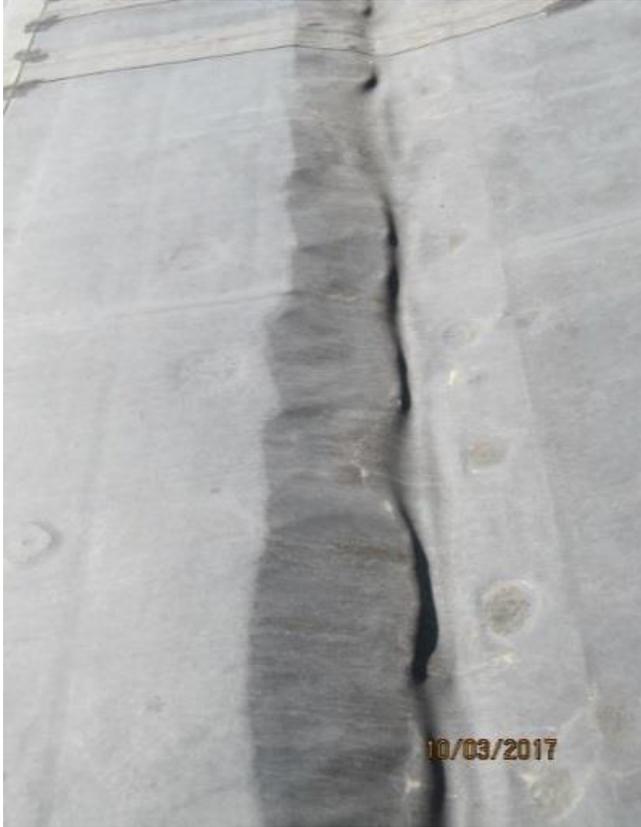
THE CONNECTION BETWEEN ROOF IS NOT SMOOTH AND CREATES A CHANEL

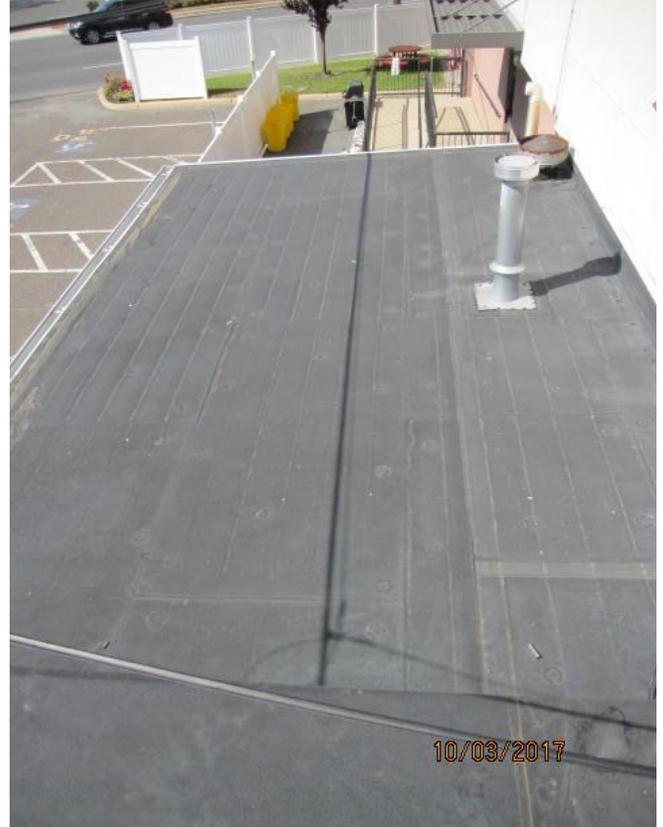
MISSING FLASHING AT THE VENT
