## **Hamilton Township in Mercer County**

### **Stormwater Outfall Assessment**

Developed by Rutgers Cooperative Extension Water Resources Program

December 2015

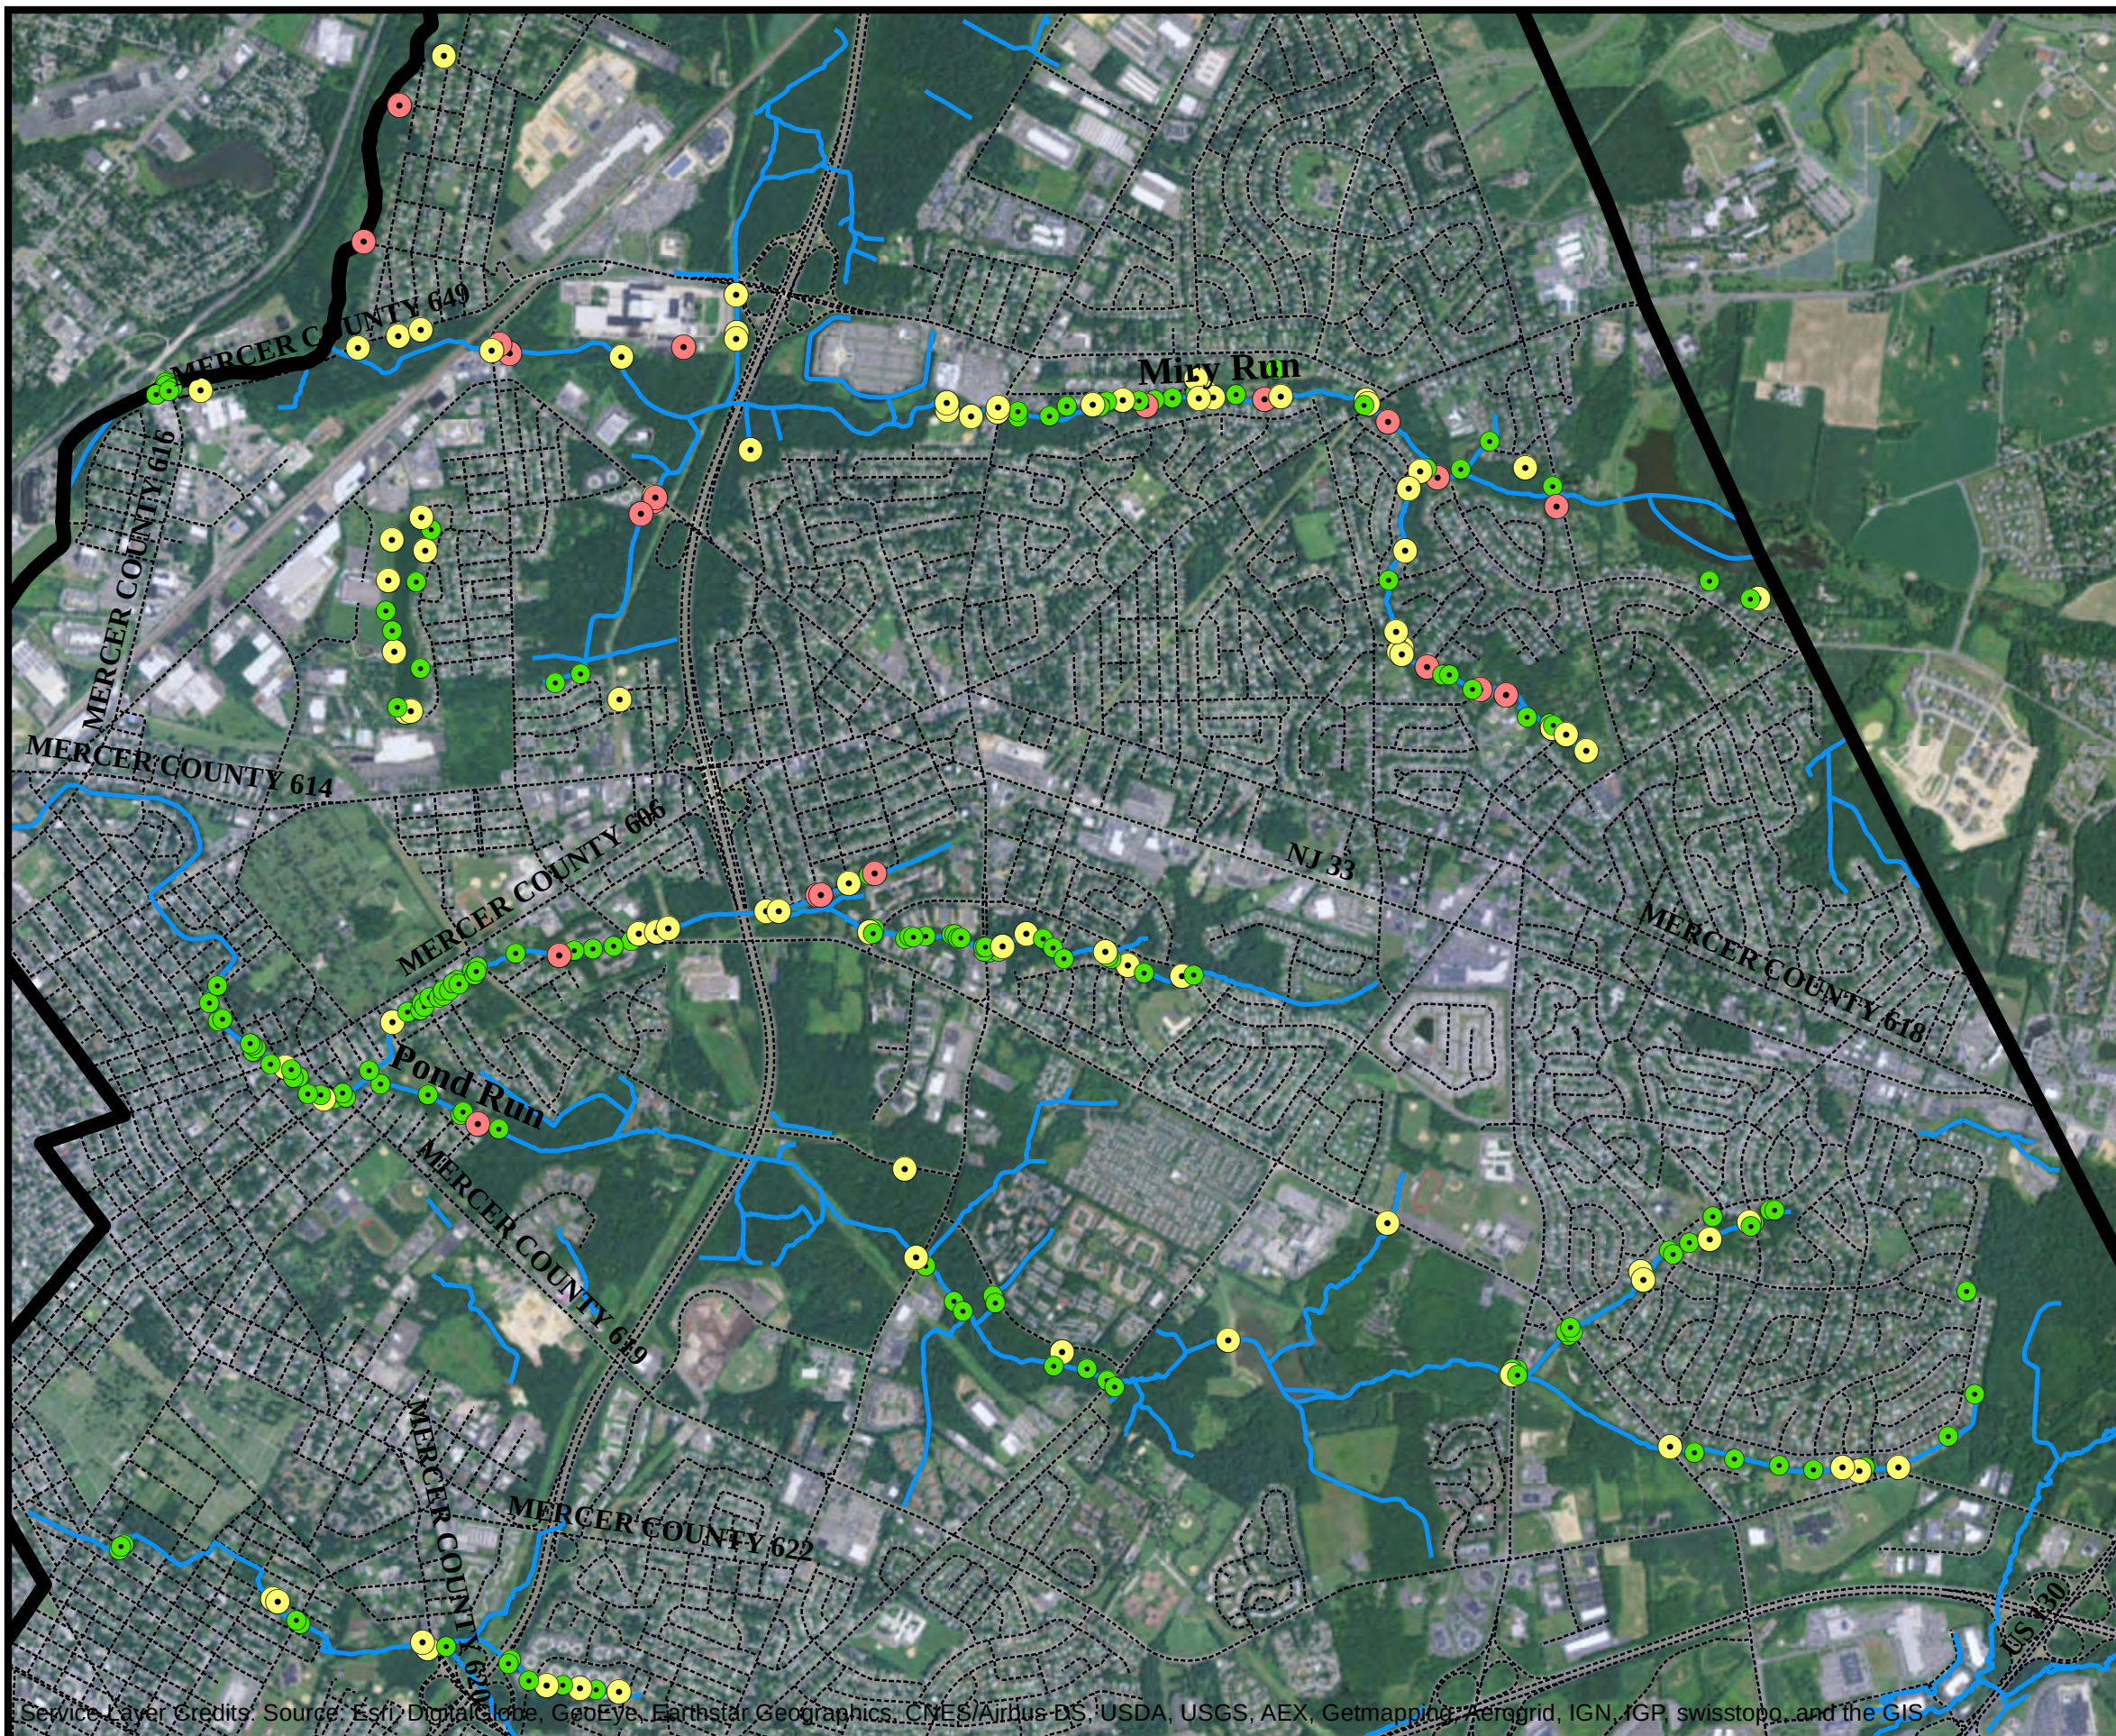
## Outfall Maintenance Prioritization

A maintenance prioritization was developed using the field data collected for the 261 stormwater outfalls. Priority was given to outfalls that showed significant signs of deterioration, were causing downstream erosion, were unstable due to erosion, or showed signs of illicit connections. Consideration was also given to the amount of vegetation growth in and around the outfall, quantity of sediment deposits, areas of known commercial or industrial uses and other factors.

- High: 21
- Medium: 82
- Low: 158

1. The 21 outfalls identified as high priority for maintenance should be visited by Township personnel and a plan and schedule should be developed to take necessary corrective actions as soon as possible.
2. A complete maintenance plan and schedule should be developed for all stormwater outfalls to address the deficiencies noted in this assessment in a timely manner.

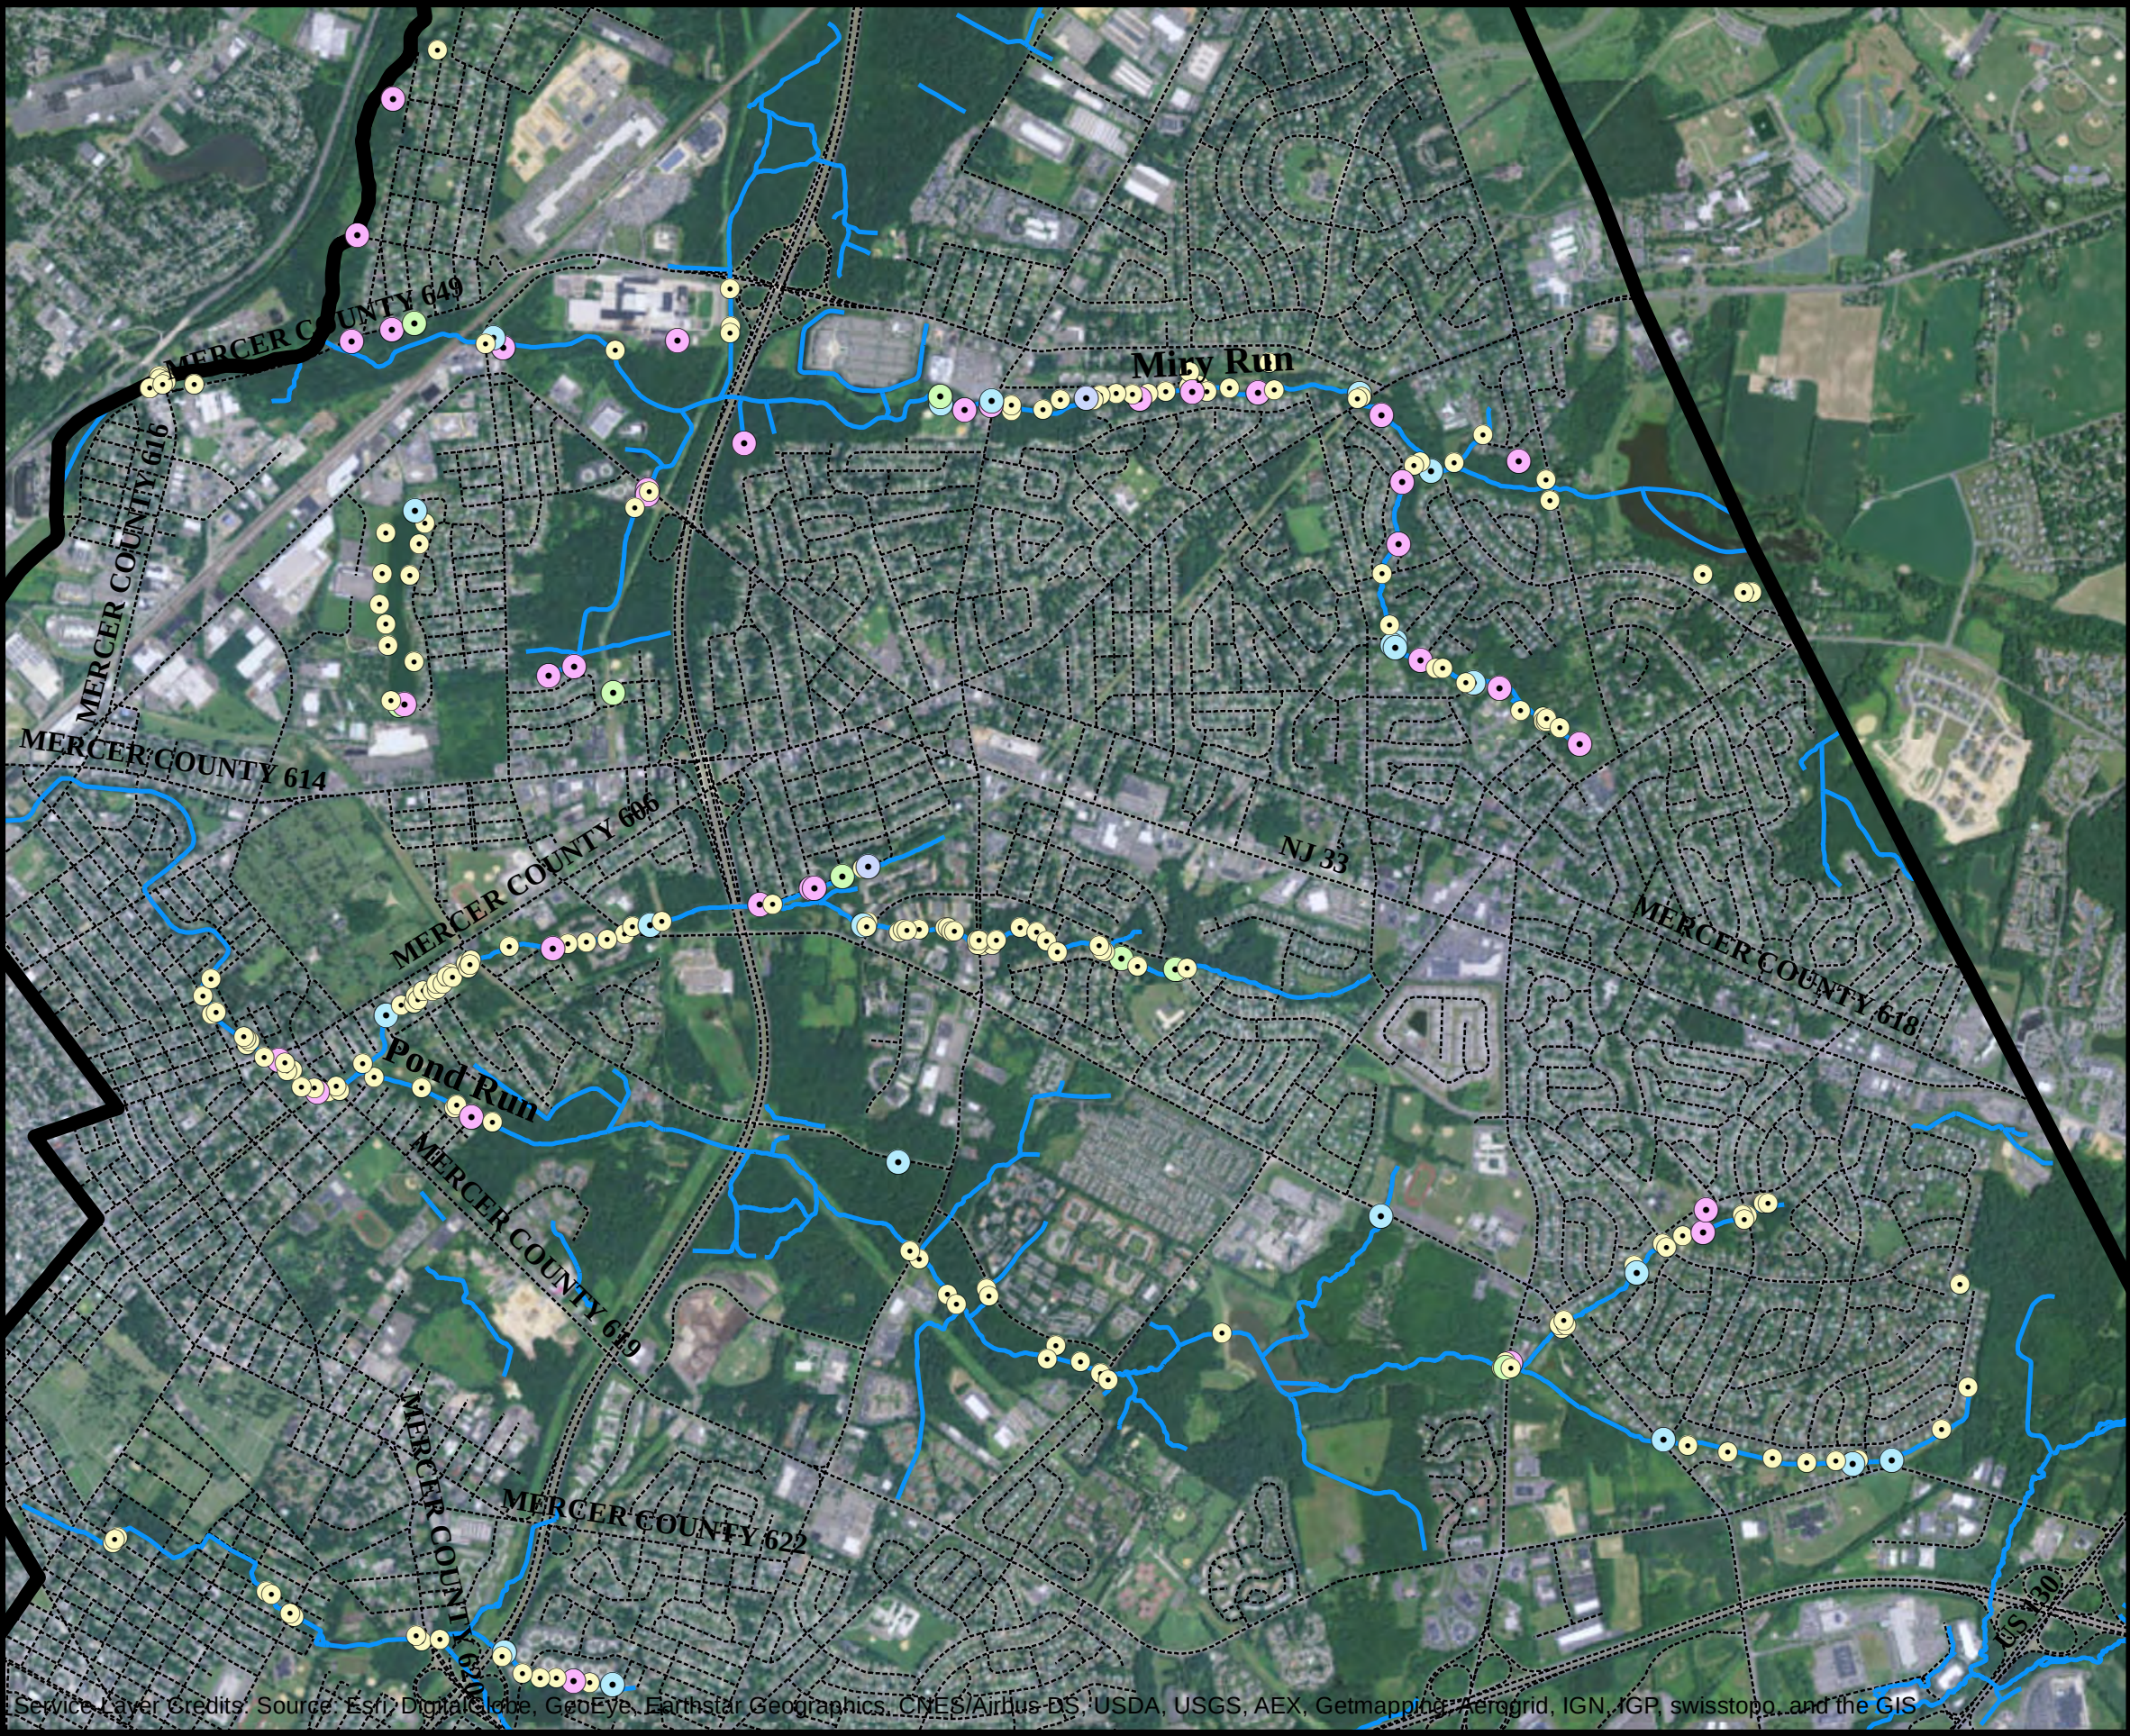
Outfall Pipe Condition

- Corrosion: 8
- Cracking: 34
- Peeling: 2
- Spalling: 21
- Normal: 198

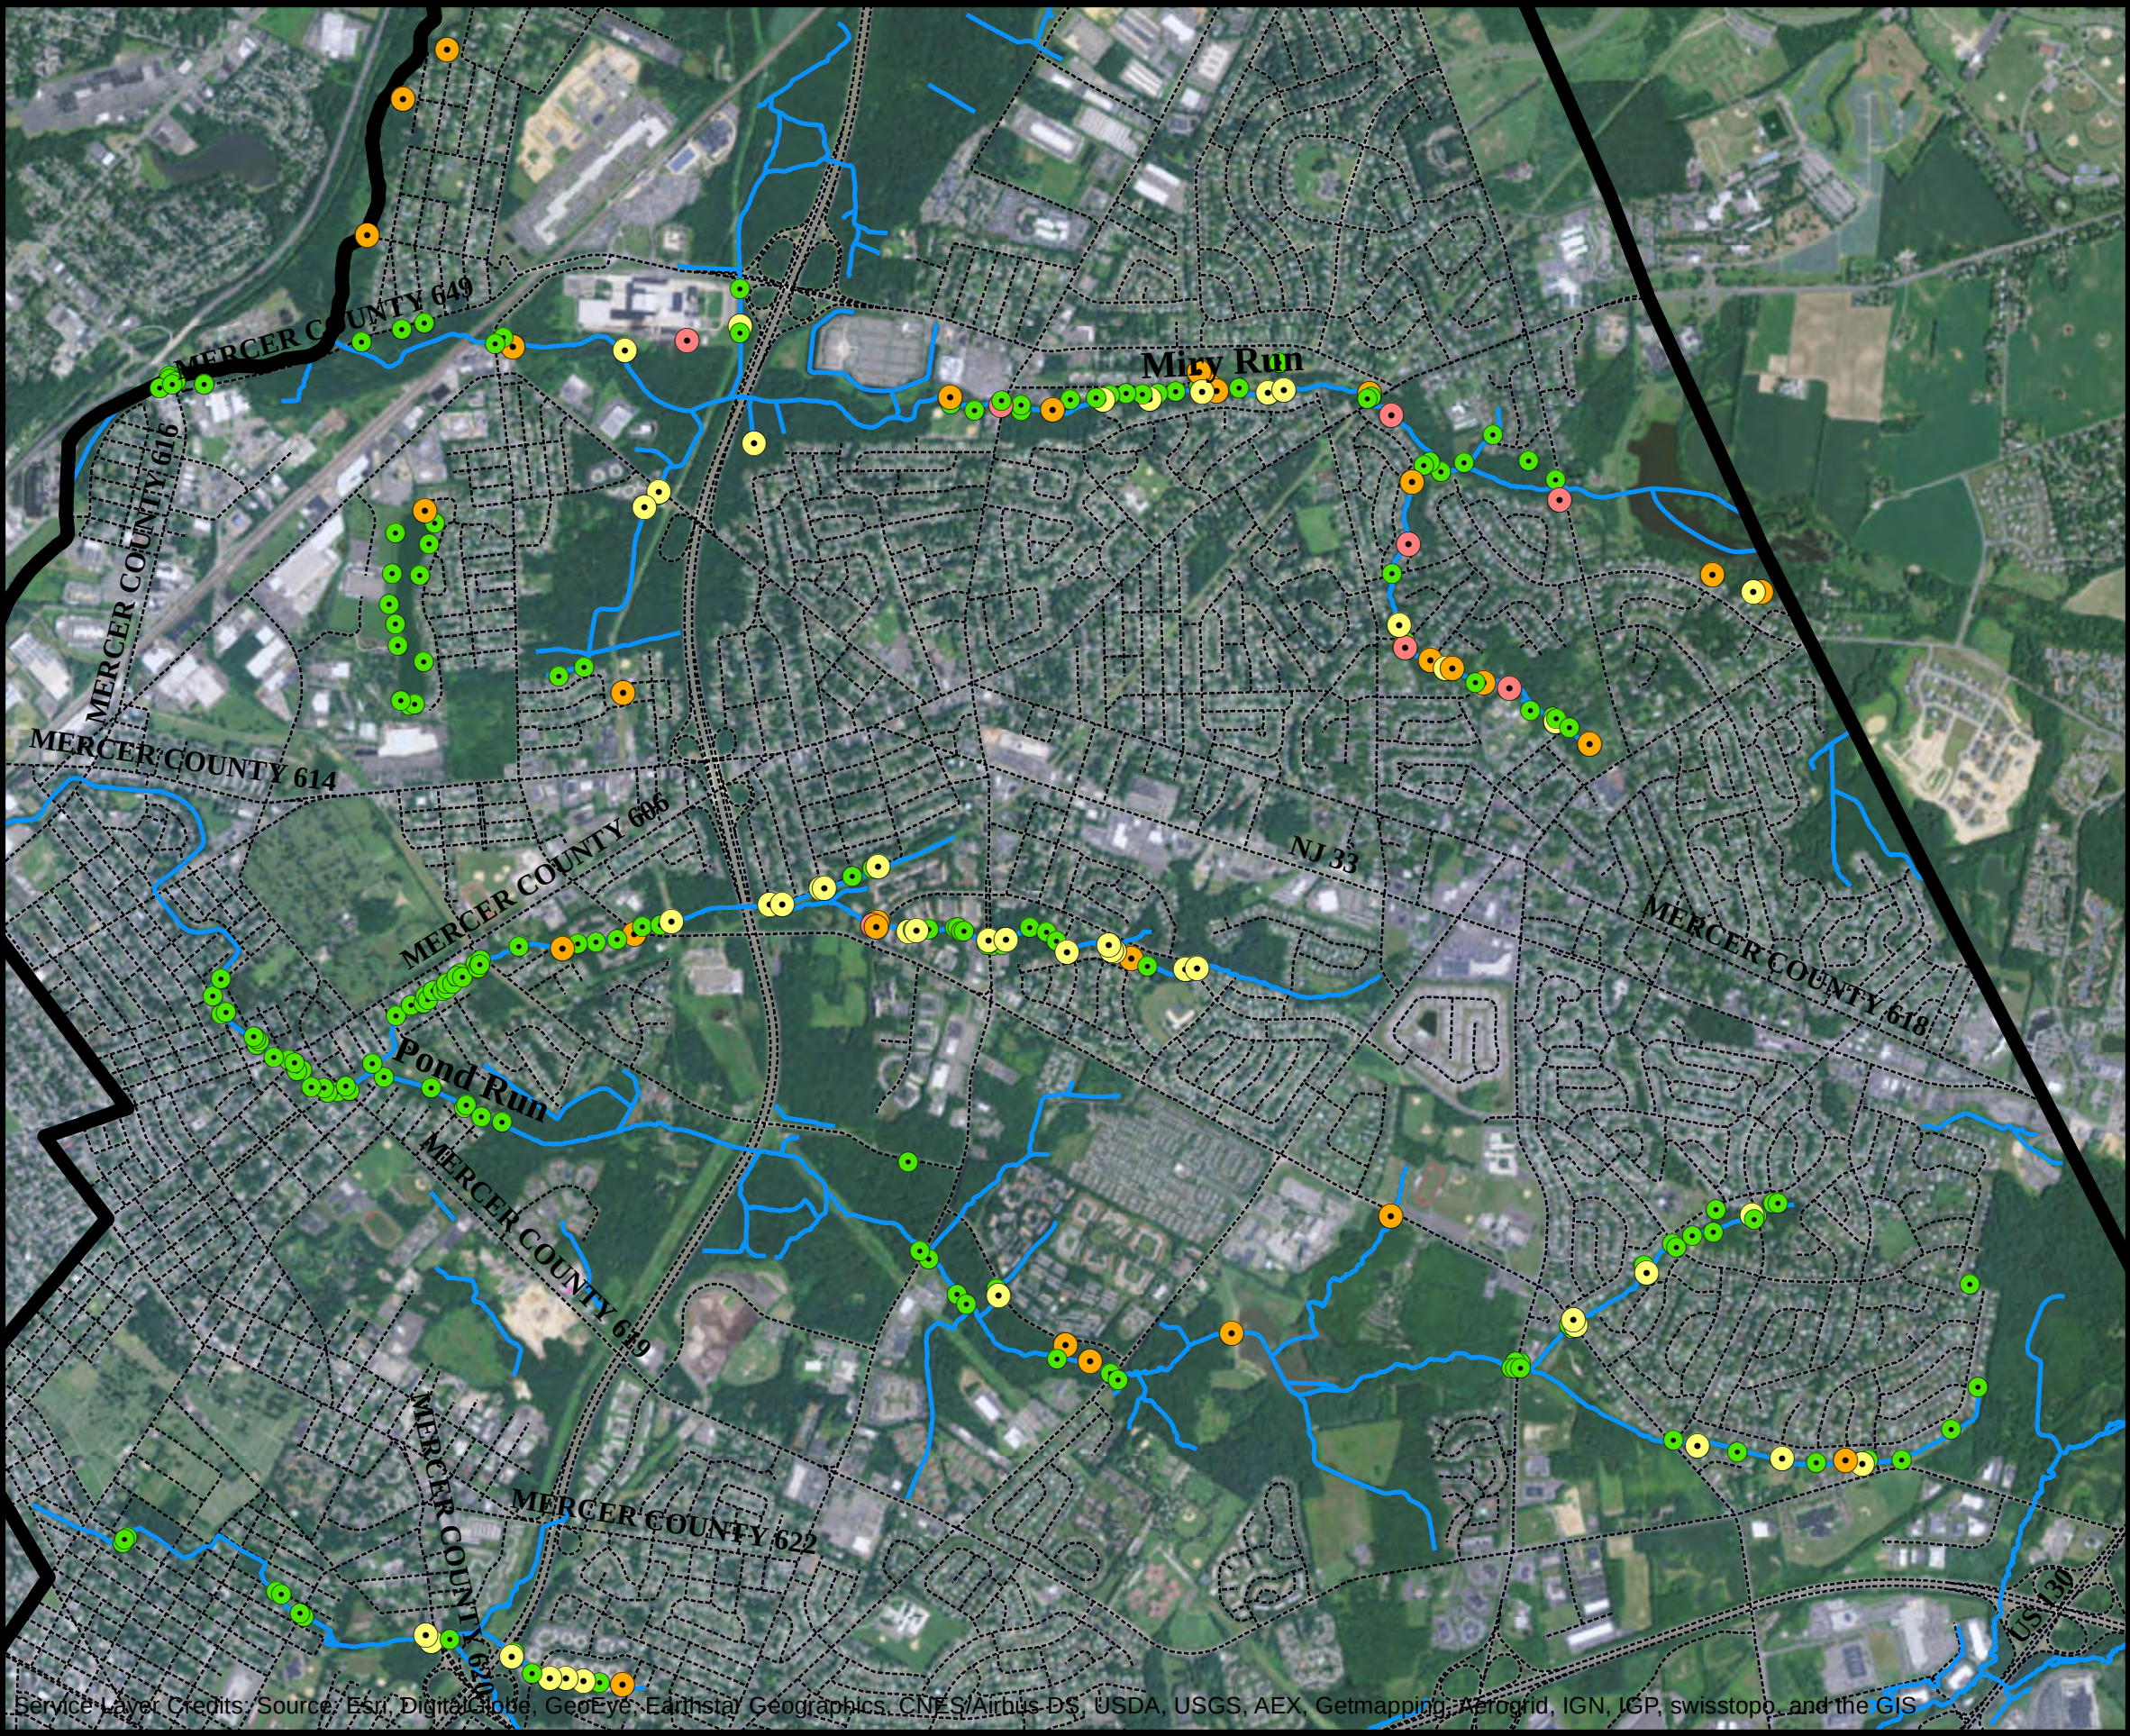
Downstream Erosion

- High: 8
- Medium: 30
- Low: 43
- None: 182

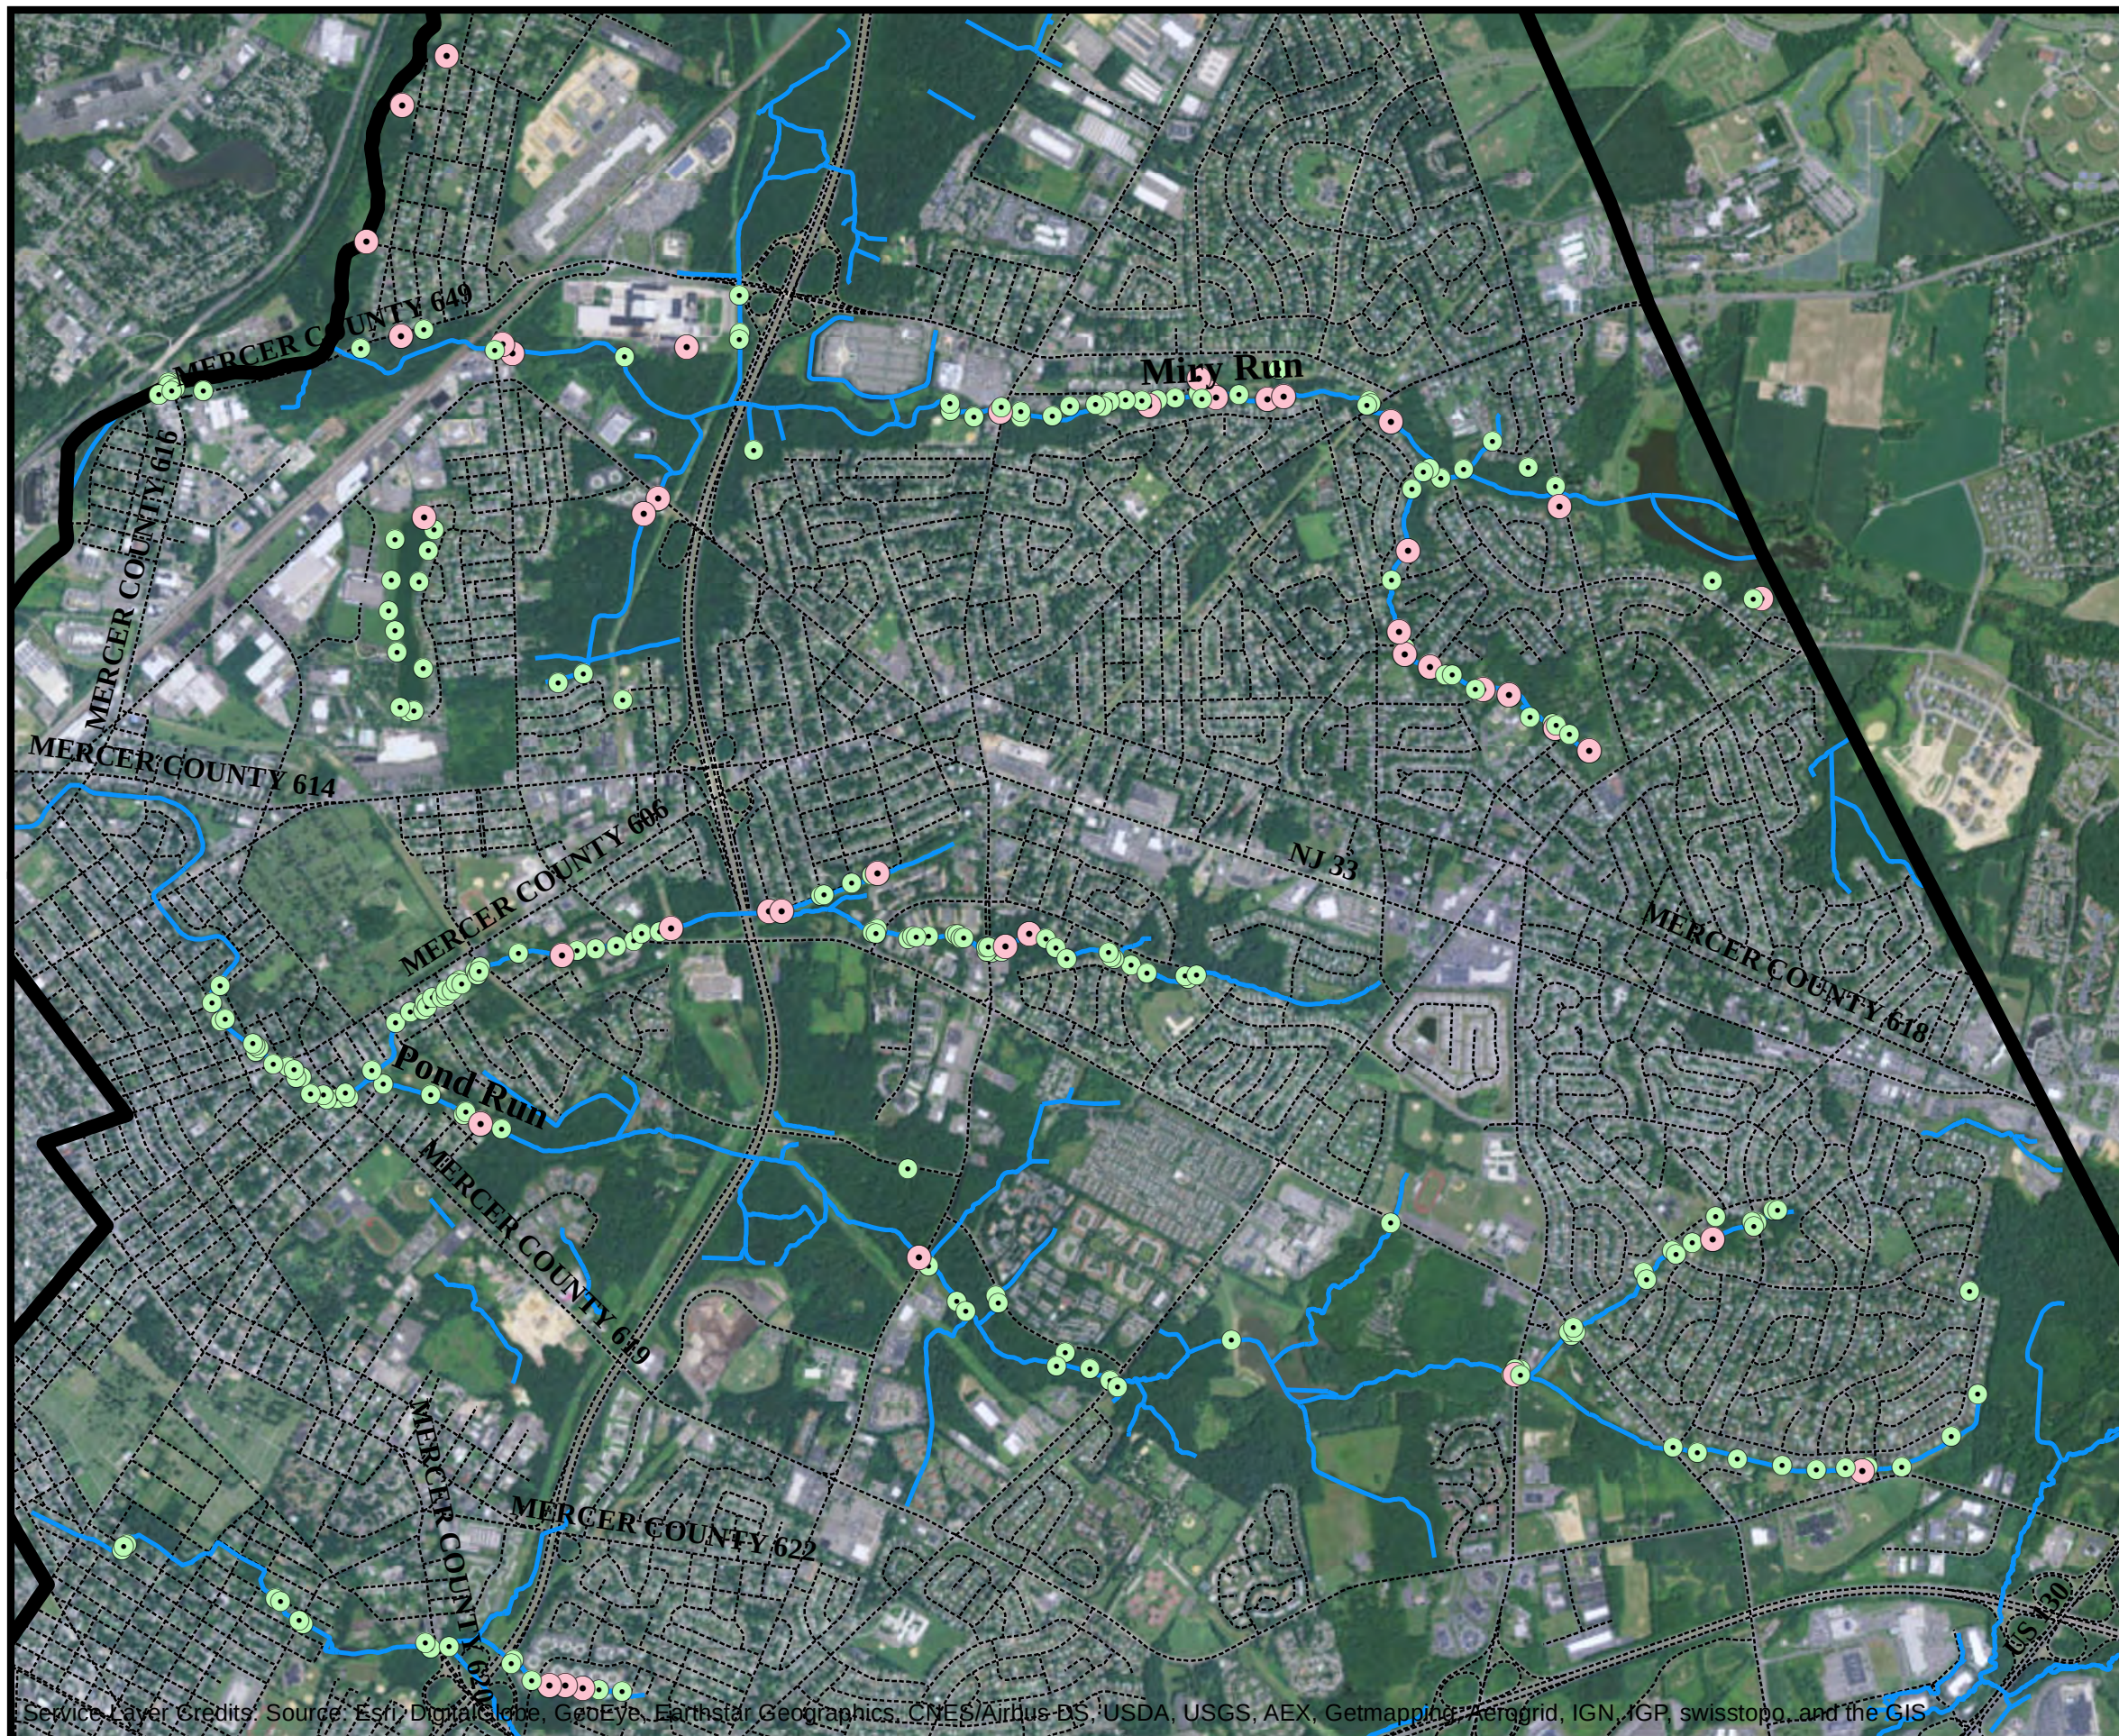
## Outfall Stability

- Unstable: 43
- Stable: 218
