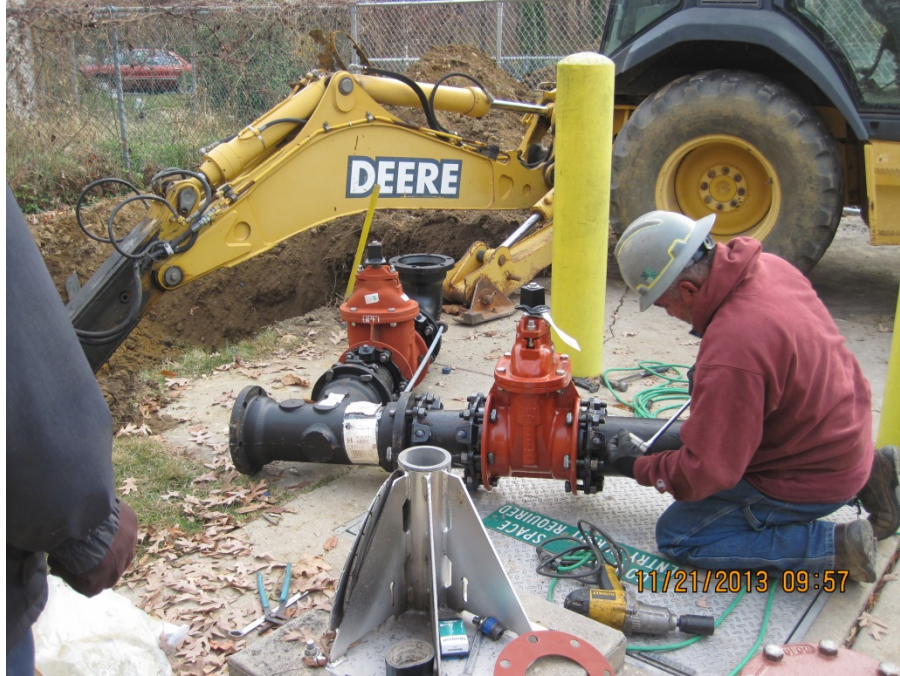
Bypass piping being installed at Park Avenue Pumping Station.

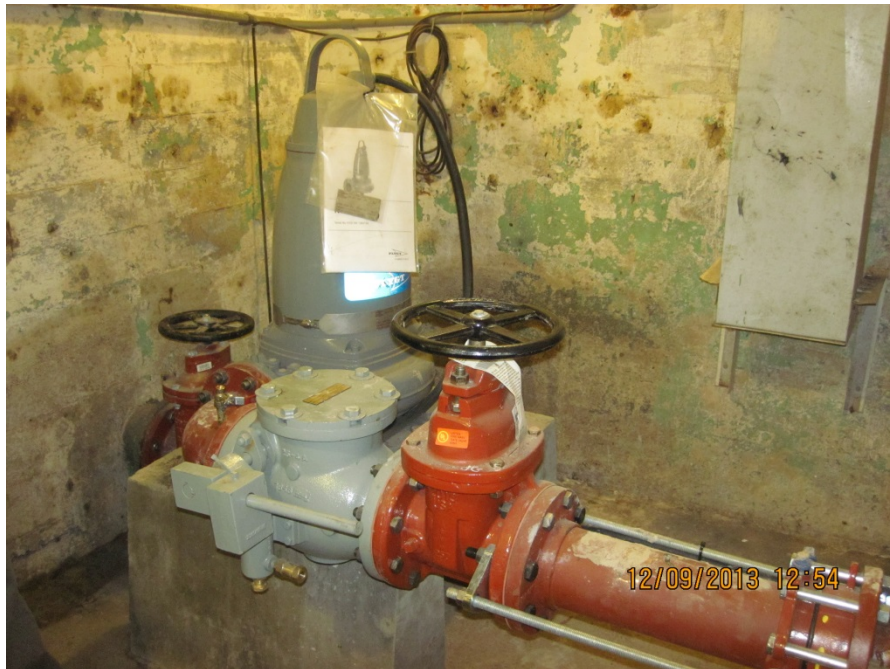
A new pump, valves and piping also at Park Avenue Pumping Station.

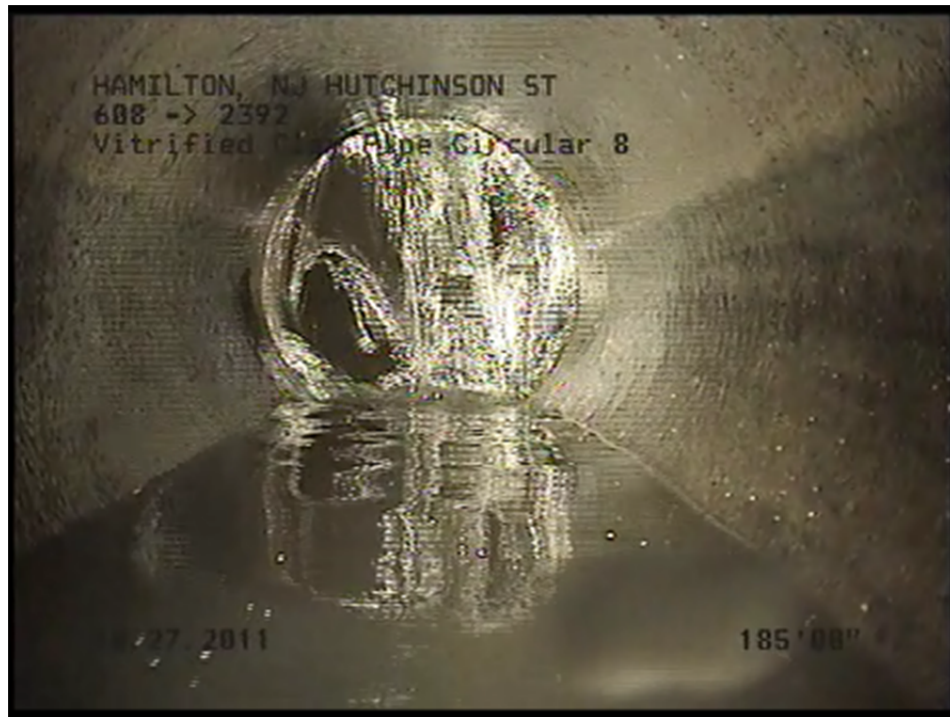
Video Inspection of a broken pipe on Hutchinson Street before repairs are made.

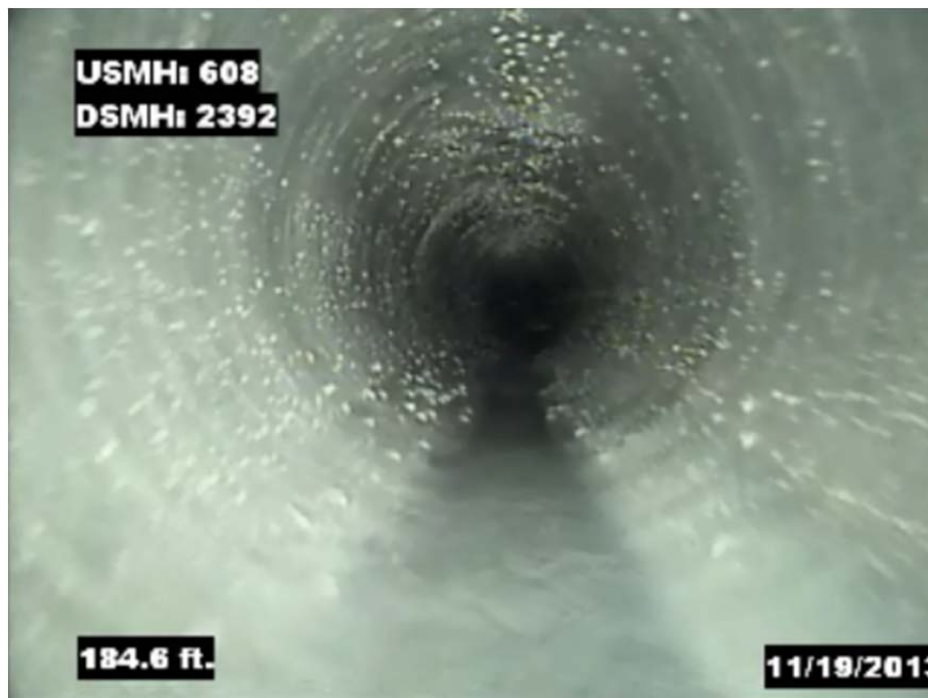
Video Inspection of same pipe after rehabilitation using Cured-In-Place Pipe (CIPP) lining.
