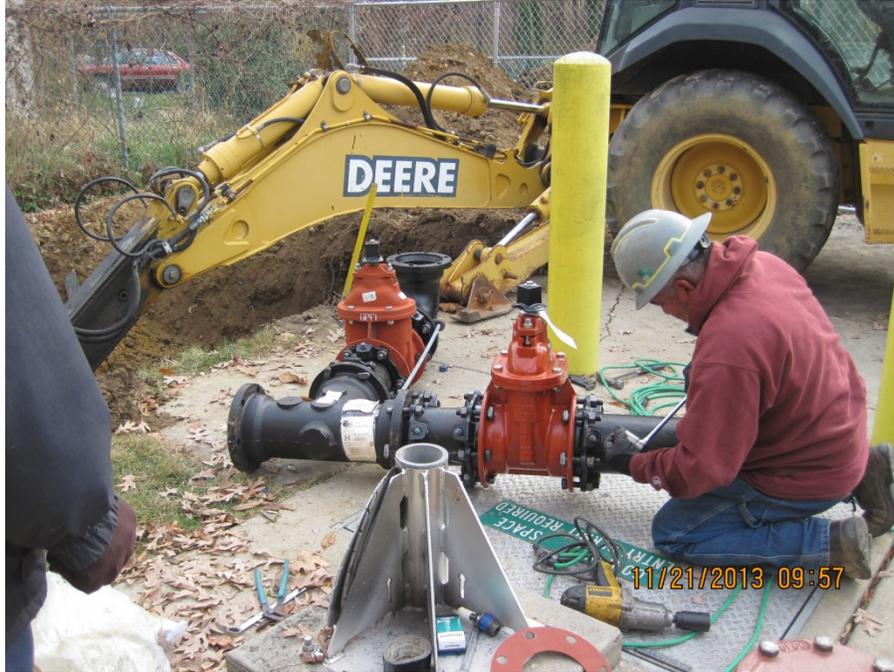
Bypass piping being installed at Park Avenue Pumping Station.

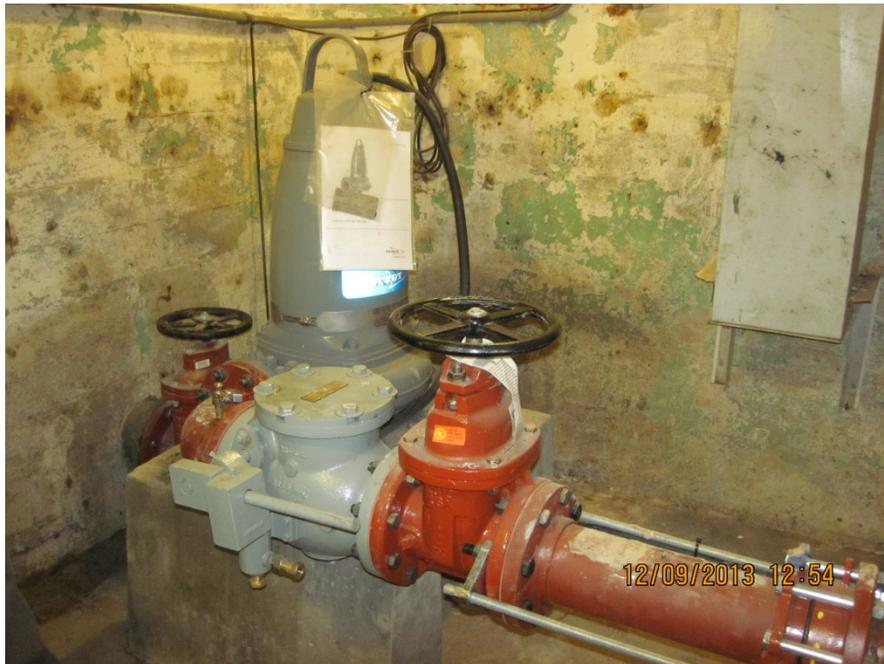
A new pump, valves and piping also at Park Avenue Pumping Station.

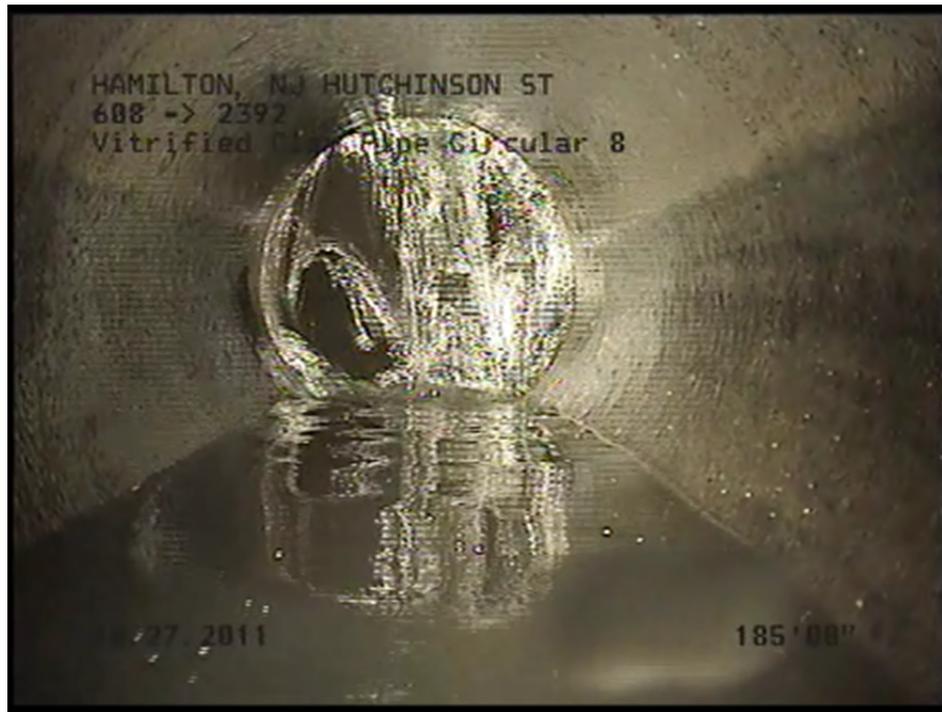
Video Inspection of a broken pipe on Hutchinson Street before repairs are made.
