**A 2013 SURVEY OF POTENTIAL VERNAL POOLS
IN HAMILTON TOWNSHIP, MERCER COUNTY, NEW JERSEY**

Prepared for the Township of Hamilton

**Deborah J. Kratzer
Kratzer Environmental Services**

**Jill S. Dodds
Biostar Associates, Inc.**

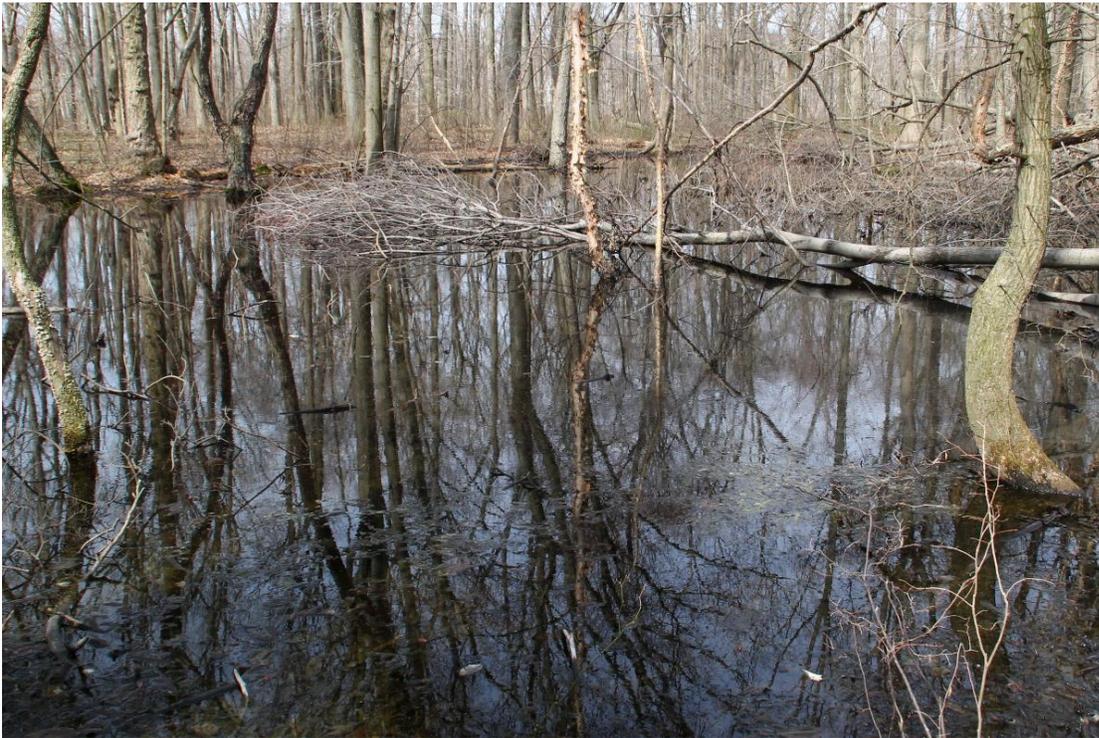
The pool occurred in a natural depression about one thousand square meters in size, and was one to two feet deep in the center during the spring months. It was located at the edge of a red maple-sweetgum forest, and had ironwood and buttonbush growing around the edges. No emergent or floating herbaceous plants were seen, but a heavy growth of algae was noted both in the water and on the surface. The partially submerged branches of several fallen trees offered suitable substrate for those amphibians which prefer to attach their egg masses to woody debris (photo 3.1-a). The adjacent field was agricultural, and appeared to be an evergreen tree farm. Although the pool was located within a forested wetland complex, it was isolated from other nearby ponds and had no permanent inlet or outlet, so it met the first criteria.

Photo 3.1-a. Pool 7765 on April 9 2013.

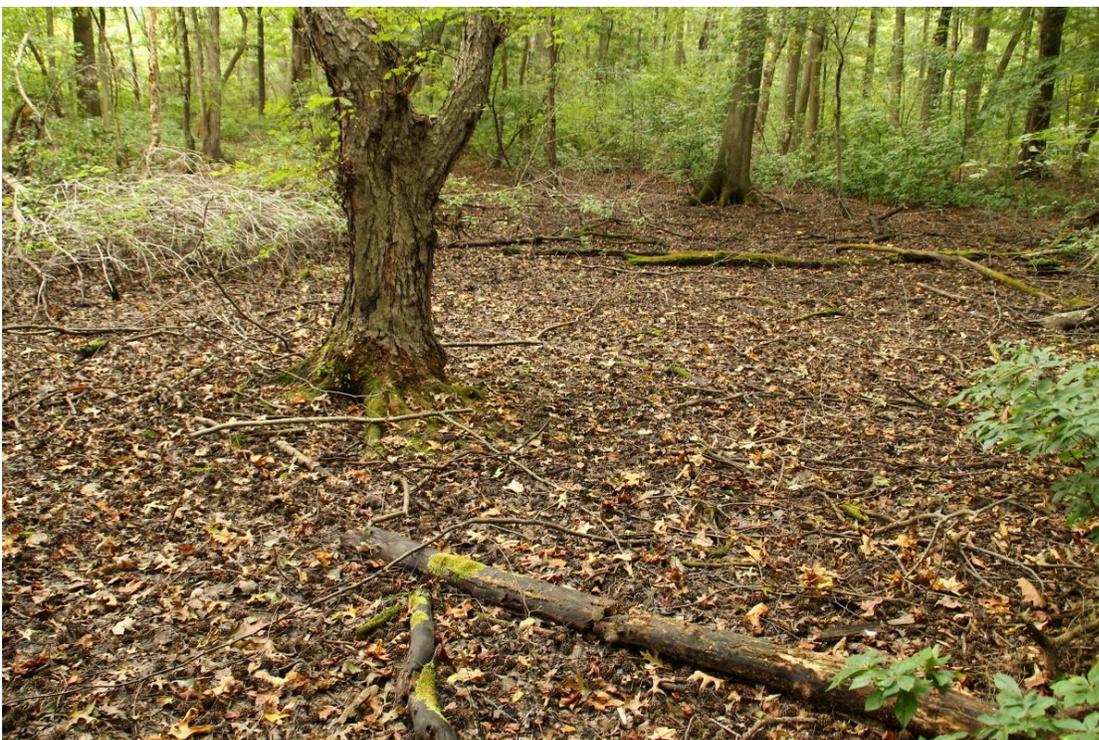
The pool held water continuously throughout the months of April and May, and was still up to two feet deep at the end of May, meeting the third criteria. By early September, the depression was completely dry, thereby meeting the fourth criteria for certification (photo 3.1-b).

Photo 3.1-b. Pool 7765 on September 10 2013.

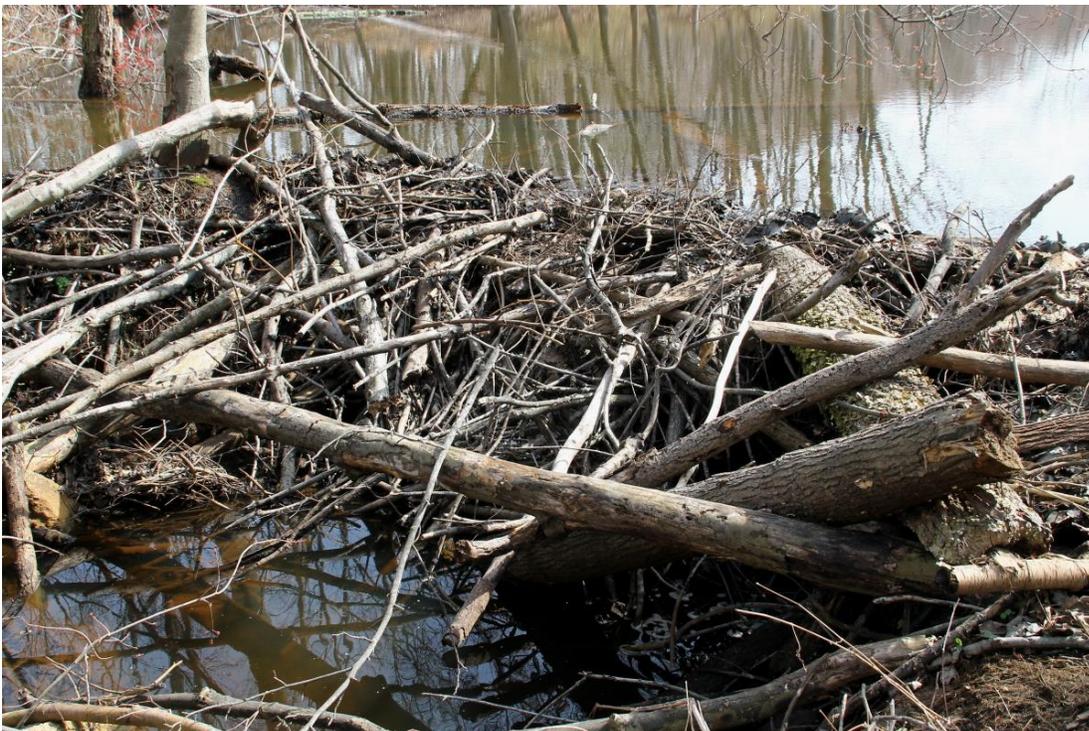
The large pond held a considerable amount of water, and the levels did not fluctuate between the spring and fall seasons. Observation of beavers swimming around above the dam confirmed that it is presently functioning as a permanent pond.

Photo 3.2-b. Beaver dam blocking outflow at Pool 7769.

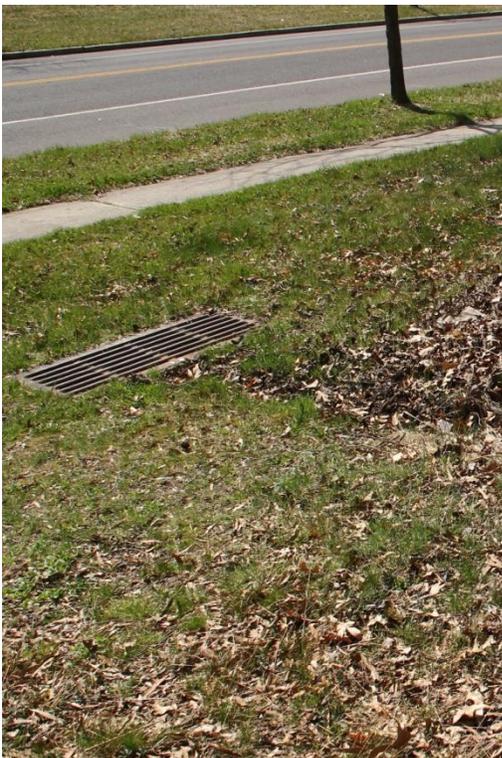
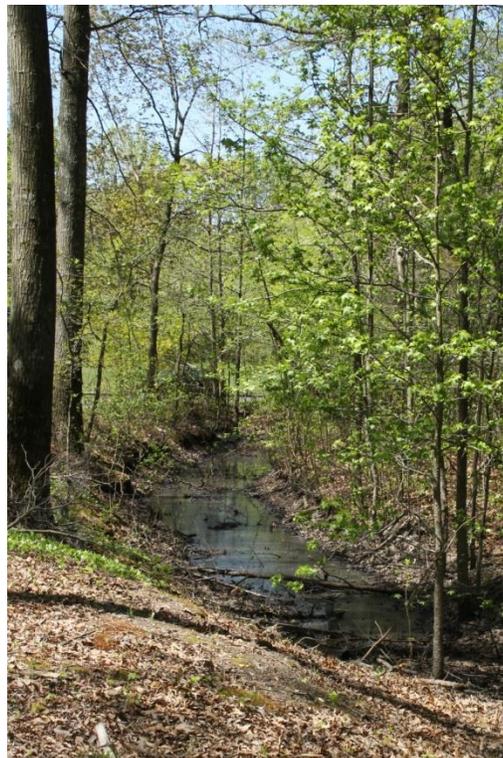
Photos 3.3-b and 3.3-c show roadside storm drain and ditch that enters the pool.

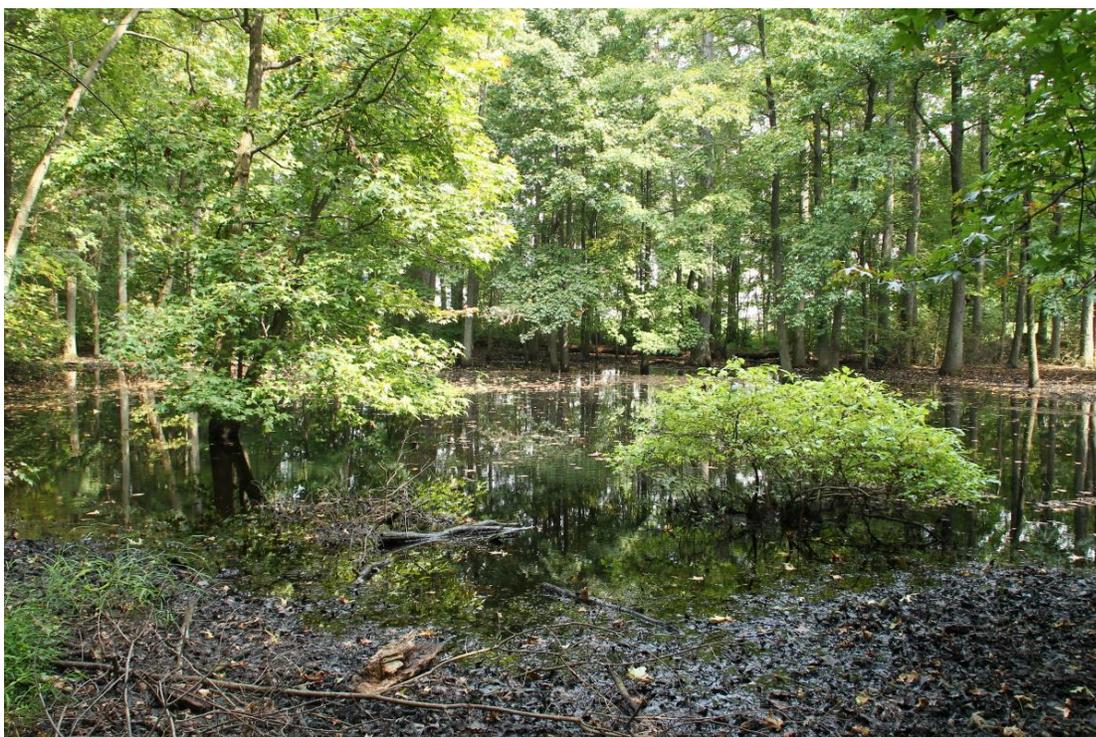
The pool maintained consistent water levels throughout the spring months. By early September, the water level had dropped considerably although the basin was not completely dry (photo 3.3-e). No fish were found while dipnetting for aquatic life, and it is likely that the pool does dry up completely at some point during a year of average rainfall. Because the first two criteria were met, 7943 can automatically be certified as vernal and documentation of the pond in a completely dry state was not necessary.

Photo 3.3-e. Lowered water level in Pool 7943 on September 10.

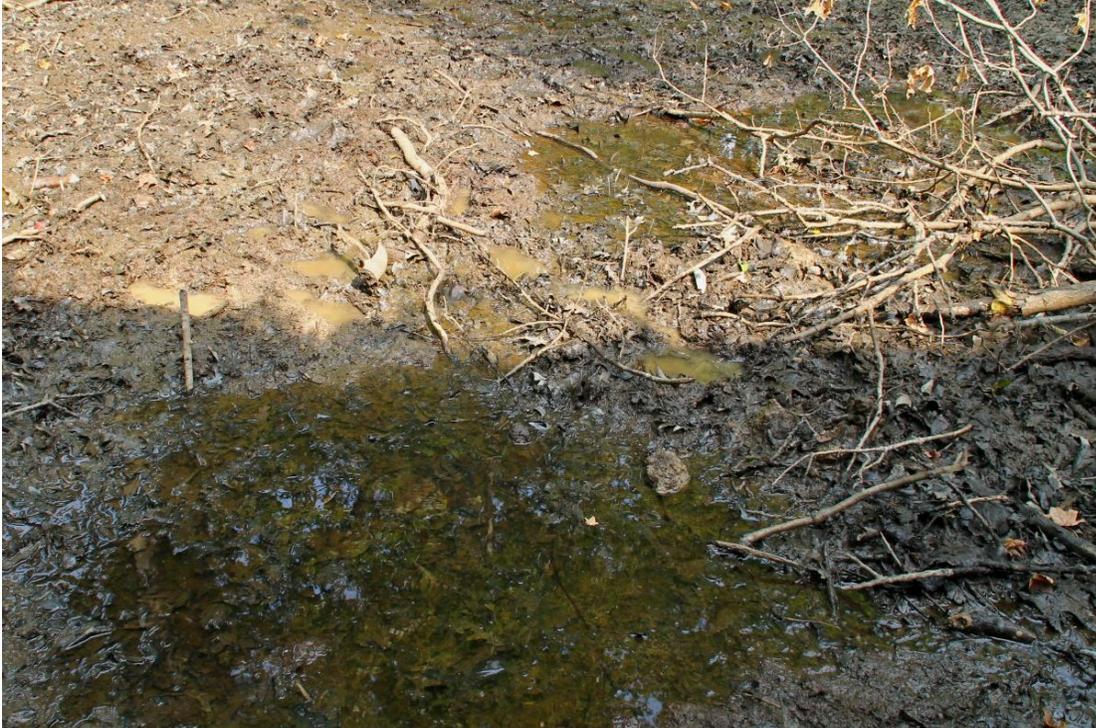
The pond retained water throughout the spring months, but was nearly dry by early September (photo 3.4-b). Only a few shallow puddles remained in the deepest part of the pond (photo 3.4-c). However, the puddles contained a number of small fish (photo 3.4-d), demonstrating that the pool is not fish-free when it is connected to the larger system, and therefore does not meet the fourth criteria.

Photo 3.4-c. Small puddles remained in early September.

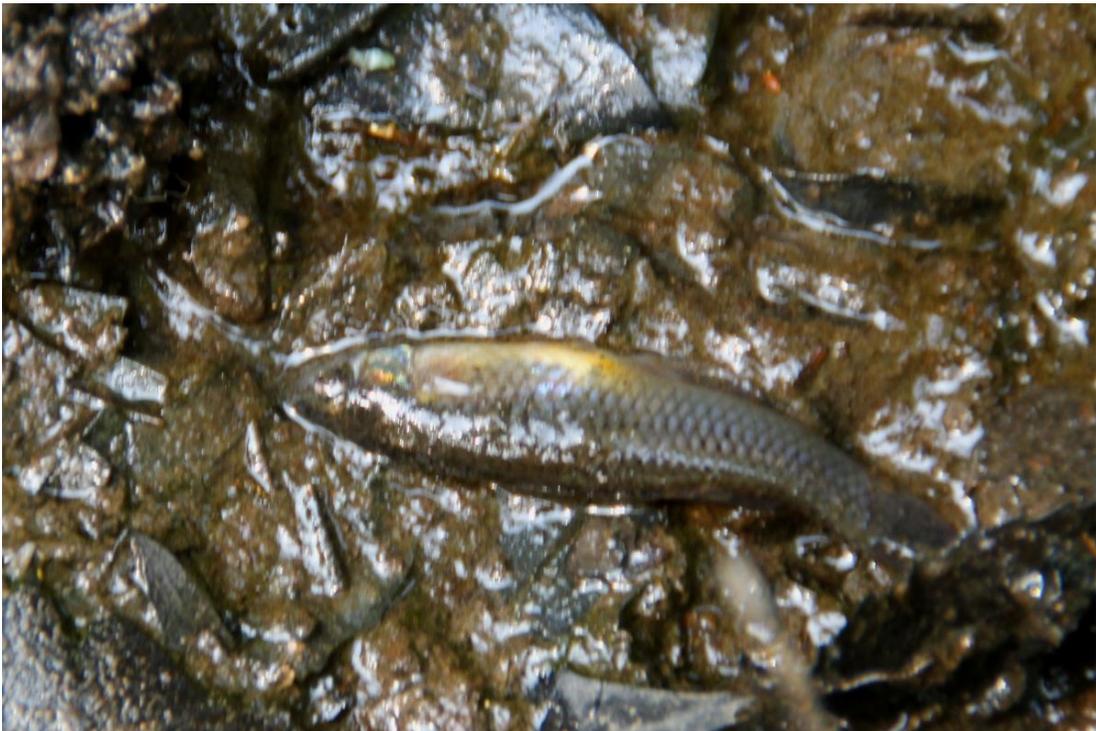
Photo 3.4-d. A number of small fish were found stranded in the puddles.

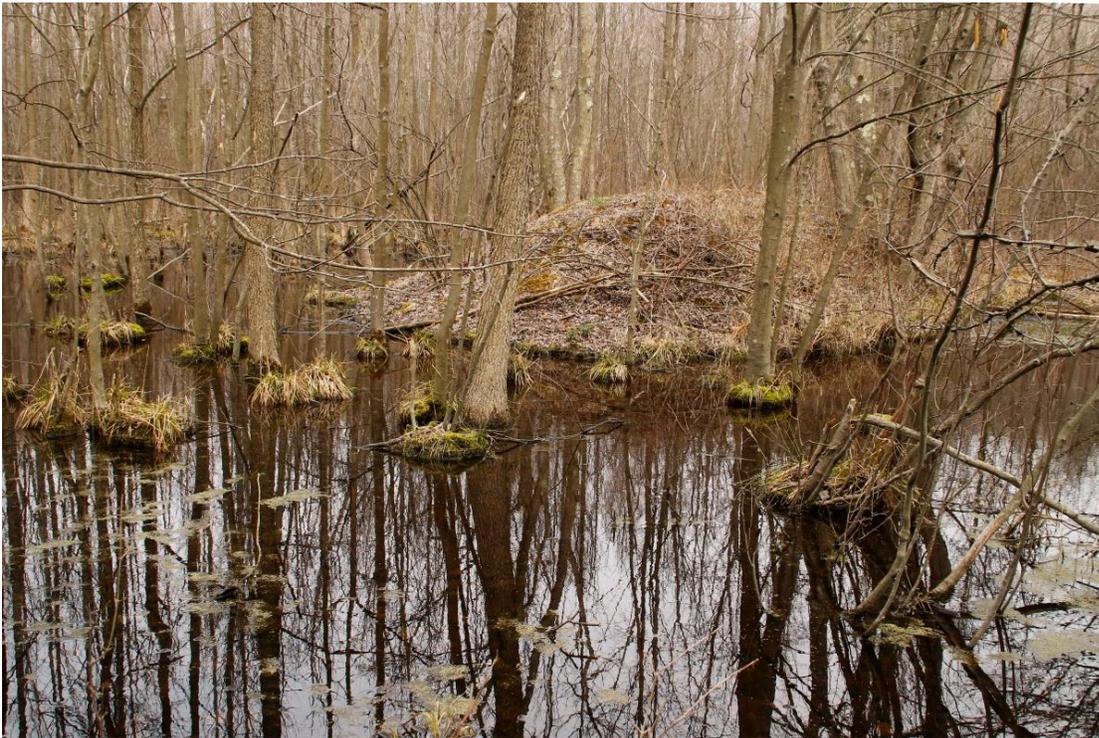
Photo 3.5-a. Pool 7954 on April 15 2013.

A variety of trees, shrubs and tussock sedges were scattered throughout the shallow depression that forms Pool 7954, which is approximately 750 square meters in size (photo 3.5-a). Although it was isolated from other pools in the Veteran's Park wetland complex, there was a pipe directing runoff from the park's adjacent entryway and parking area toward the pond (photo 3.5-b). However, it had no permanent flowing inlet or outlet and met the first criteria.

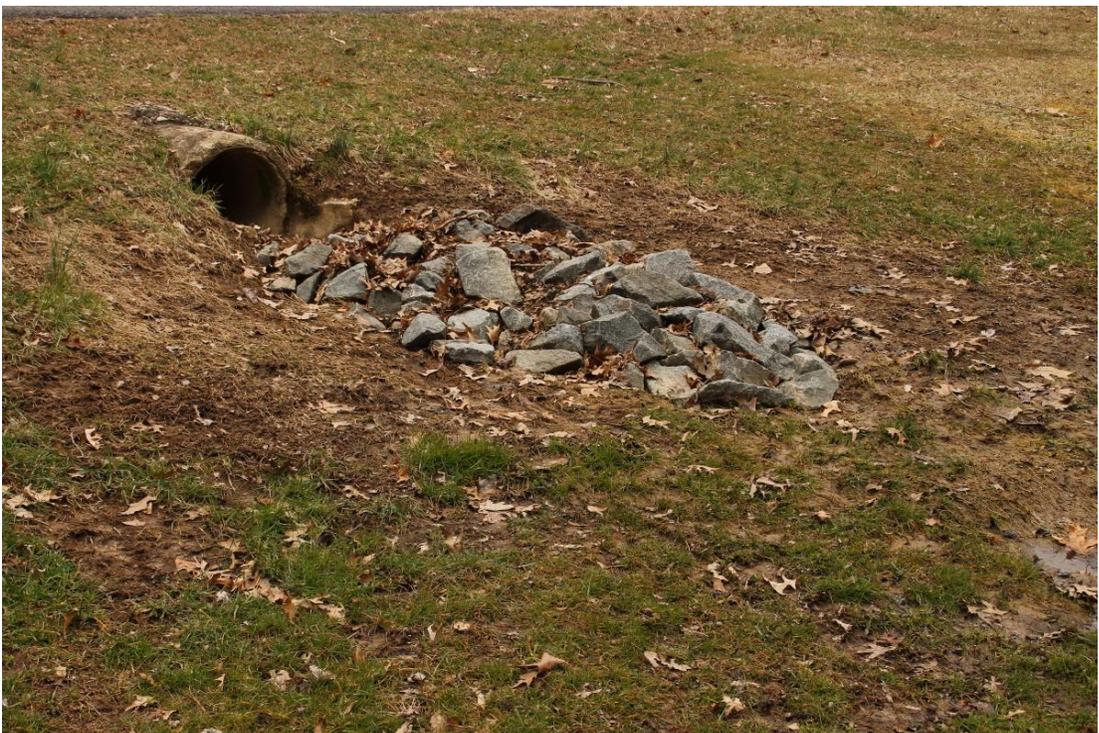
Photo 3.5-b. Drainage pipe from driveway/parking area leading into pool.

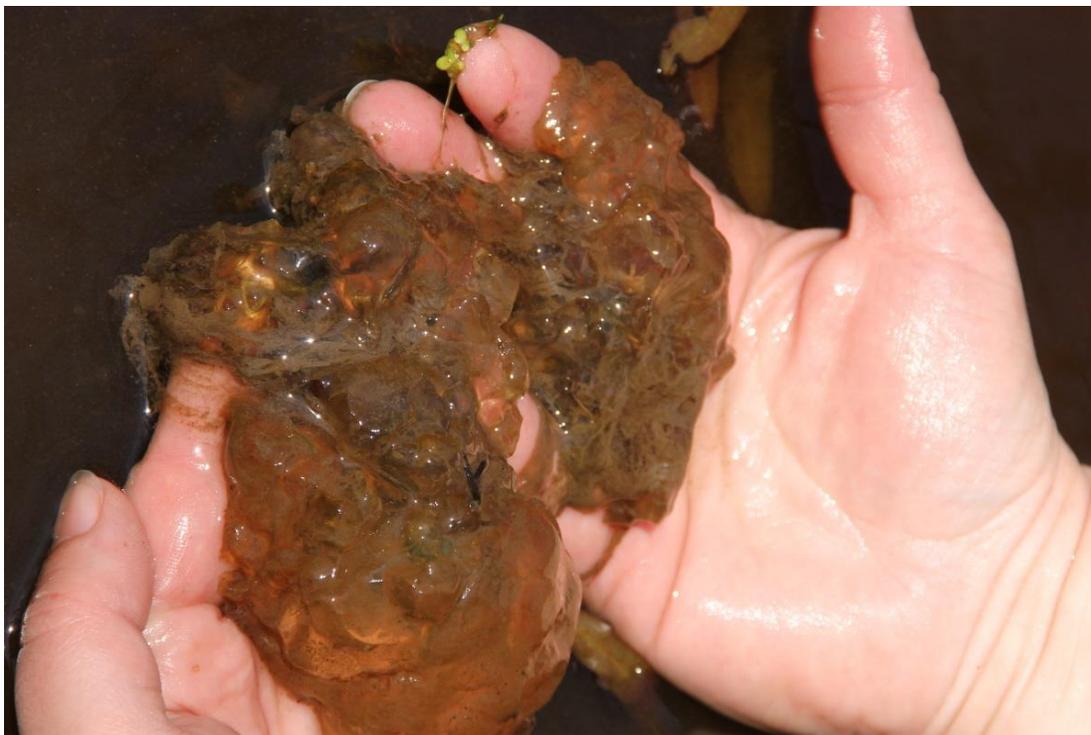
A number of wood frog egg masses were found in the pool on April 15. Most of the larvae had already wiggled their way out of the eggs, but a few tadpoles could still be seen in the gelatinous masses (photo 3.5-c). The presence of this obligate vernal pool breeder automatically fulfilled the second criteria, and healthy populations of facultative species including the northern spring peeper and green frog were present as well. Although mosquito larvae and water mites were noted in passing, no formal sampling of invertebrates was carried out at this location.

Photo 3.5-c. Remains of wood frog egg mass on April 17 2013.

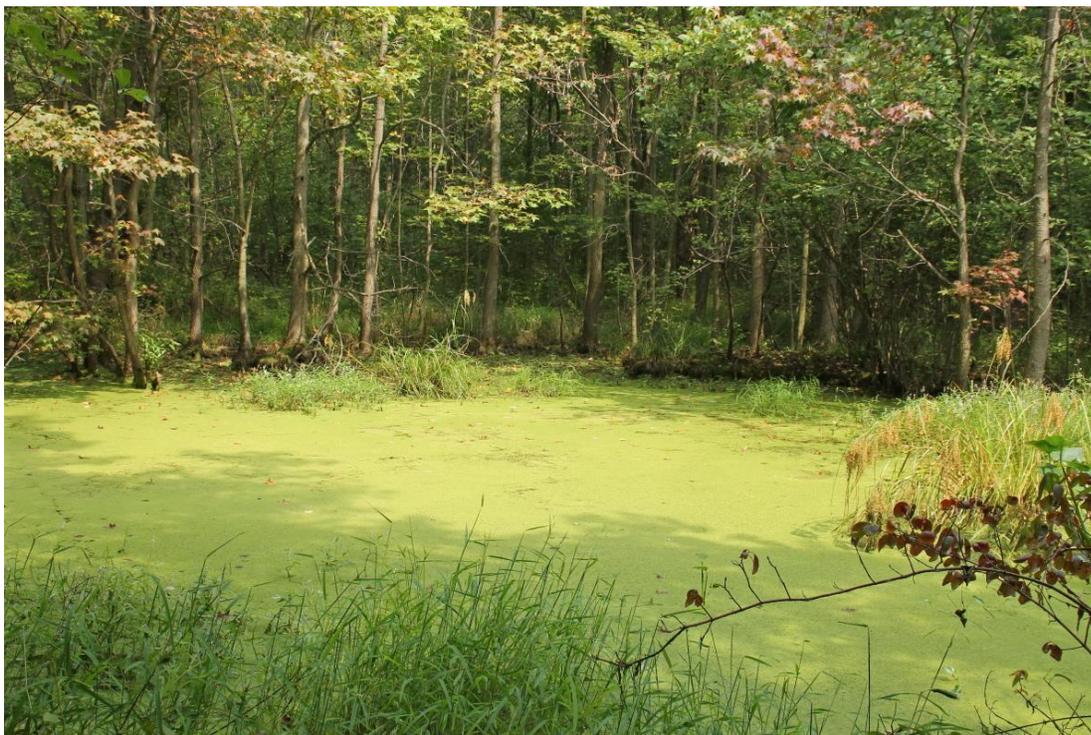
The pool held water throughout the spring. Although much of its surface area dried up over the course of the summer, a small area in the deepest part of the pond was still holding water and supporting a duckweed mat on September 10th (photo 3.5-d). Because the first two criteria were met, 7954 can automatically be certified as vernal and documentation of the pond in a completely dry state was not necessary.

Photo 3.5-d. Pool 7954 on September 10 2013.

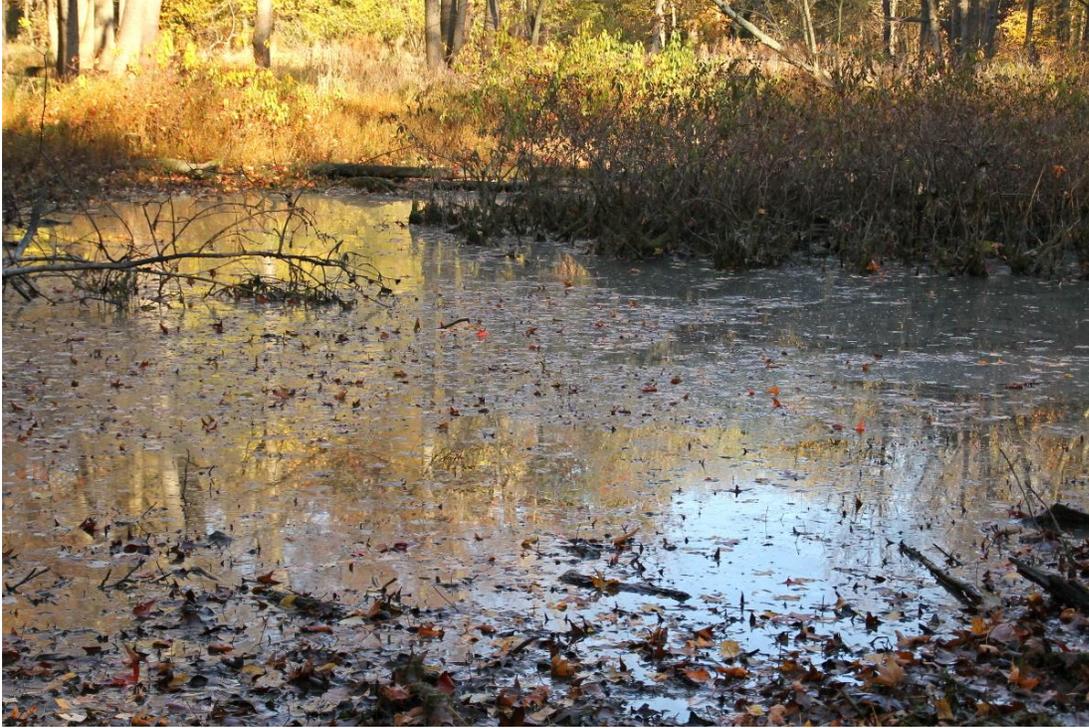
Notable drops in the water level occurred between the early spring and late summer months, but a substantial amount of water remained in the southern portion of the pond through the end of October (photo 3.6-c). By early September, however, a few small dry depressions were evident at the upper end where the chorus frogs and peepers had been noted during the spring (photo 3.6-d). It is possible that part of the area defined as Pool 7958 functions as vernal habitat, but as a unit it appears to be a permanent pond.

Photo 3.6-c. The southern end of 7958 still held plenty of water on October 28.

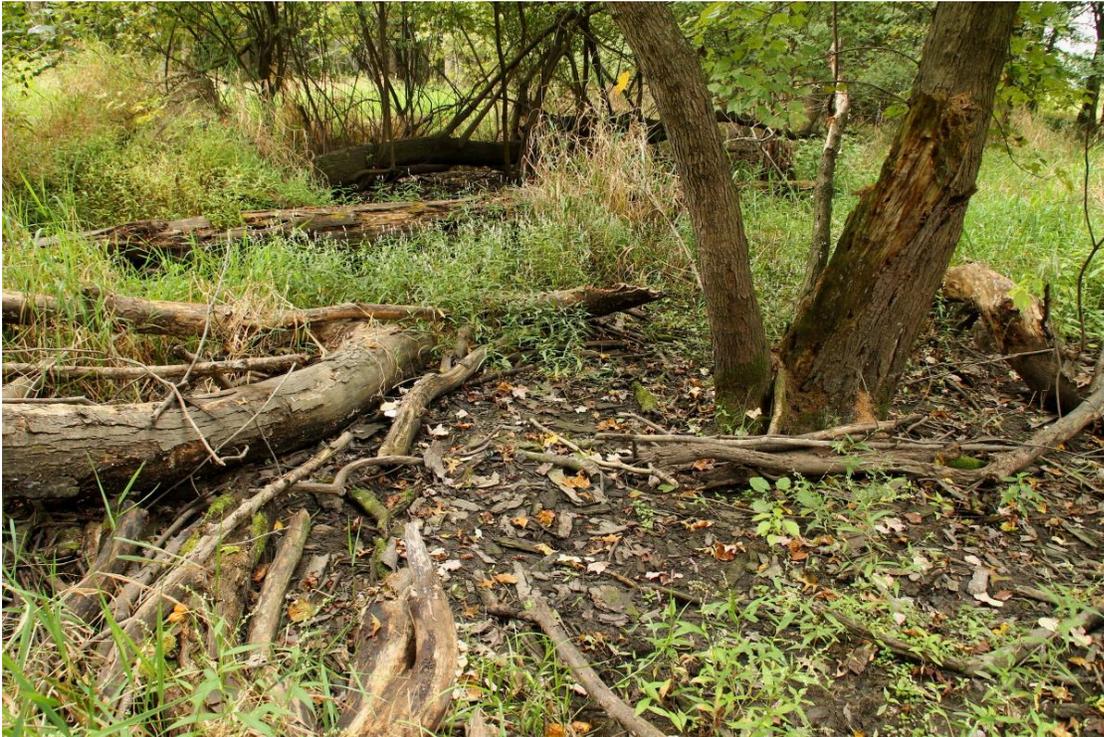
Photo 3.6-d. Small dry depressions were present in the northern end of 7958 by early September.

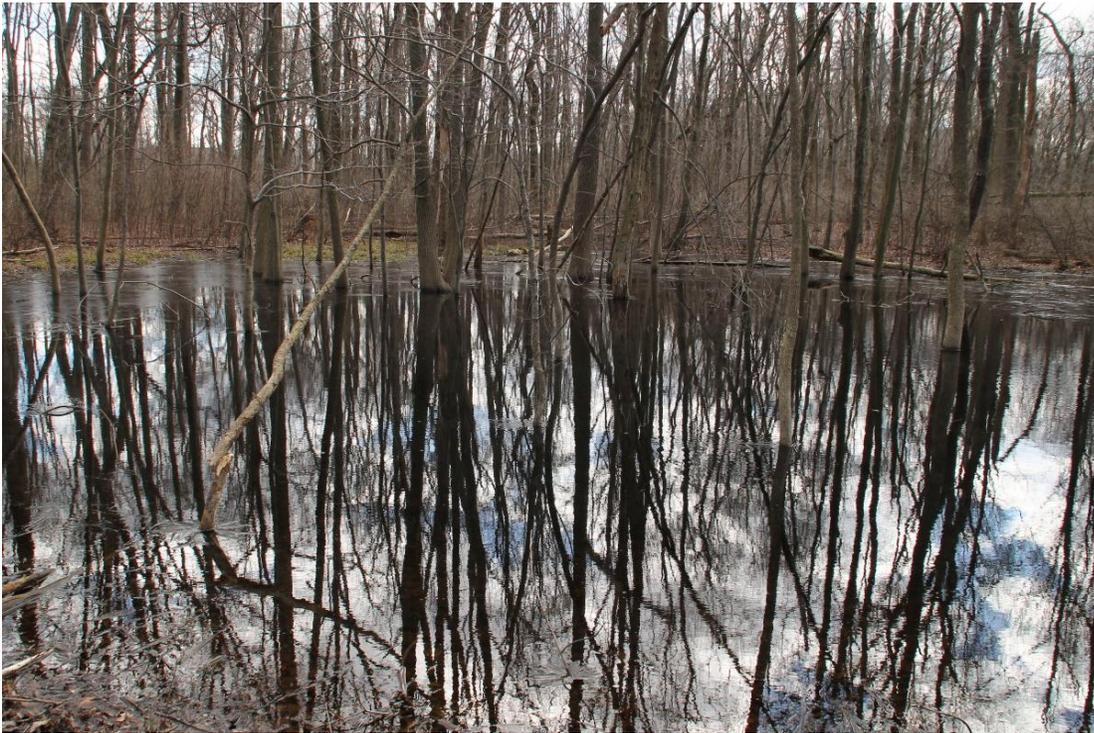
Photo 3.7-a. Pool 7966 on March 22 2013.

Although Pool 7966 appeared to have good vernal pool potential at the first site visit, most of the water had disappeared by early April (photo 3.7-b), and the depression was completely dry by early May (photo 3.7-c). The shallow water and brief hydroperiod made it an unsuitable breeding site for most amphibians.

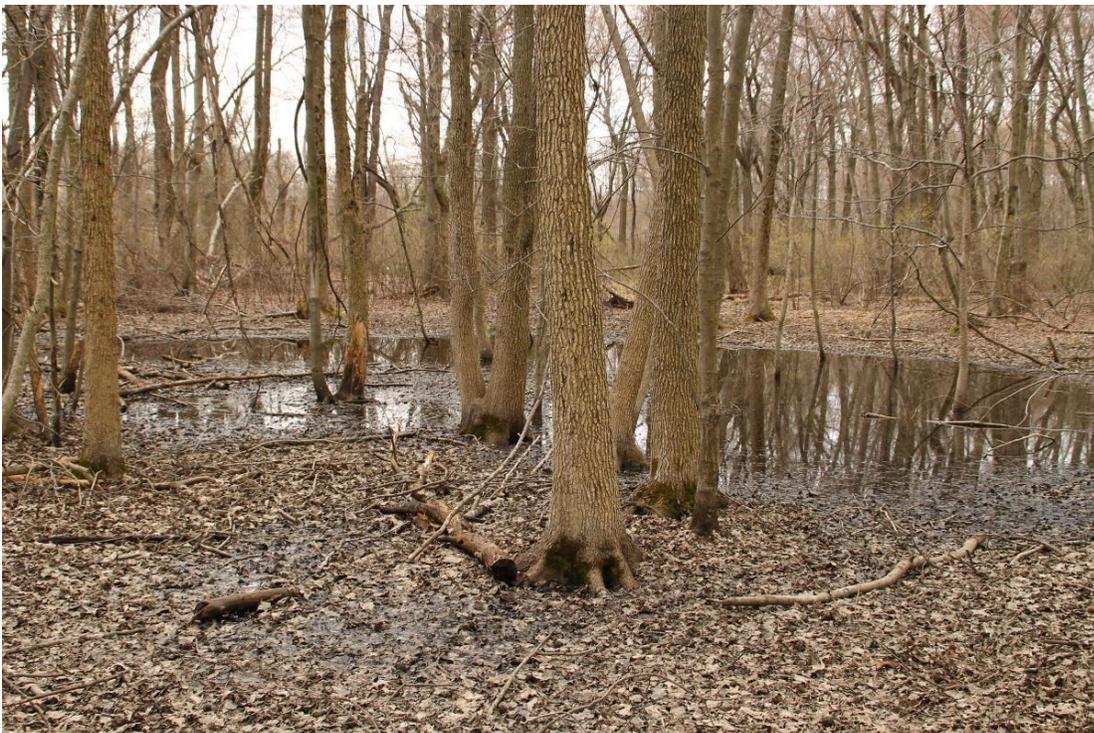
Photo 3.7-b. Pool 7966 on April 10 2013.

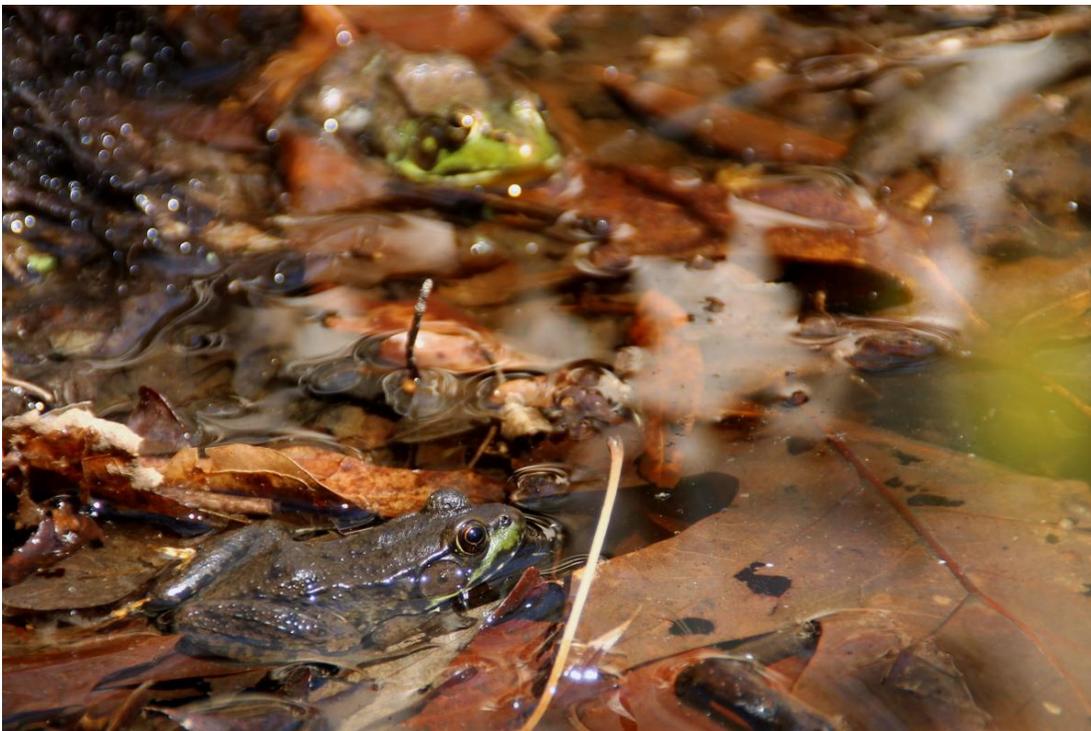
Photo 3.8-b. Green frogs were abundant around the pond.

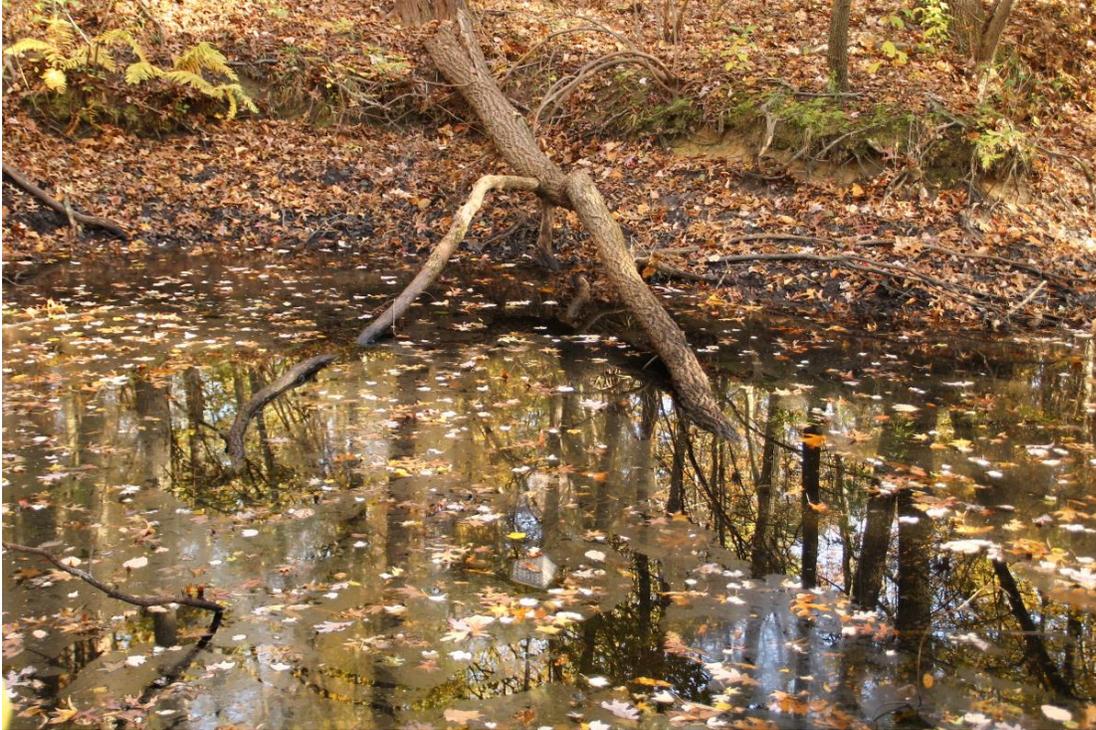
Photo 3.8-c. Pool 7970 on October 28 2013.

The water level in the pool appeared to be fairly stable throughout the spring and summer months, and although it may have dropped a bit by early September it was still one to two feet deep. The pond continued to hold a substantial amount of water through the end of October (photo 3.8-c). The final criteria could not be satisfied, as this appeared to be a permanent pond.

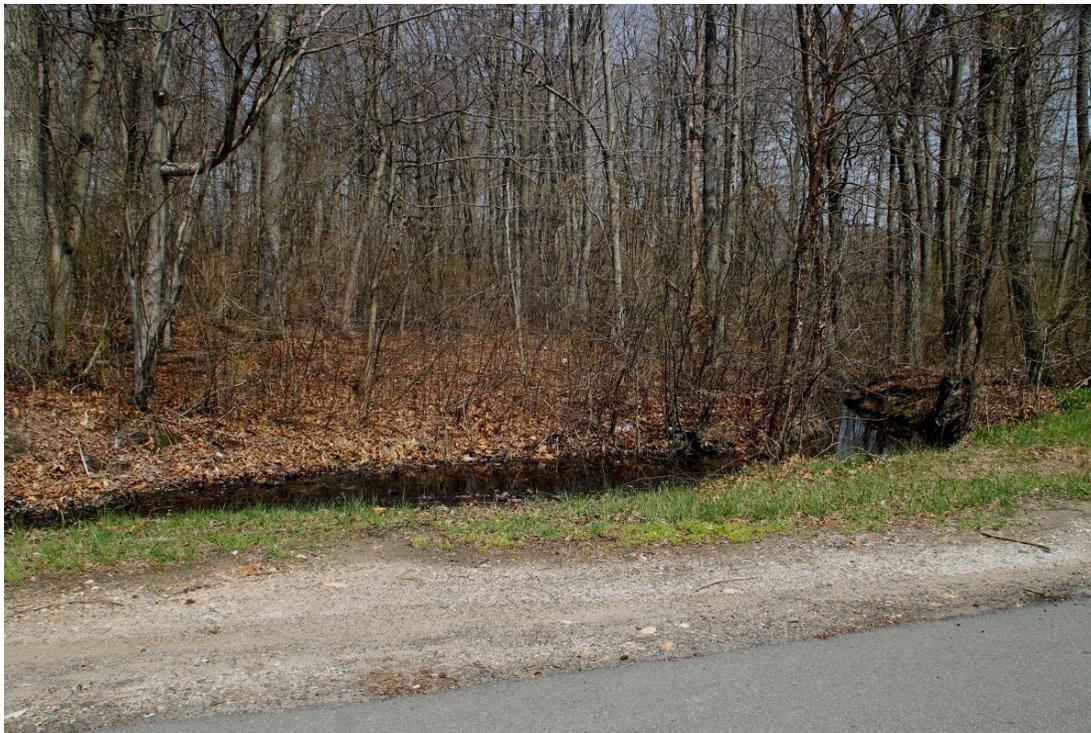
Pool 7974 and Pool 7978 were contiguous and remained connected to one another throughout the spring and summer and on into the dryer fall months. Together the pools occupied an area approximately 300 square meters in size. Two views of the wetland complex are presented in photos 3.9-a and 3.9-b. Although the pools were connected to each other, they were separate from other waterways and had no permanent inflow or outflow. It was noted, however, that a ditch receiving road runoff during periods of high flow emptied directly into the pool system (photo 3.9-c).

Photo 3.9-c. A roadside ditch emptied directly into the ponds.

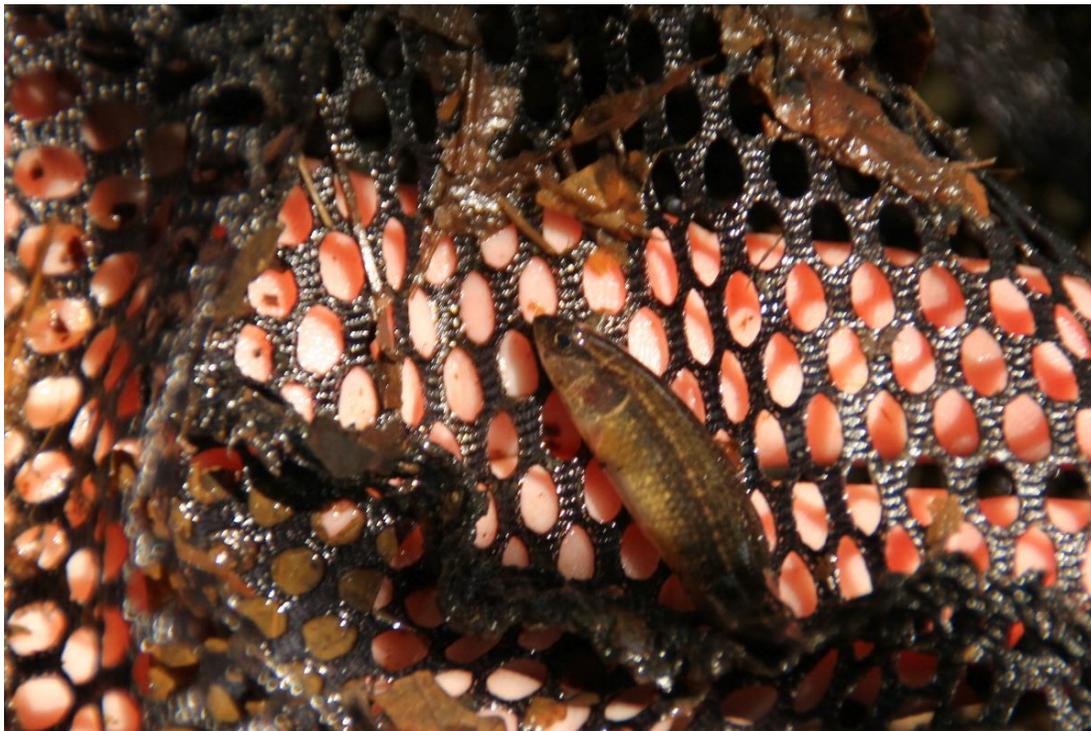
No change in the water level of the pools was noted between early spring and late summer visits. Furthermore, a small fish was found while sampling for aquatic life (photo 3.9-d), so the pool did not meet the fourth criteria.

Photo 3.9-d. A small fish was captured in the pools.

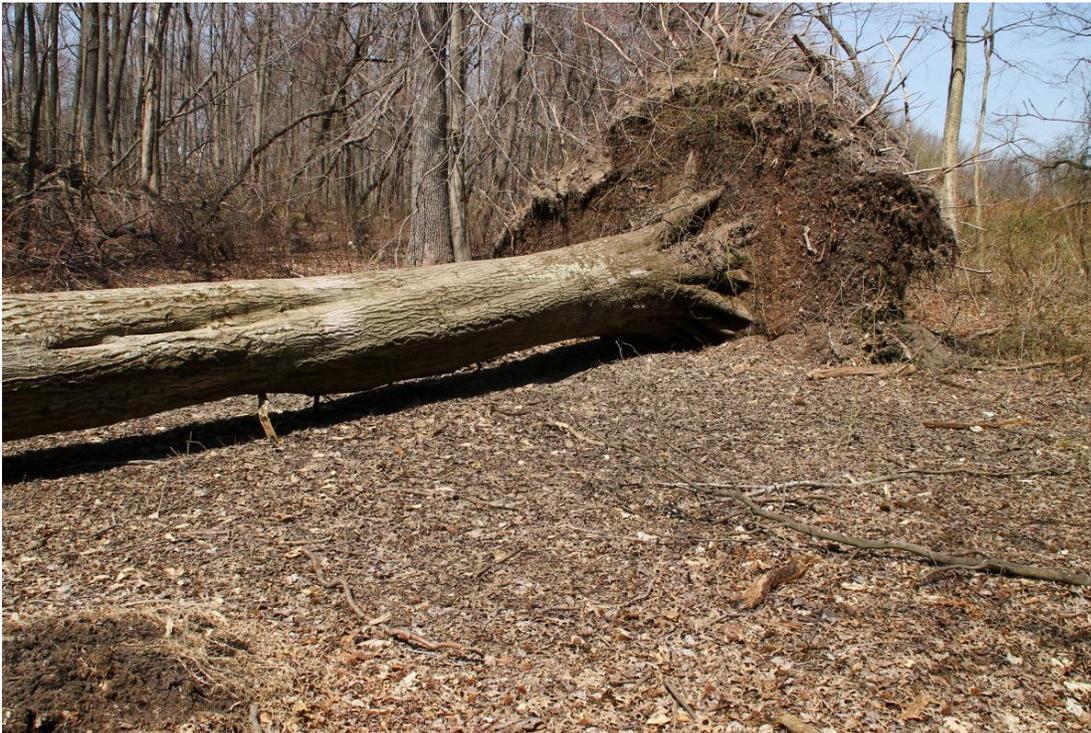
Pool 7996 was a natural depression with no visible inflow or outflow at the edge of a forested area. On first view, the outline of the pond was clearly visible but the basin appeared to be dry (photo 3.11-a). Upon closer examination, however, a small pool about 12 square meters in size and one to two feet deep was found at the base of an uprooted tree.

Photo 3.11-a. The original basin of Pool 7996.

The evidence suggests that Pool 7996 was once an average-sized vernal pool, but that the hole created by the absent root mass of a fallen tree changed the hydrology of the site and significantly reduced the volume of the pond. As the tree fall appeared to be relatively recent, it is possible that a few of the wood frogs returning to their former procreation site just made the best of the situation. Although 7996 was definitely functioning as vernal breeding habitat in 2013, it is uncertain whether it will continue to be utilized by the frogs. The pool may stabilize and return to its former dimensions as the soil settles, or it may dry up too quickly to allow sufficient time for the larvae to develop. A follow-up visit to this location during April of 2014 is recommended.

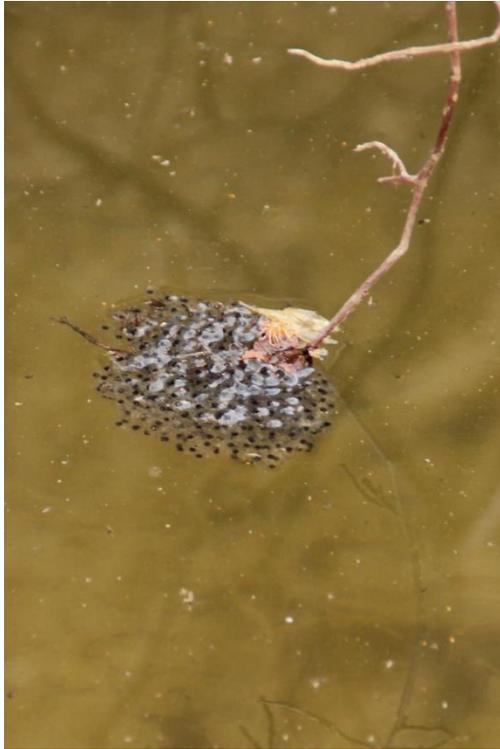
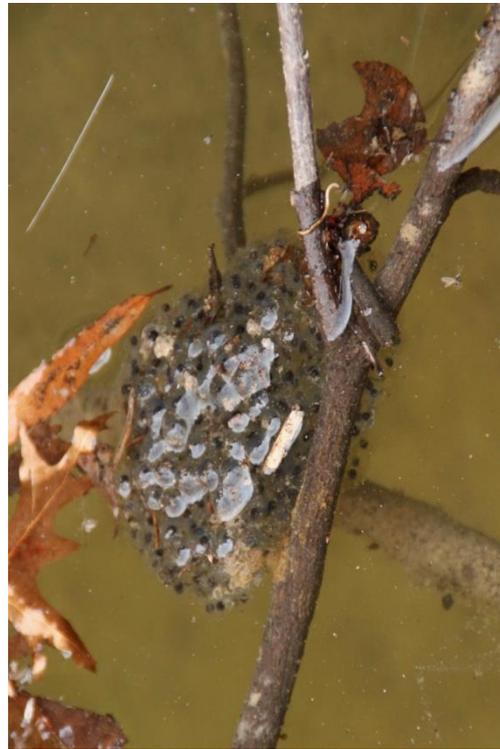
Photos 3.11-c and 3.11-d. Some wood frog egg clusters in Pool 7996.

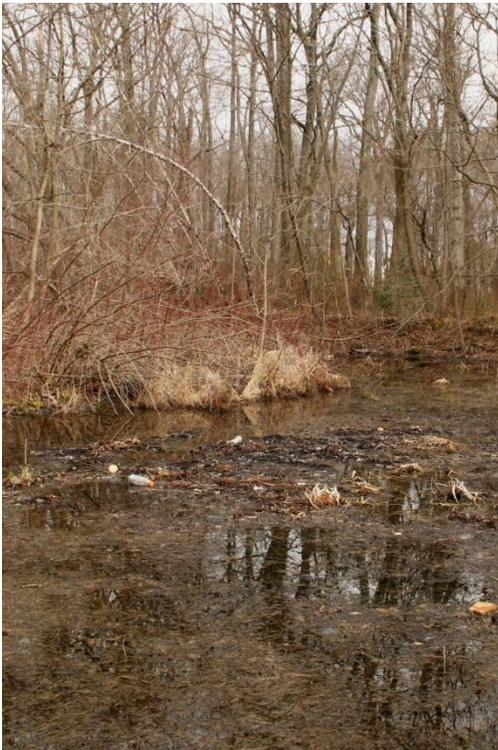
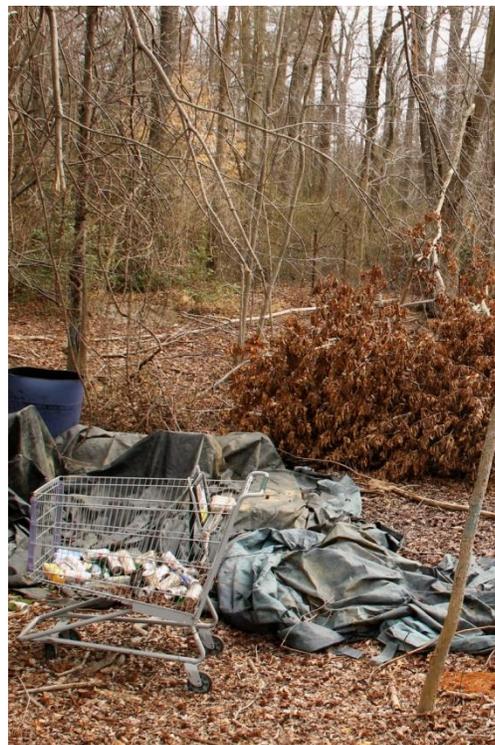
Photos 3.12-b and 3.12-c. Trash in and around the pond.

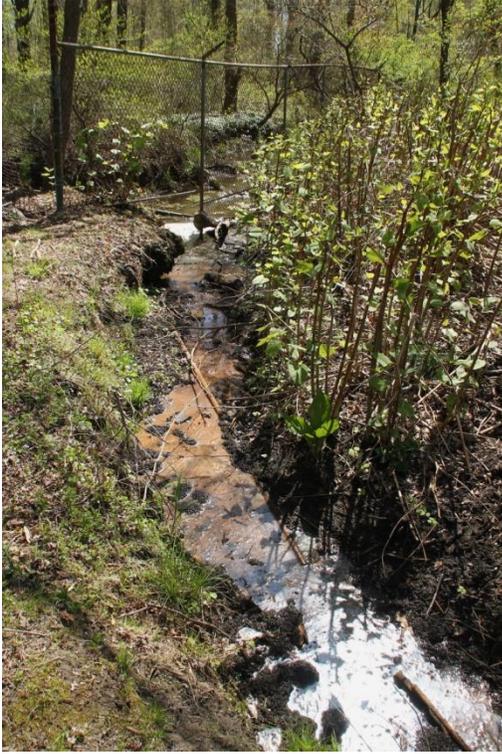
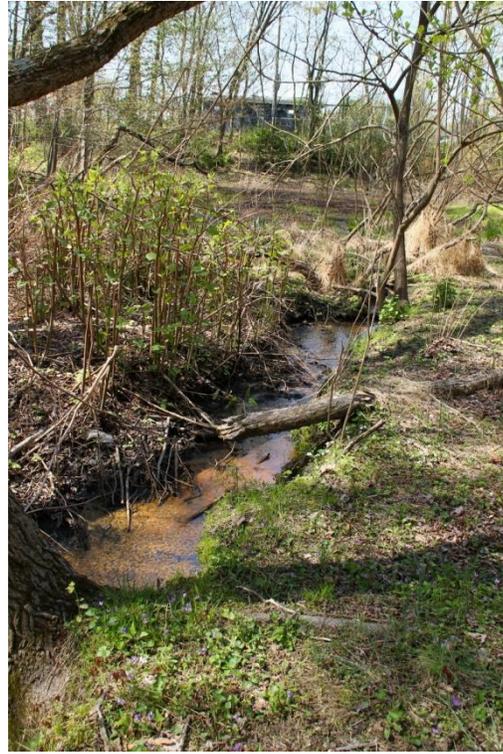
Photos 3.12-d and 3.12-e. Two views of the ditch connecting the pond and stream.

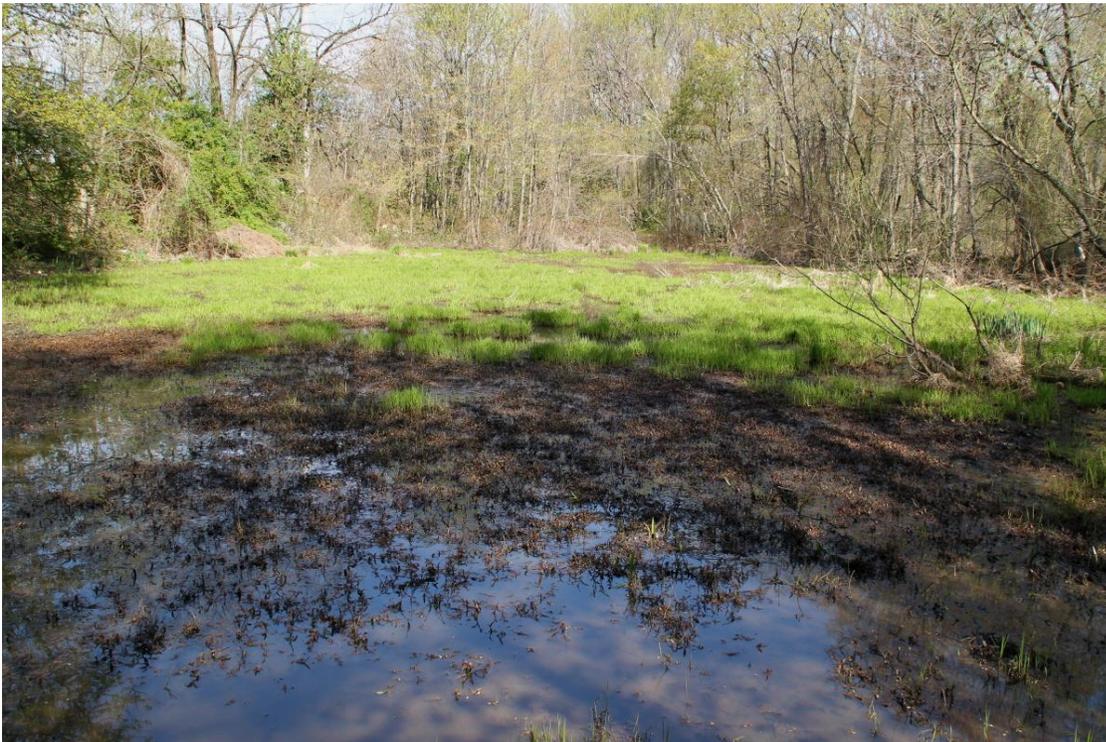
Photo 3.12-f. Pool 8000 on April 25 2013.

Surface water was present during late March, but by mid-late April most of the pond was made up of a thick layer of saturated mud with a few shallow ponded areas scattered throughout (photo 3.12-f). Monitoring of the water levels was discontinued once the connection to the stream was documented.

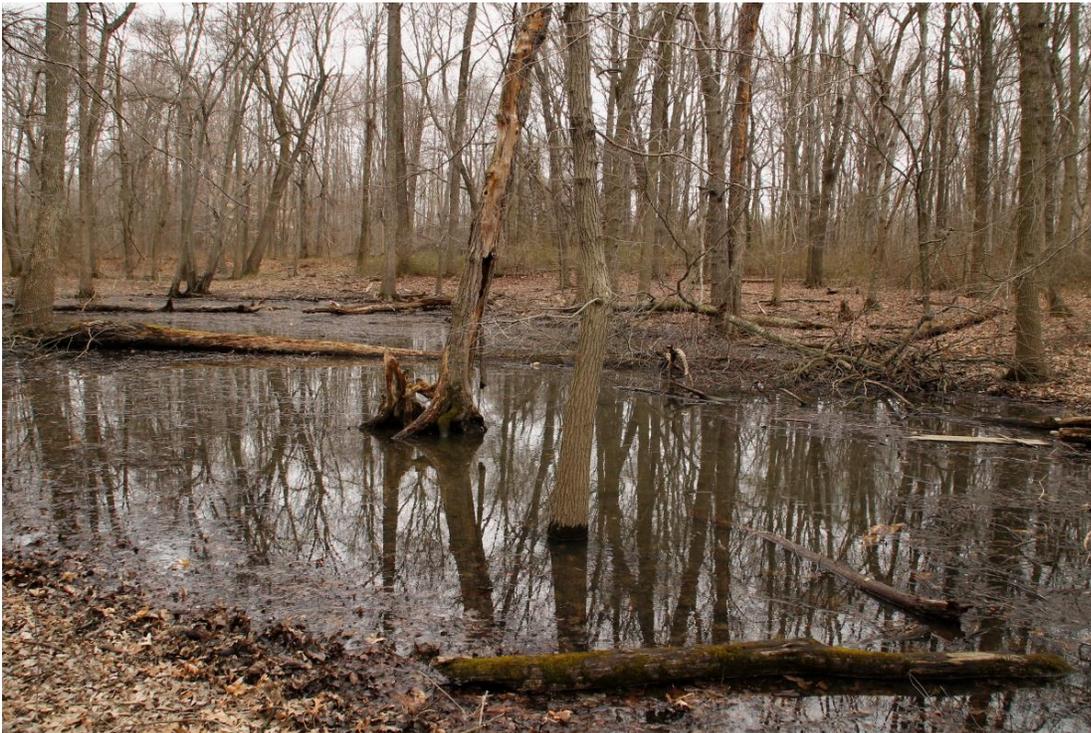
Photo 3.13-a. Pool 8008 on March 21 2013.

The water level observed during the initial visits was noted as one to two feet deep at the center, but the pool did not seem to be fully occupying the available depression (photo 3.13-a). By early May the pond bed was completely dry (photo 3.13-b).
