**A 2013 SURVEY OF POTENTIAL VERNAL POOLS
IN HAMILTON TOWNSHIP, MERCER COUNTY, NEW JERSEY**

Prepared for the Township of Hamilton

**Deborah J. Kratzer
Kratzer Environmental Services**

**Jill S. Dodds
Biostar Associates, Inc.**

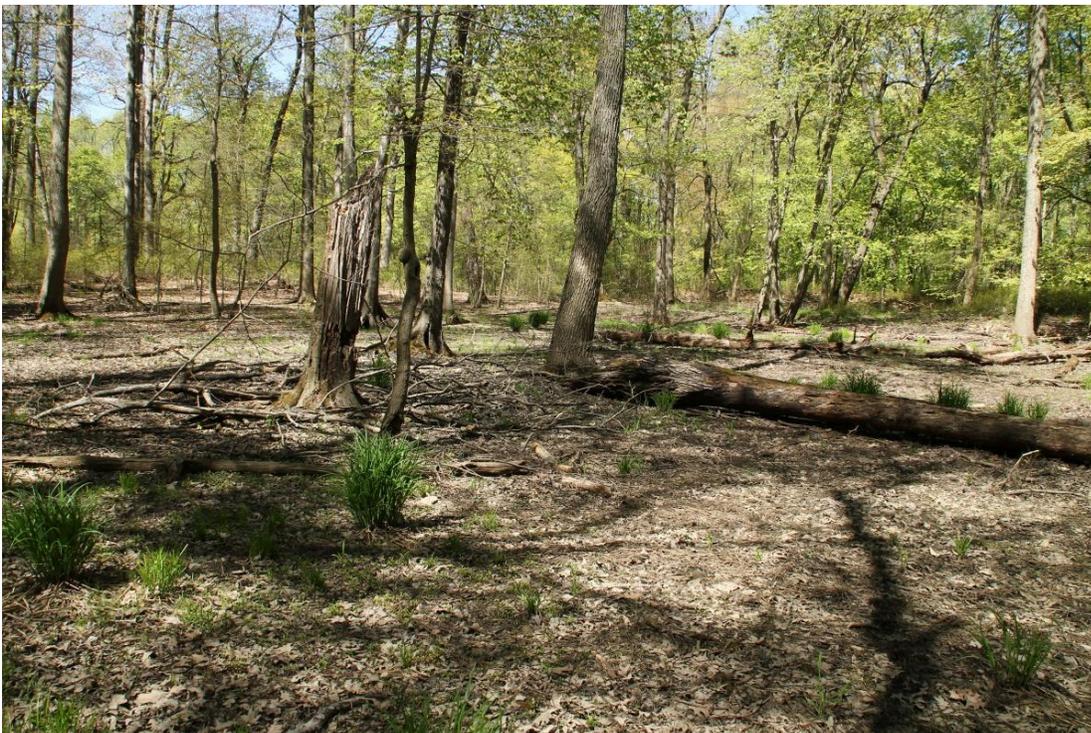
The water level observed during the initial visits was noted as one to two feet deep at the center, but the pool did not seem to be fully occupying the available depression (photo 3.13-a). By early May the pond bed was completely dry (photo 3.13-b).

Photo 3.13-b. Pool 8008 on May 3 2013.

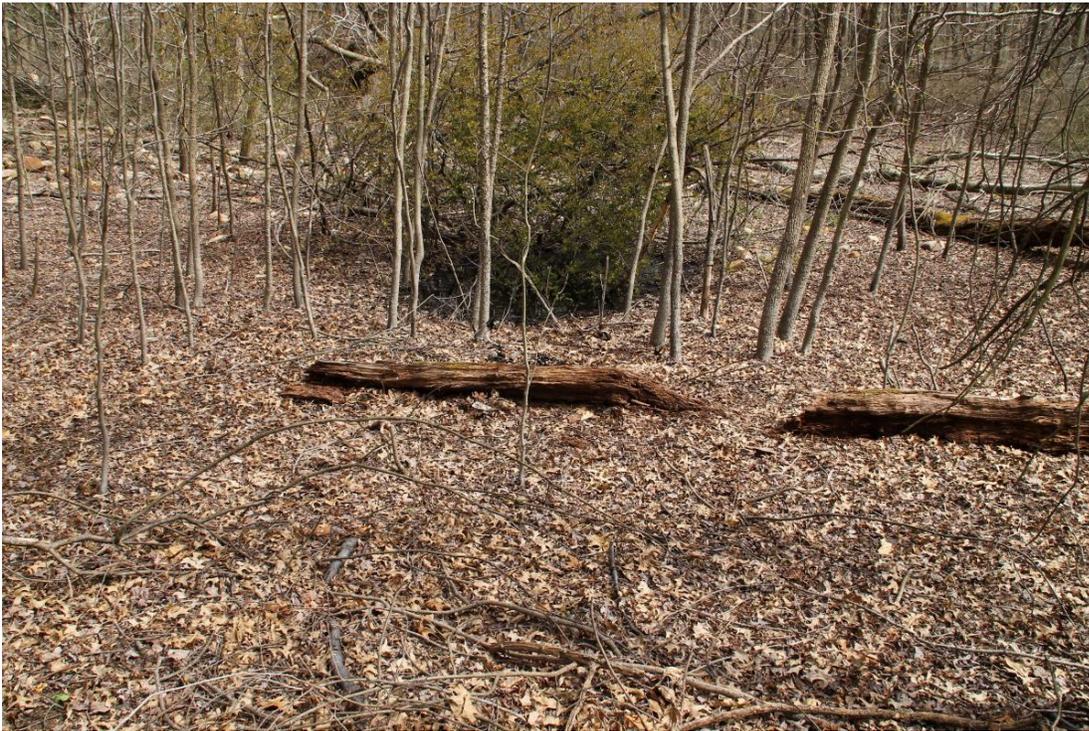
Photo 3.14-a. Pool 8012 was nearly dry on March 21 2013.

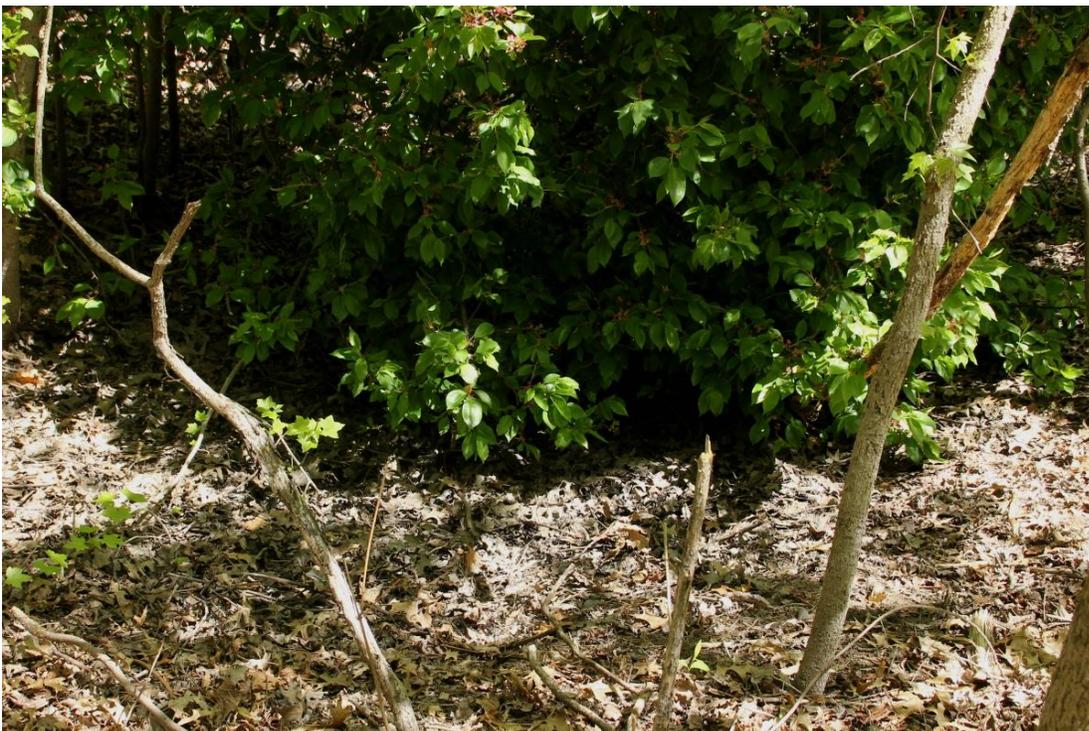
Very little water was present in the basin during the early spring, and it was completely dry by the beginning of May (photo 3.14-b).

Photo 3.14-b. By May 3rd the water had completely dried up.

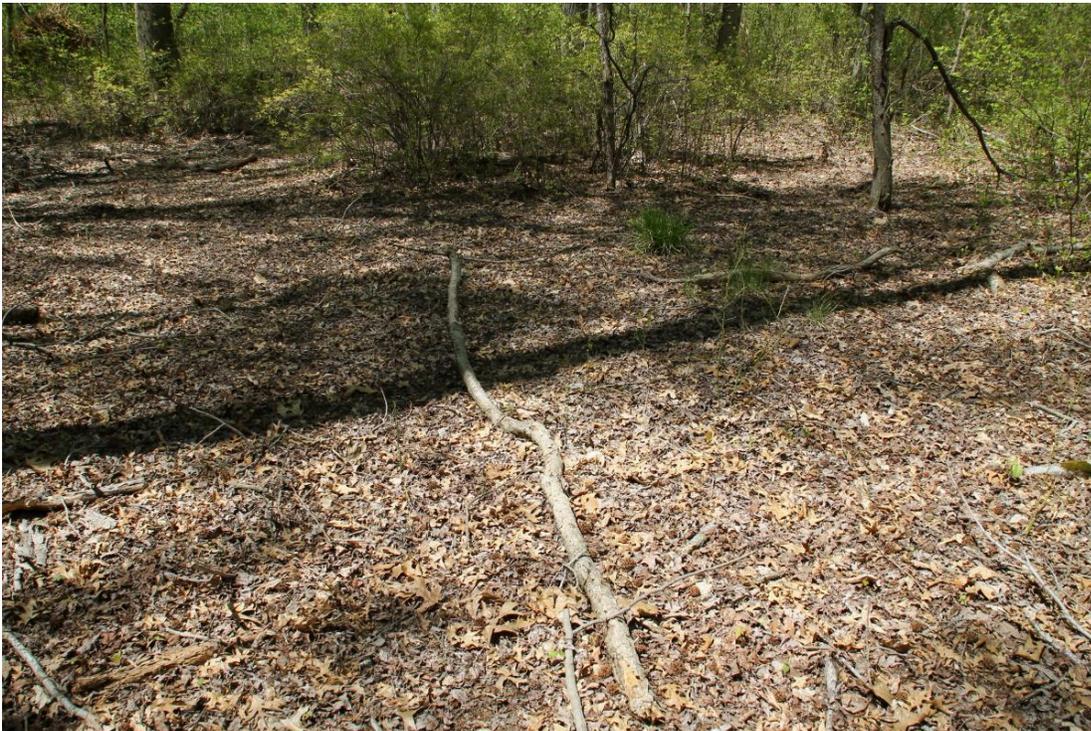
Photo 3.15-b. Pool 8016 on May 3.

Unlike some of the other sites examined during this study, Pool 8016 was not a small remnant pond in a larger depression. In this case the entire depression was diminutive. Not surprisingly, the water had completely dried up by early May (photo 3.15-b).

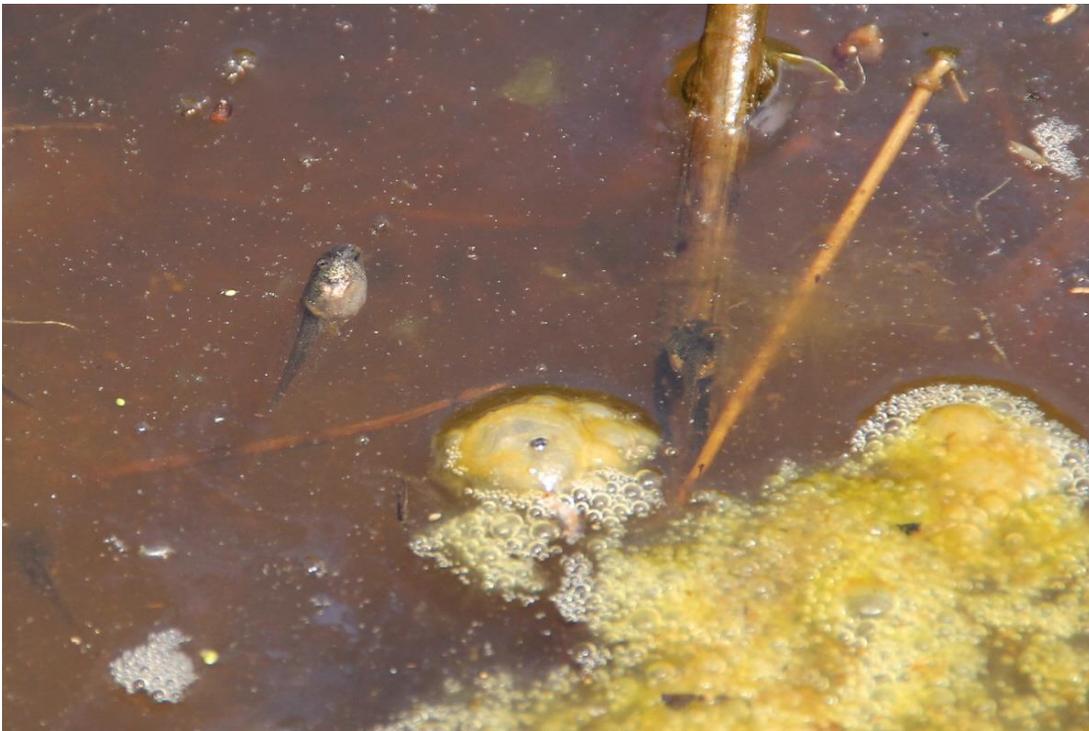
Photo 3.16-b. Wood frog tadpoles were abundant in the pond on May 6.

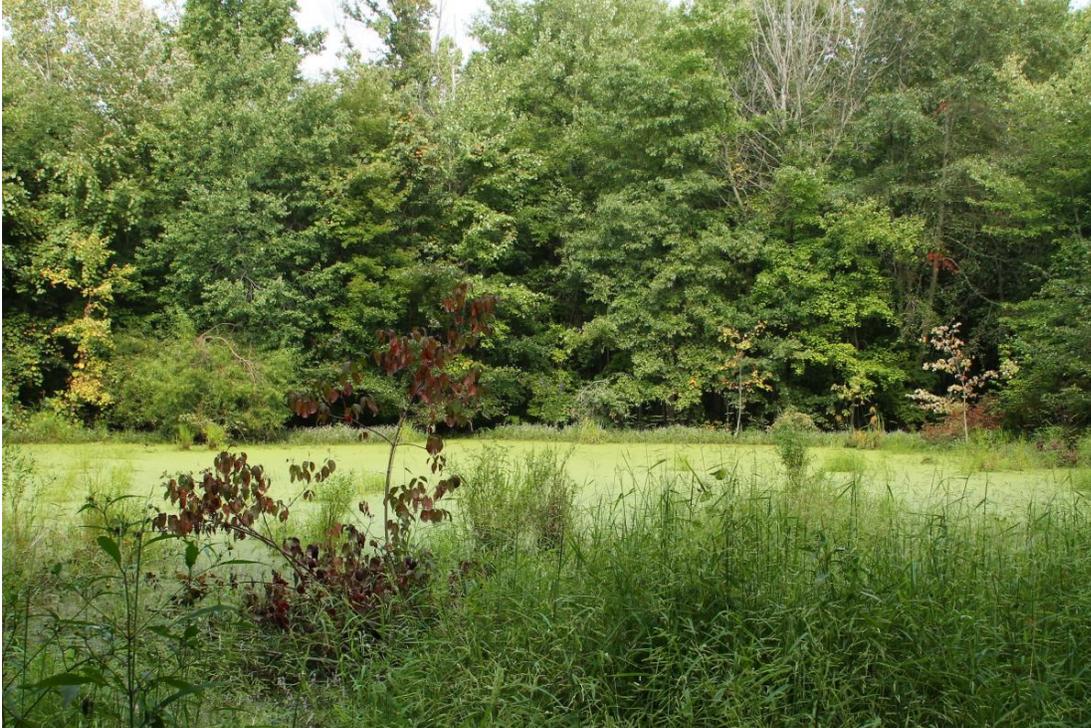
The water level had substantially decreased by early September, although the pond still held a fair amount of water (photo 3.16-c). Because the first two criteria were met, 8024 can automatically be certified as vernal and documentation of the pond in a completely dry state was not necessary.

Photo 3.16-c. The pool still held some water and had a solid cover of duckweeds on September 10.

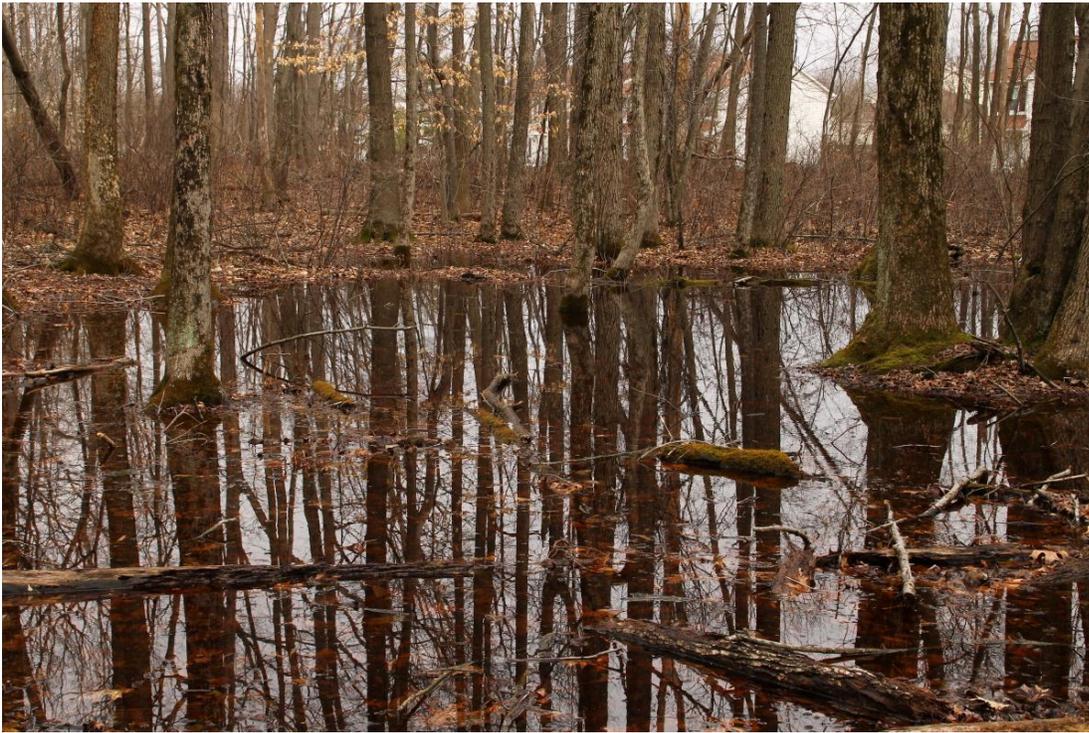
Photo 3.17-a. Pool 8062 on March 21 2013.

Pool 8062 was located on the edge of a woodland patch behind Dunmoor Court South. It was set in a natural depression approximately 2100 square meters in area and had no permanent inflow or outflow, although it was positioned to receive runoff from the adjacent residential lots (photo 3.17-a). Forest composition included a number of beech trees as well as the oak-maple-sweetgum mix typical throughout the Township, and the pond was edged by wetland-loving shrubs such as sweet pepperbush, highbush blueberry and fetterbush.

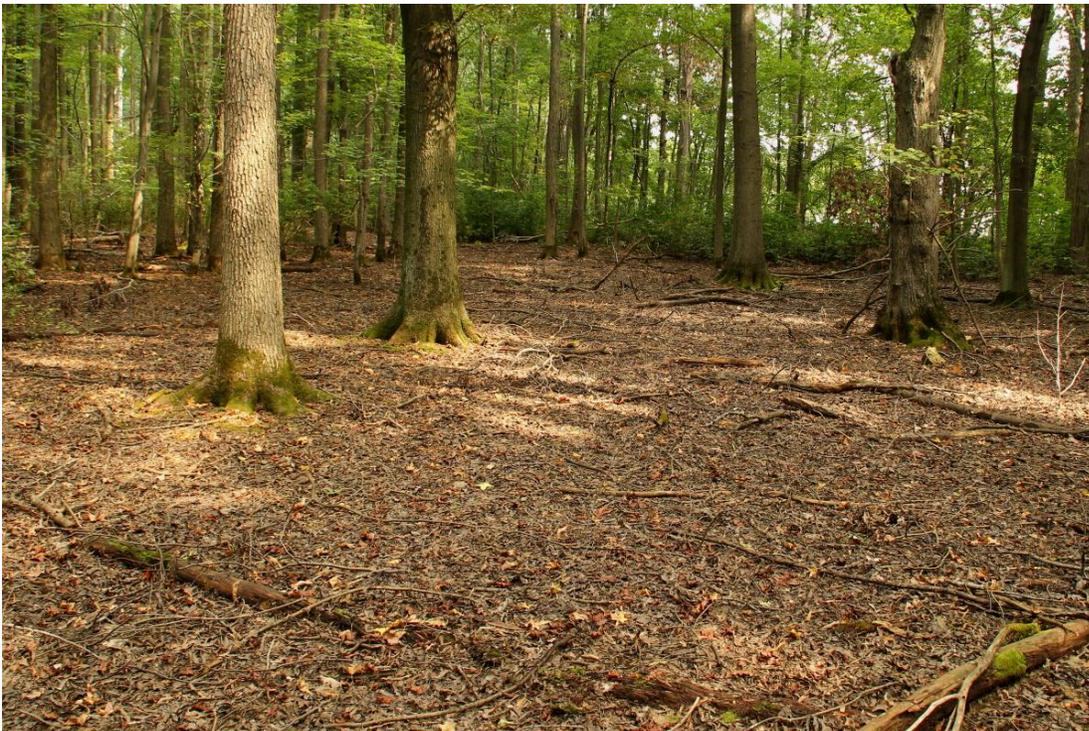
Photo 3.17-b. Pool 8062 on September 10.

Although 8062 was rather shallow, it held water continuously from late March through mid-June. The pond bed was completely dry by early September (photo 3.17-b).

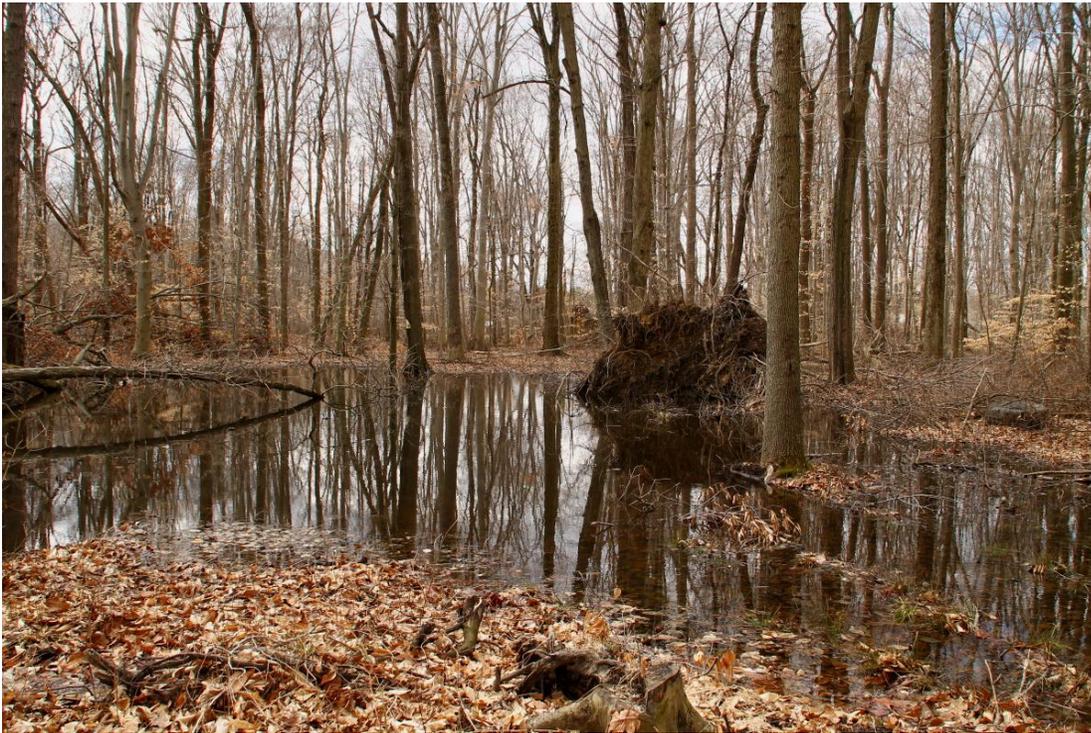
Photo 3.18-a. Pool 8090 on March 22 2013.

Pool 8090 was one of a number of natural depressions scattered throughout the forested area between Edgewood Road and the Back Creek tributary. The pools in the woodland were isolated both from the creek and from one another. The target pool occupied about 900 square meters and contained sufficient shrubby growth and woody debris to attract the kinds of amphibians that require such substrate for attachment of egg masses (photo 3.18-a).

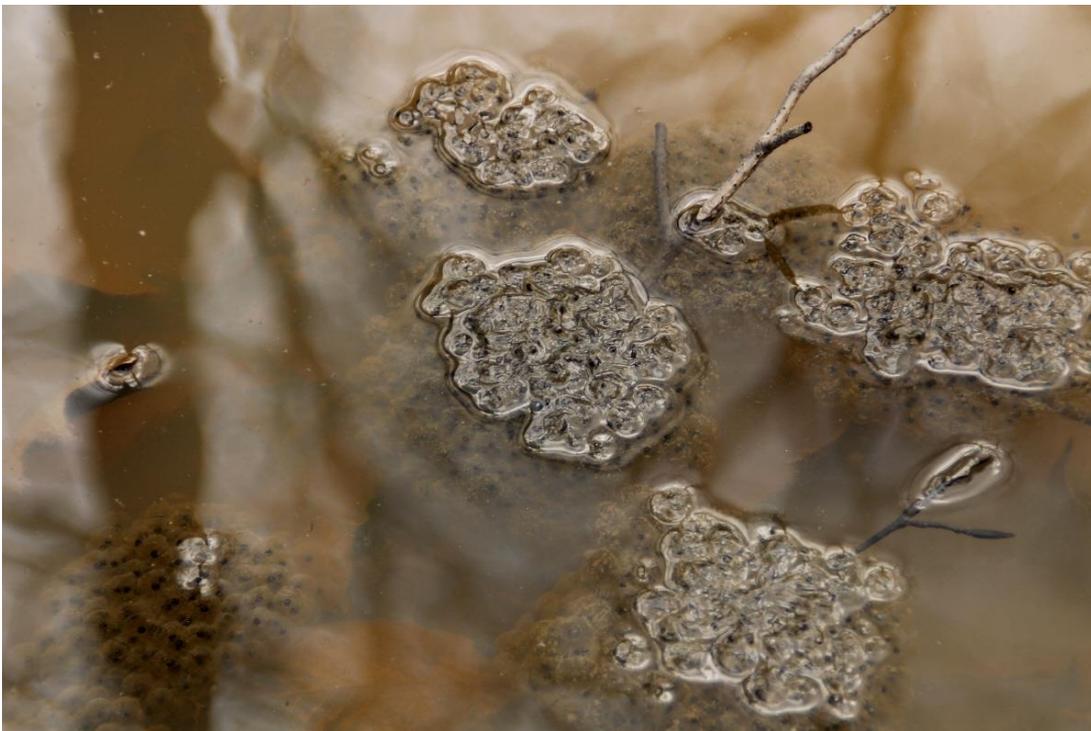
Wood frog egg masses were abundant in the pool, and were also present in some nearby tire-ruts that were filled with water (photo 3.18-b). Egg masses could also be seen in a nearby pool that was not on the numbered list of potential vernal pools in the Township. Because the wood frog is an obligate vernal pool breeder no additional efforts were made to document the pond's fauna, although some spring peepers were also noted on site.

Photo 3.18-b. Wood frog eggs were abundant on the site.

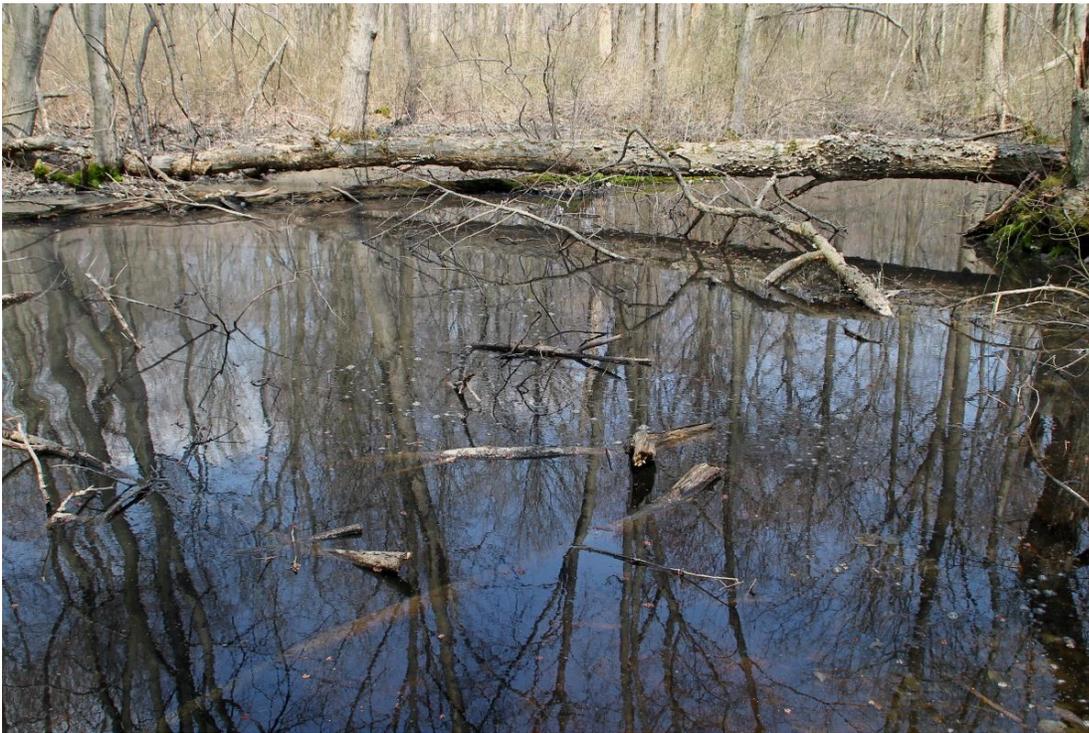
Photo 3.19-a. Pool 8104 on April 10 2013.

Pool 8104 was approximately 240 square meters in size, and about a foot deep in the center. It was located in a maple-oak-sweetgum forest with a notable amount of greenbriar in the understory. The pond occurred in a shallow natural depression with no permanent inflow or outflow (photo 3.19-a).

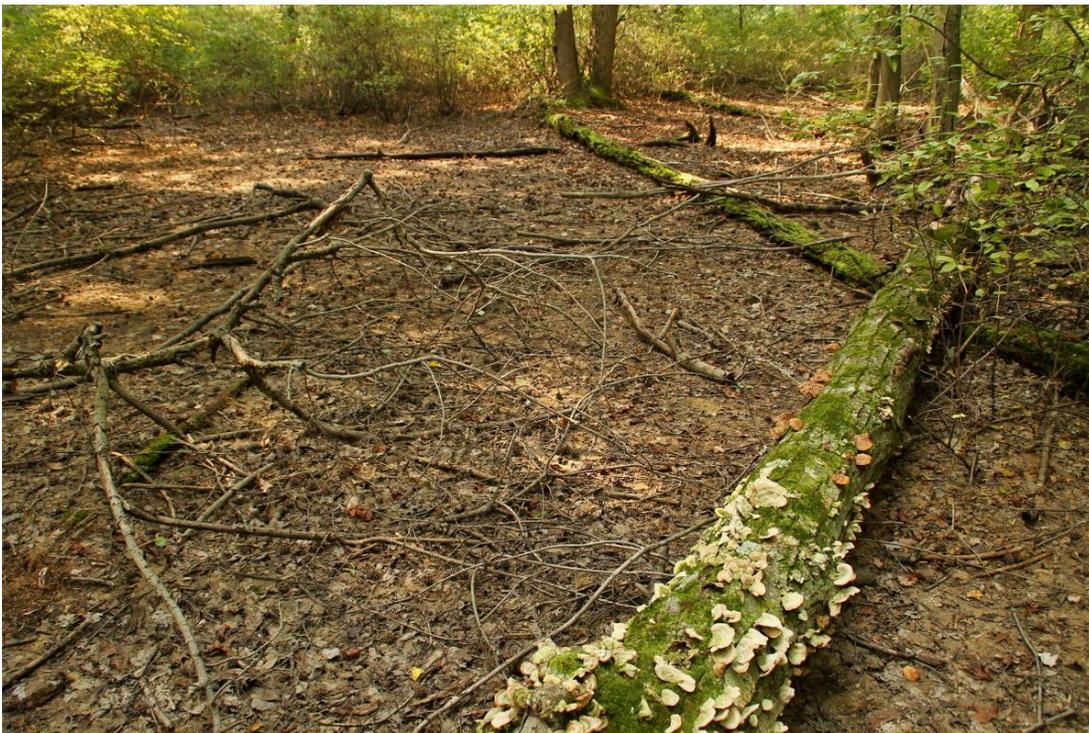
Photo 3.19-b. Pool 8104 on September 10.

The pond held water consistently from mid-April through mid-June. In fact, it was noted on a June 14 visit that water levels were higher than they had been earlier in the spring. By the end of the summer, the basin was completely dry (photo 3.19-b).

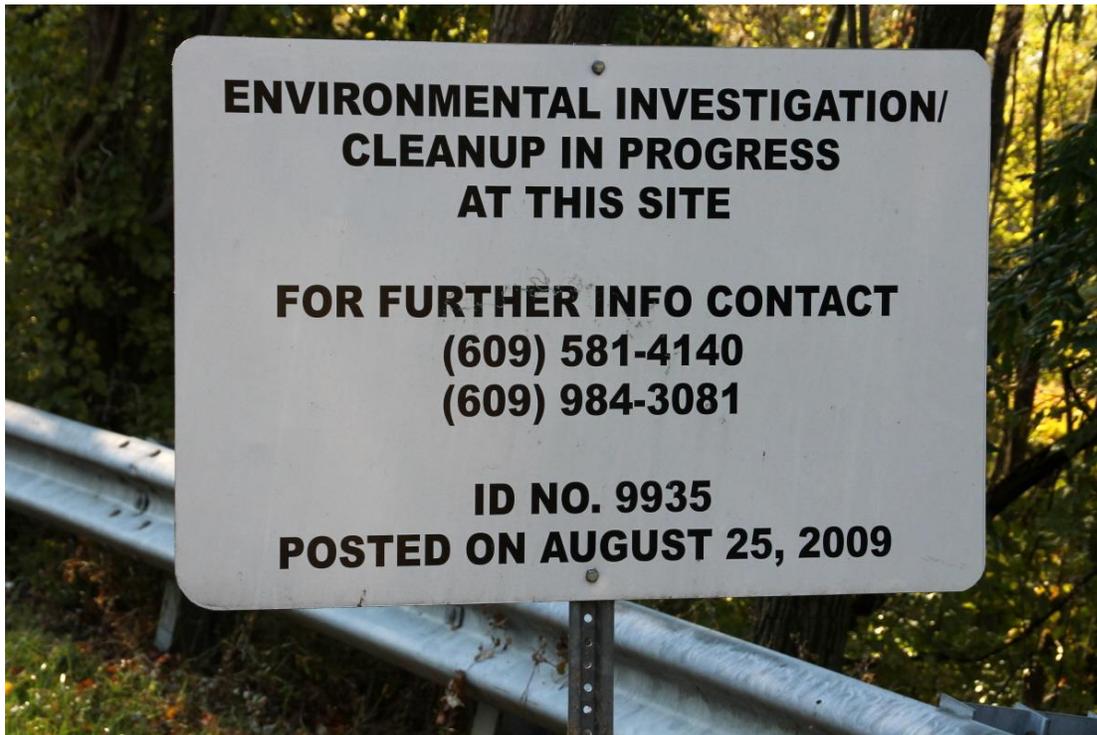
The Township identified these two pools as former sludge lagoons, and a quick drive up to the site confirmed that these large open bodies of water were not likely to offer high quality vernal habitat (photo 3.20-a). A second look at the end of the season showed that the pools were still full and would therefore be considered permanent ponds (photo 3.20-b). No formal survey was carried out for the lagoons.

Photo 3.20-a. The two former sludge lagoons were not included in the survey.

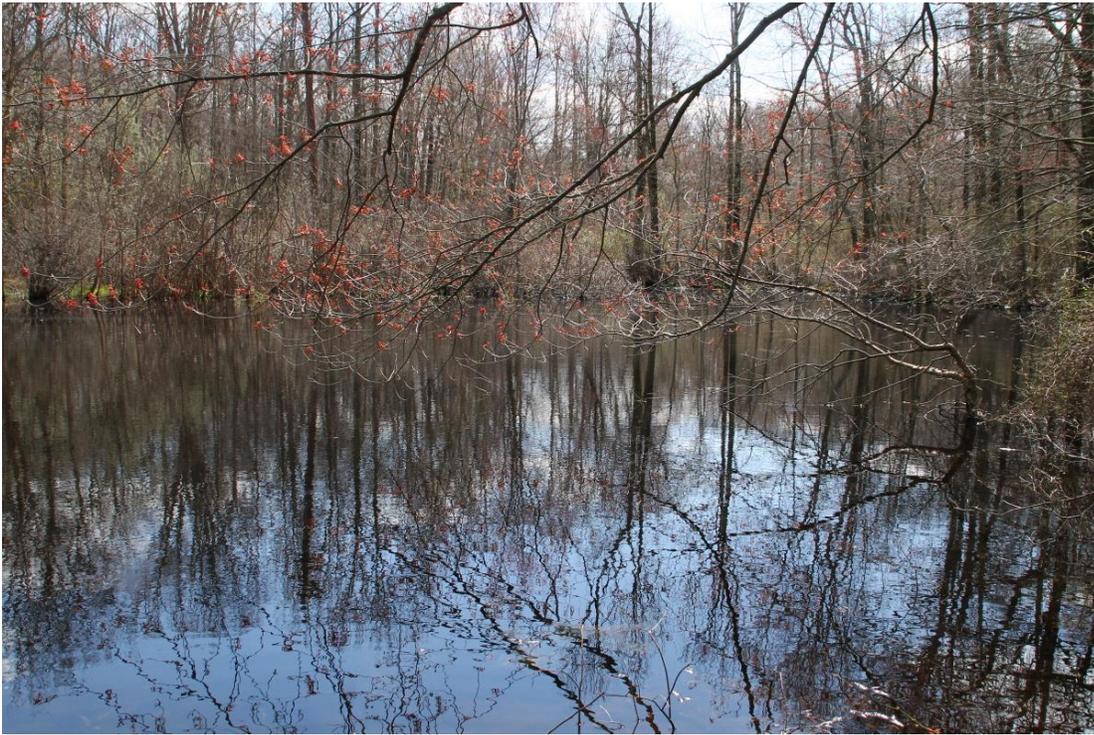
Pool 8566 was a deep pond occupying about a quarter acre on the north side of Cypress Lane (photo 3.22-a). Although it was immediately adjacent to a shallow wetland and ditch that lead toward a nearby uncoded tributary, it had a distinct perimeter that separated it from the adjoining wetlands. It was not apparent whether this was a naturally occurring feature or one that had been enhanced at some time in the past. Red maple, river birch and willow were typical trees growing on the banks.

Aquatic vegetation typical of established ponds was noted upon arrival at the site, and as large fish were seen jumping during the initial visit no further evidence of the pond's permanence was required.

Photo 3.22a. Pool 8566 on April 13 2013.

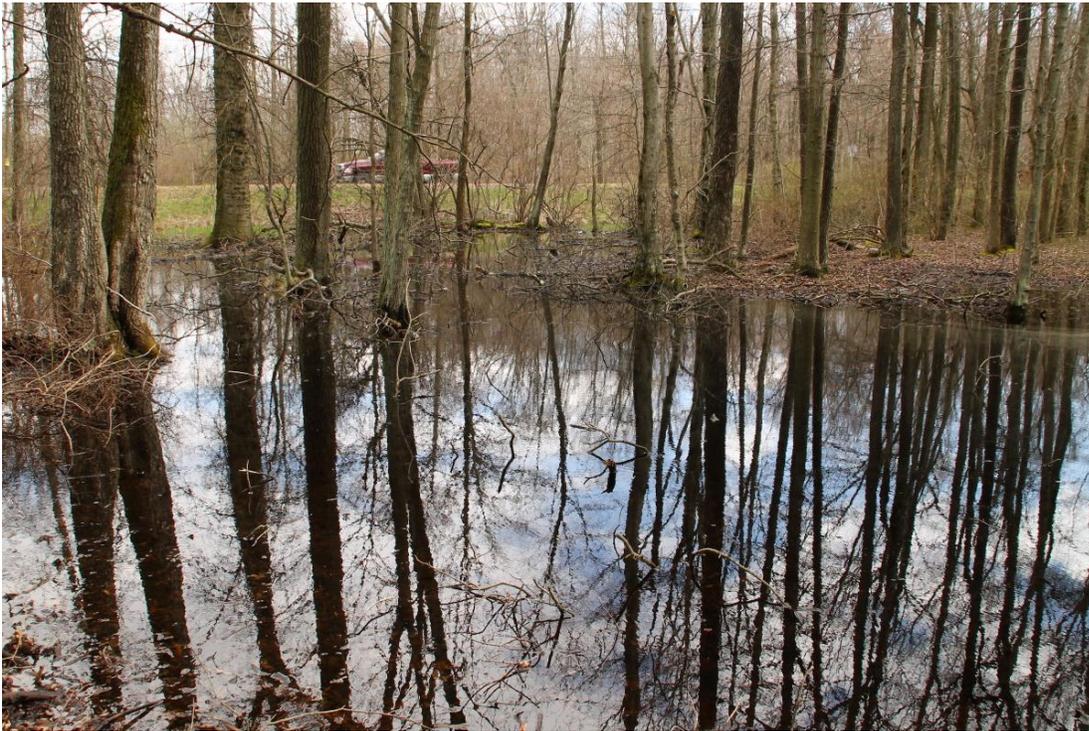
Pool 8570 occupied about 900 square meters of space at the edge of the woods on the south side of Cypress Lane (photo 3.23a). The shallow pool was immediately adjacent to the road, and a cut in the curb allowed road runoff to enter the pool directly. Trash was found in and around the pool.

Photo 3.23a. Pool 8570 on April 13 2013.

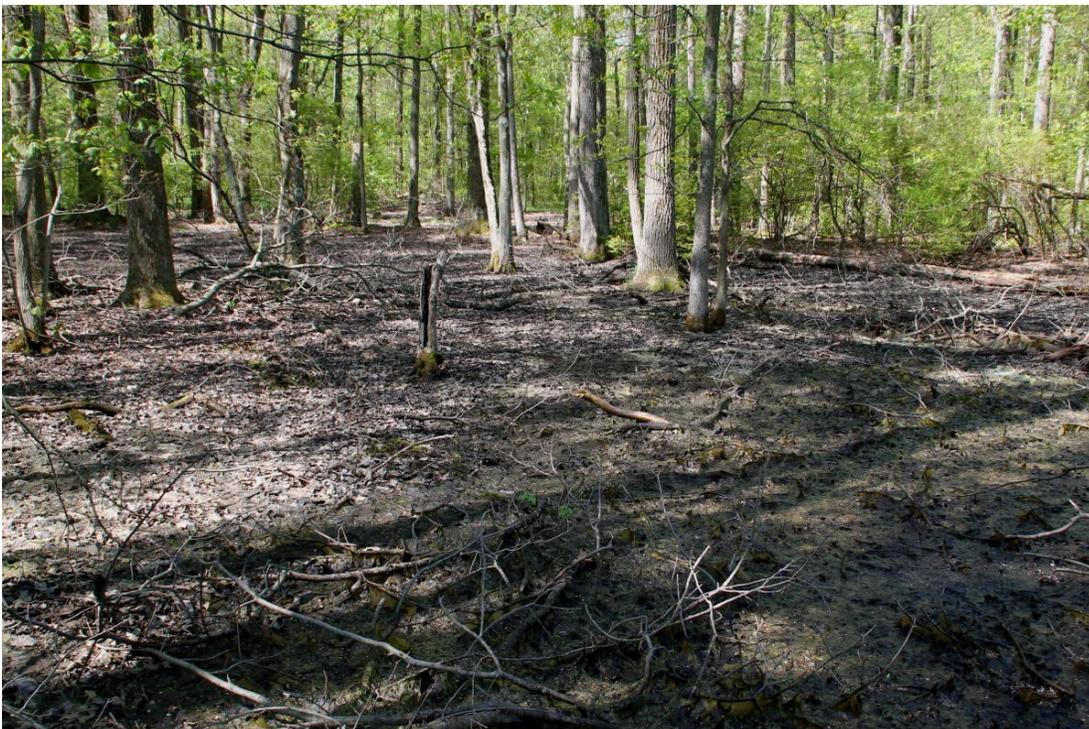
The deepest portion of the pond was only eight inches deep in the middle of April, and by early May the pool was completely dry (photo 3.23b).

Photo 3.23b. Pool 8570 on May 3.

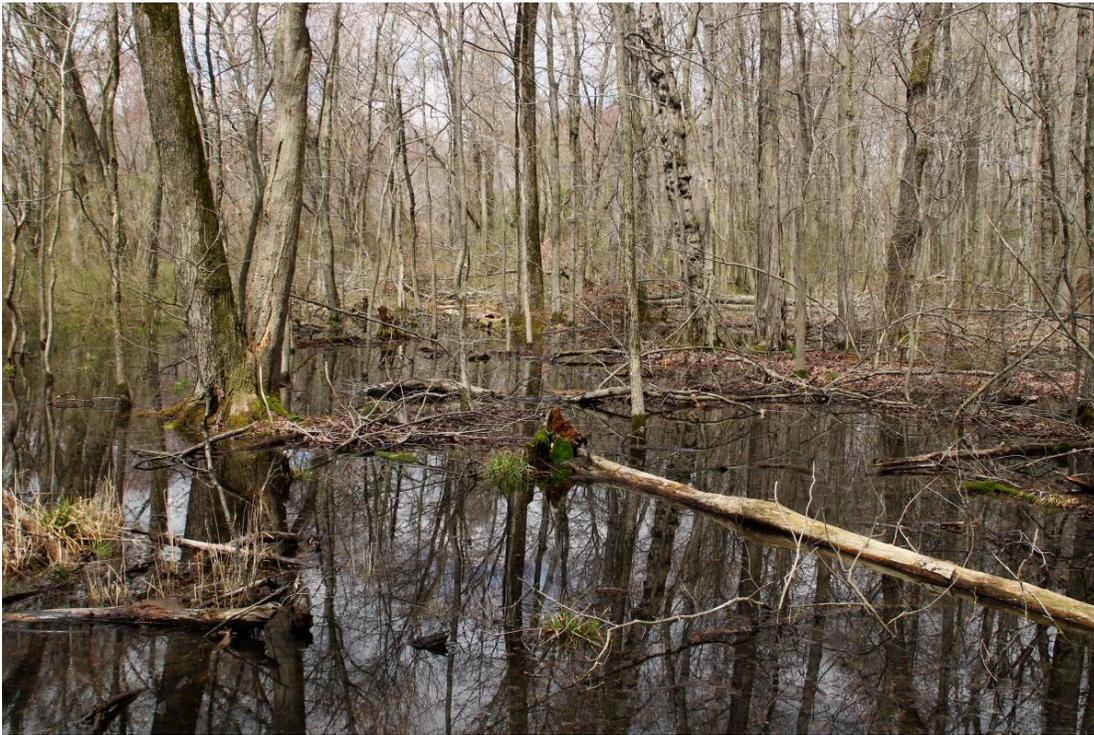
The largest portion of Pool 8574 was about 900 square meters in size, but the pool continued to meander through the woods forming a large, irregular shape (photo 3.24-a). No distinct basin could be clearly defined. Red maple and sweetgum were the dominant forest trees, while greenbriar and spicebush prevailed in the understory.

Photo 3.24a. Pool 8574 on April 13 2013.

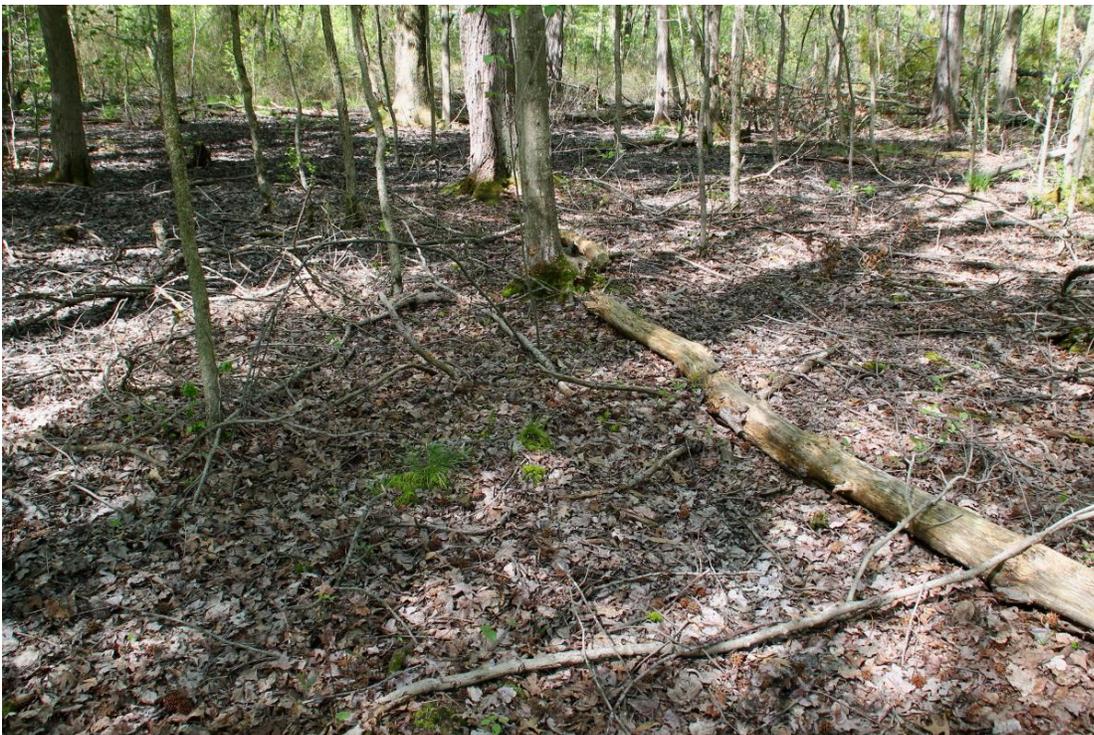
Photo 3.24b. The site was completely dry by May 3.

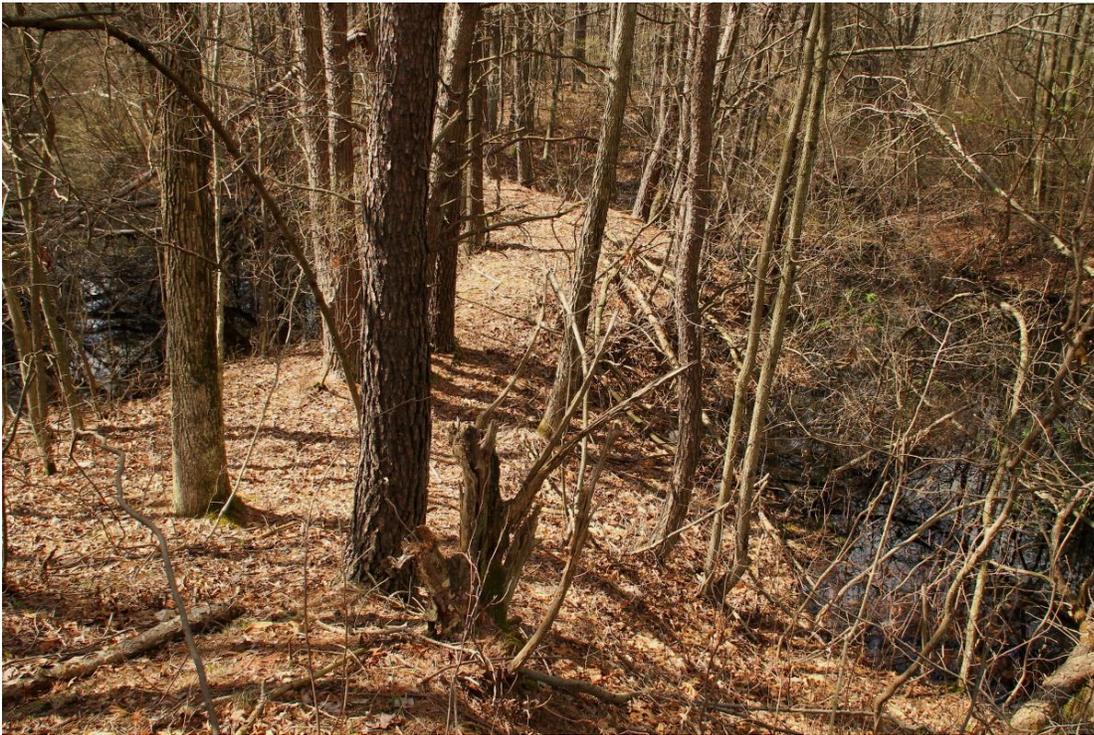
Photo 3.25-a. Pool 8578 was a series of deep pits separated by high berms.

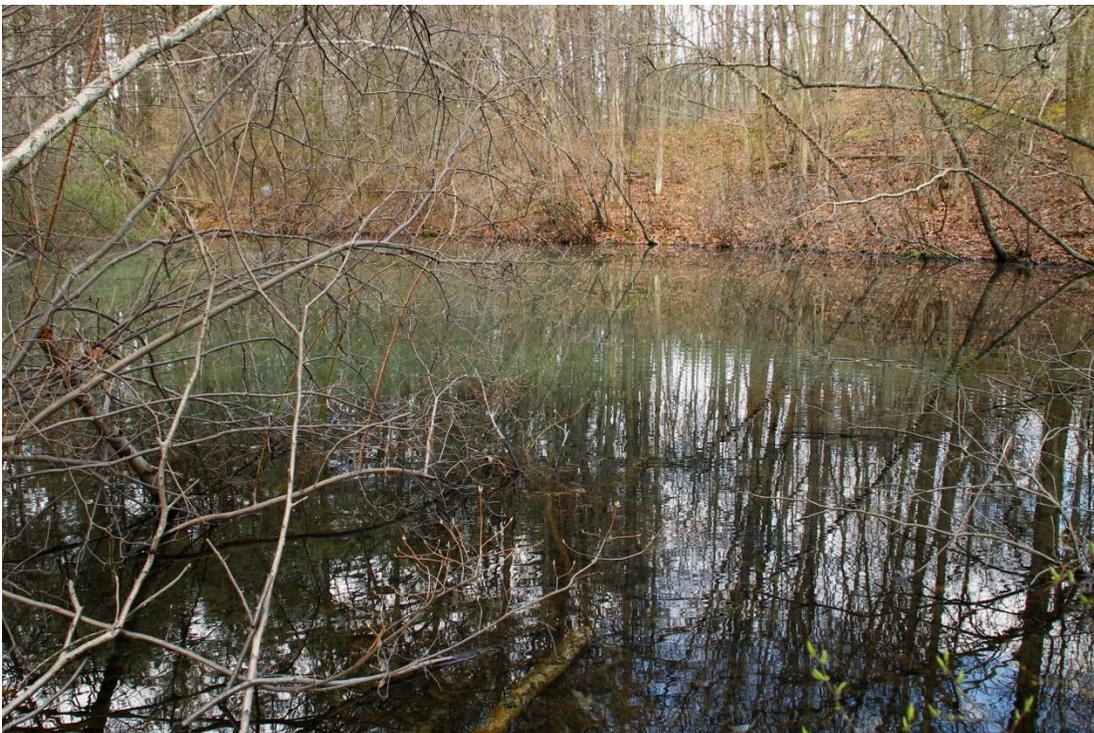
Pool 8578 was a series of interconnected deep pits surrounded by higher berms (photo 3.25a). They appeared to be the result of some former excavation. The pools had a distinctive appearance due to their light colored substrate and bright blue-green water (photo 3.25b). The total area occupied by the complex was nearly four-tenths of an acre. Although connected to one another, the pools were isolated from other aquatic systems and had no inflow or outflow.

Photo 3.25-b. The bright blue-green water was accented by the light substrate.

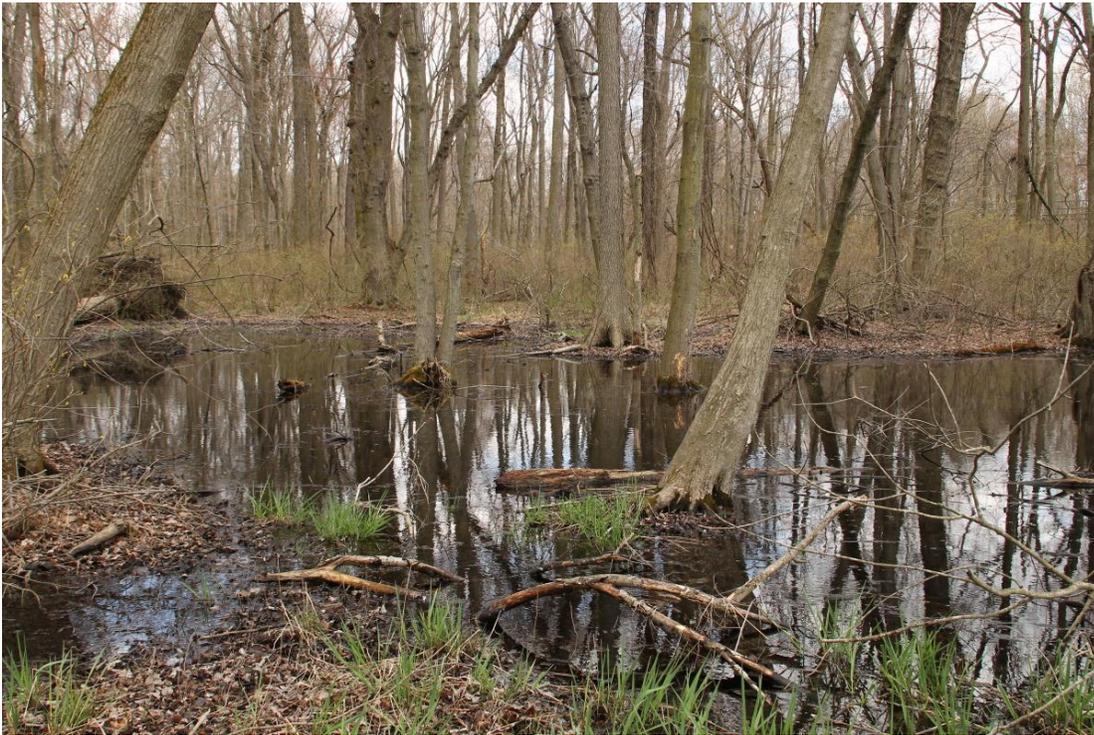
Pool 8582 was a natural depression approximately 1000 square meters in size located in a forested area near the intersection of Route 533 and a powerline right-of-way. Although it was situated between a permanent pond and a flowing creek, it was clearly separate from both and had no permanent inflow or outflow (photo 3.26-a). It was noted during the initial site survey that its position downslope from Route 533 might make it susceptible to contamination from road runoff.

Photo 3.26-a. Pool 8582 on April 13 2013.

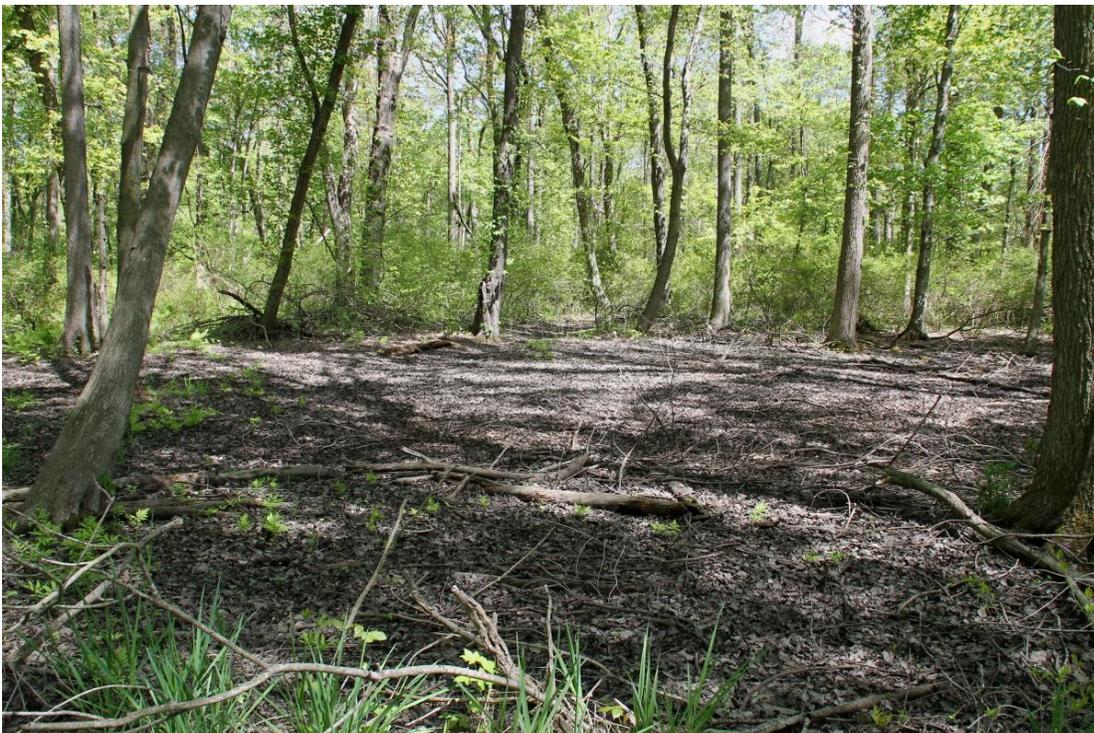
Photo 3.26-b. Pool 8582 was completely dry by May 6 2013.

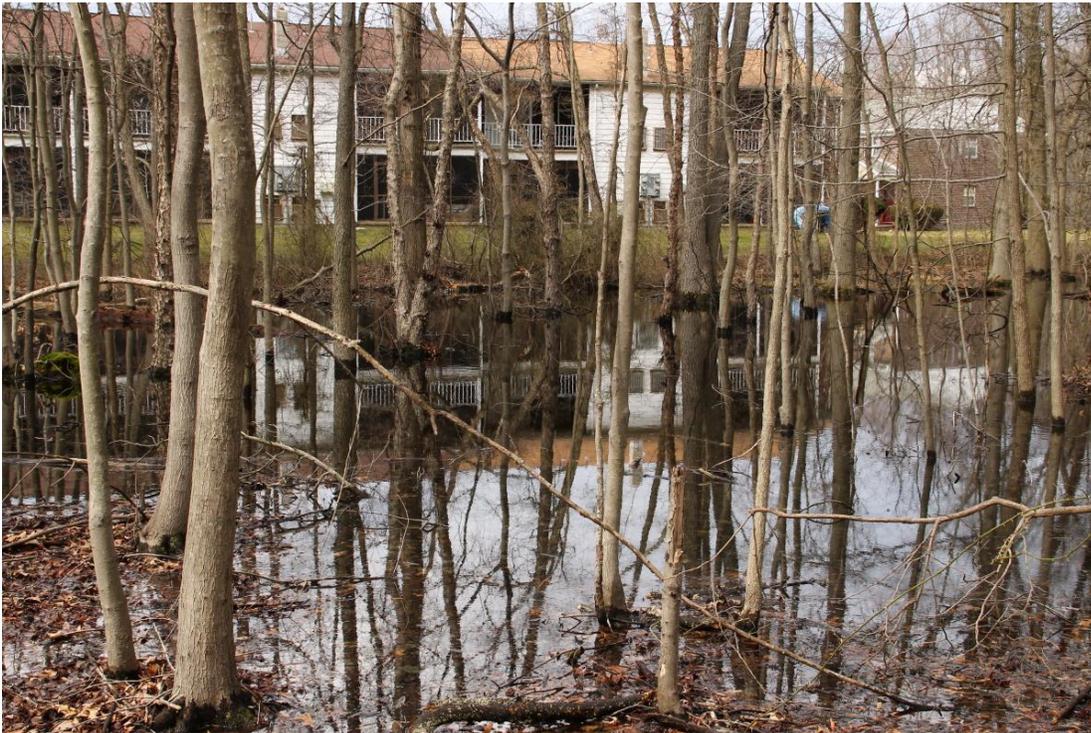
Although Pools 8604 and 8612 appeared to be separated by some distance on the map, they actually proved to be part of the same large, meandering wetland that spread throughout a three-acre section of forest. During the initial site survey on March 26, Pool 8612 appeared to be separated from the rest of the wetland system (photo 3.27-a), although it was irregular in shape and turned a corner to extend into the adjacent woods (photo 3.27-b). On the same date, a wet swale was noted between 8612 and 8604 (photo 3.27-c), and 8604 presented as a forested swamp rather than an isolated depression (photo 3.27-d). There was just enough rainfall prior to the second field visit on April 18th to demonstrate that all of those features were connected to one another when the water level rose.

Photo 3.27-a. Pool 8612 begins at the edge of a residential neighborhood.

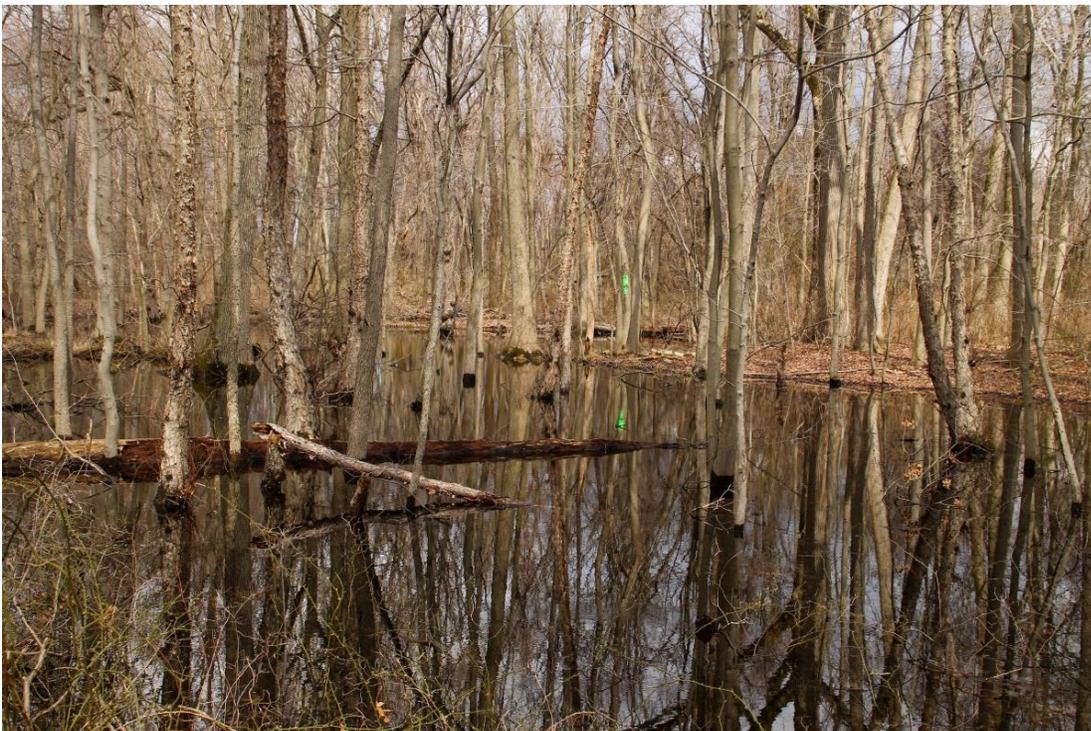
Photo 3.27-b. Pool 8612 extend into the woods and flows around a bend.

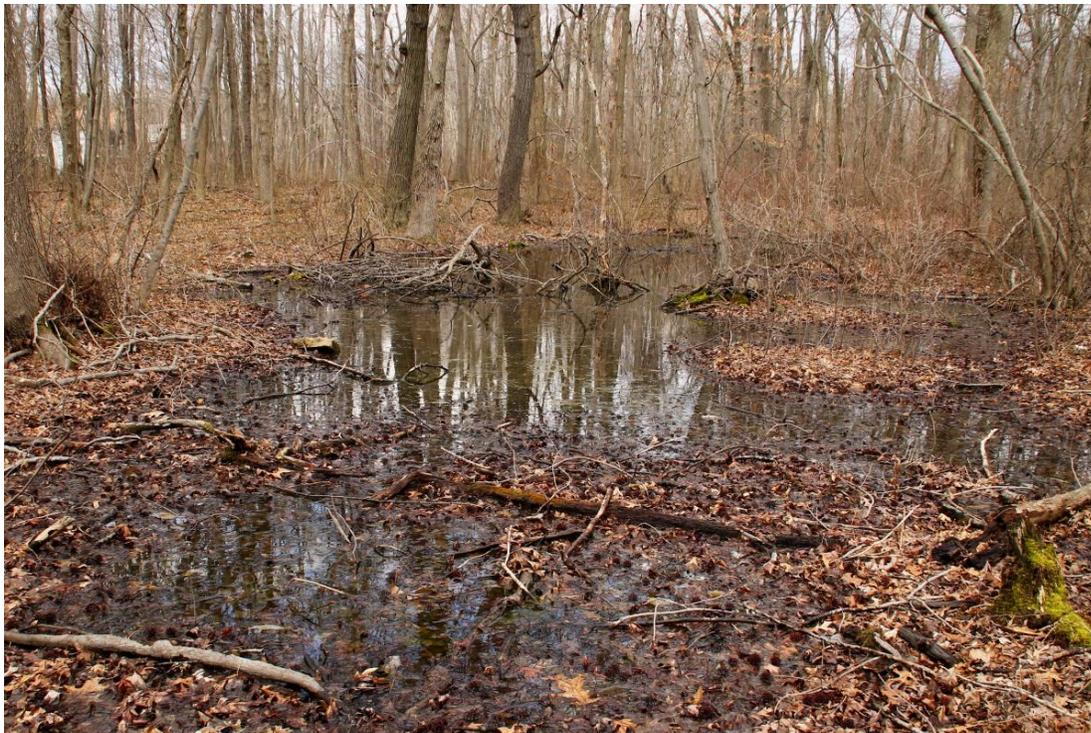
Photo 3.27-c. Part of the swale that connects 8604 to 8612, on March 26 2013.

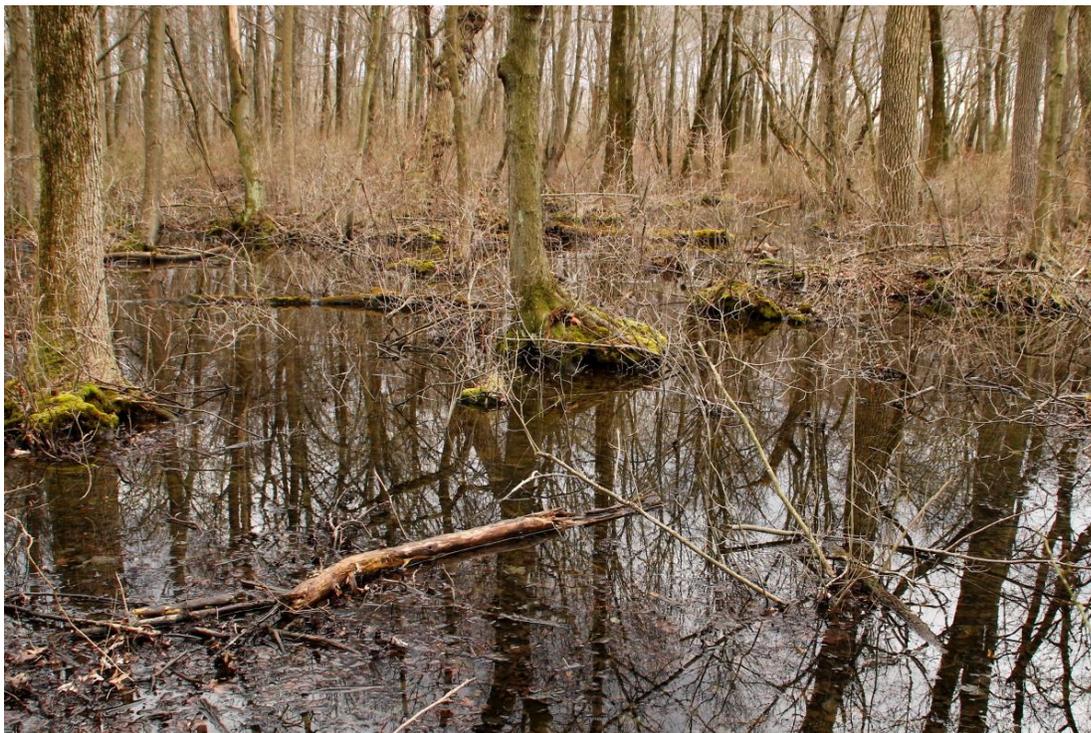
Photo 3.27-d. 8604 was a spreading forested wetland.
