**A 2013 SURVEY OF POTENTIAL VERNAL POOLS
IN HAMILTON TOWNSHIP, MERCER COUNTY, NEW JERSEY**

Prepared for the Township of Hamilton

**Deborah J. Kratzer
Kratzer Environmental Services**

**Jill S. Dodds
Biostar Associates, Inc.**

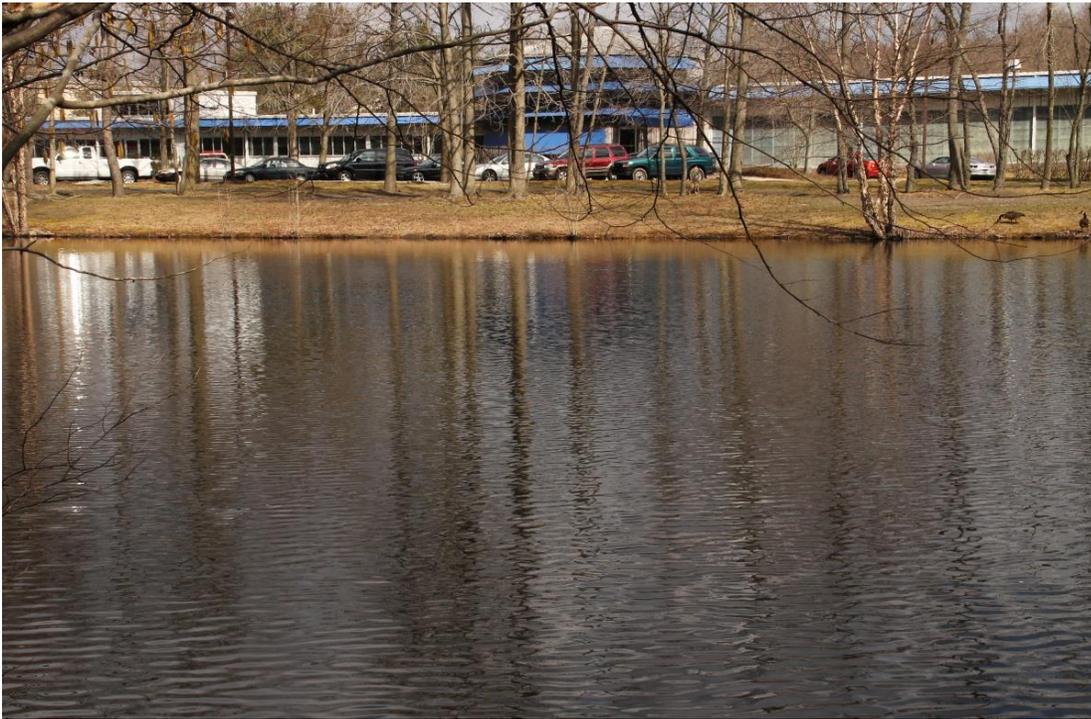
Pool 8616 was a fairly deep pond that appeared to have been developed or enhanced to create a water feature for the adjacent office building (photo 3.29-a). Although it did not have a visible connection to the nearby stream, a concrete overflow box was present at the lower end (photo 3.29-b). Lures and bobbers tangled in the bushes around the pond suggested the presence of fish.

Photo 3.29-a. Pool 8616 was a permanent pond.

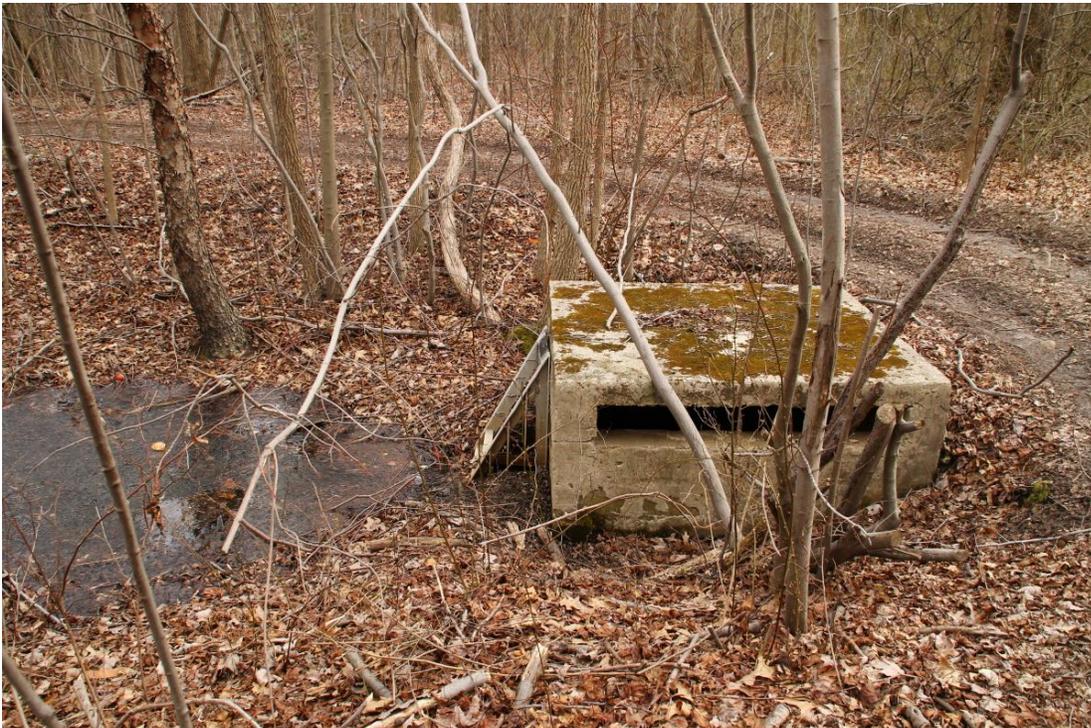
Photo 3.29-b. Concrete overflow box at Pool 8616.

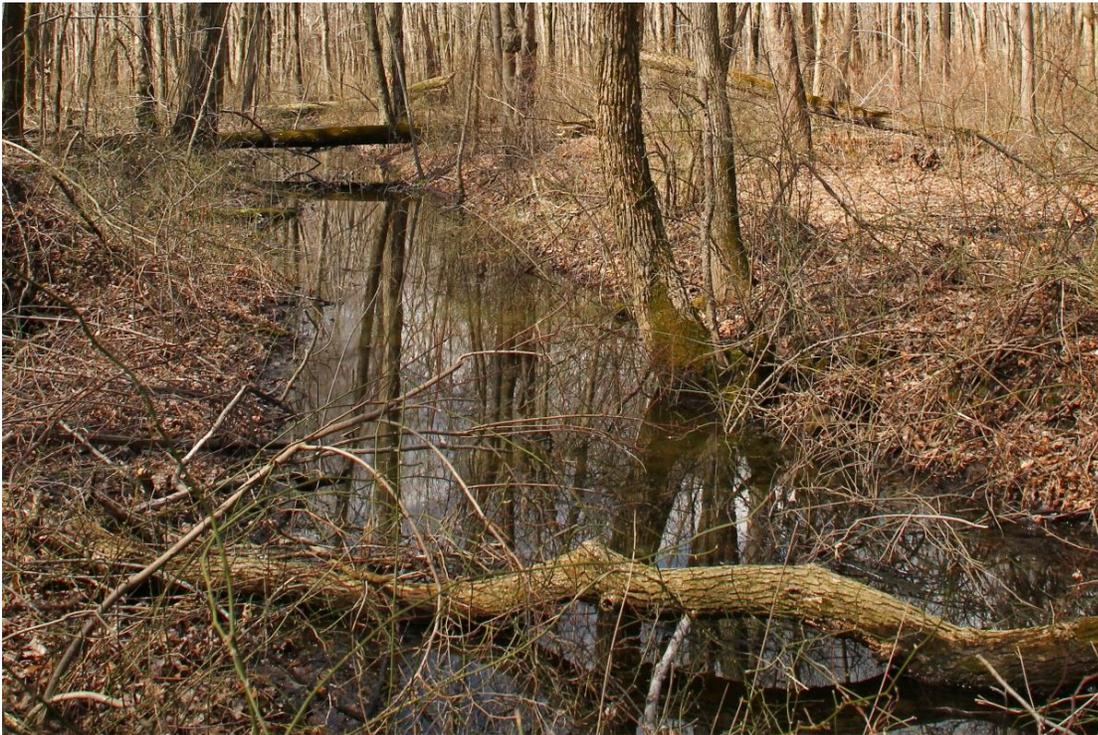
Pool 18740 did not occur in a natural swale, but instead appeared to have been formed by a combination of landscape features and human activity. The lower part was a long, narrow channel approximately 50 meters long and five meters wide (photo 3.30-a), while the upper part was shrub/cattail marsh occupying about 3750 square meters on the border of an open field (photo 3.30-b). Nearby, a smaller depression about six square meters in size was apparently formed by tire tracks. However, the entire system was distinct from the both the surrounding forested wetlands and a nearby tributary of the Assunpink Creek.

Photo 3.30-a. A view of the long, narrow portion of Pool 18740.

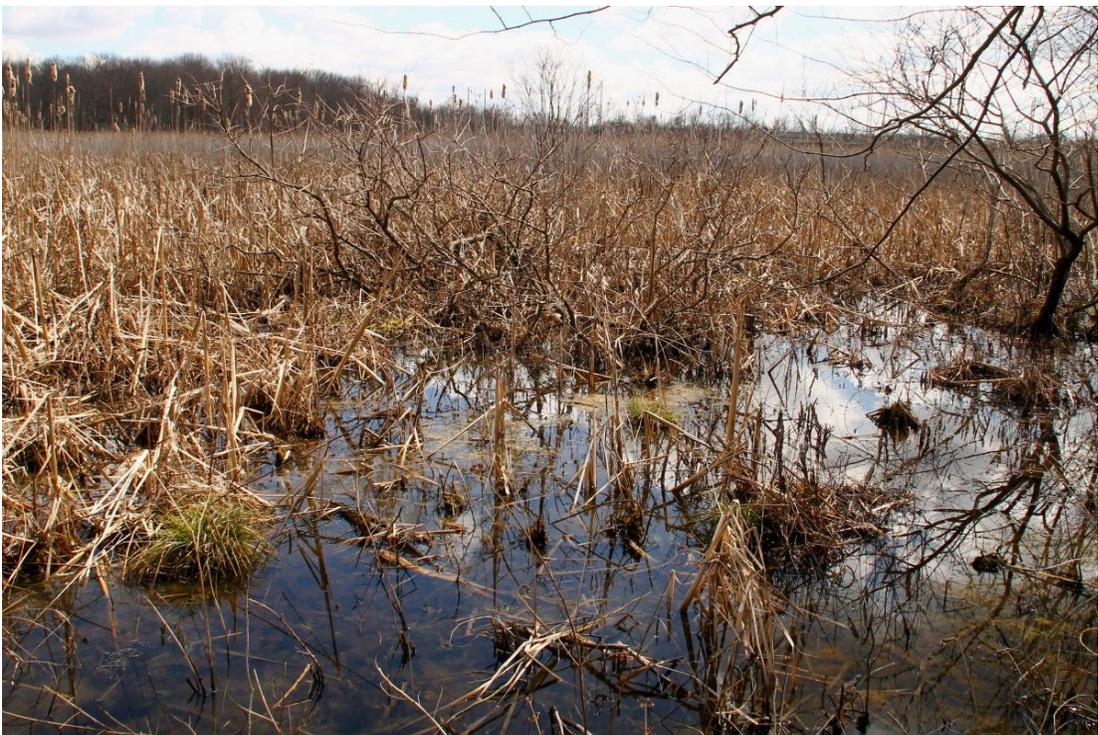
Photo 3.30-b. The upper end of 18740 was a marshy area on the edge of a field.

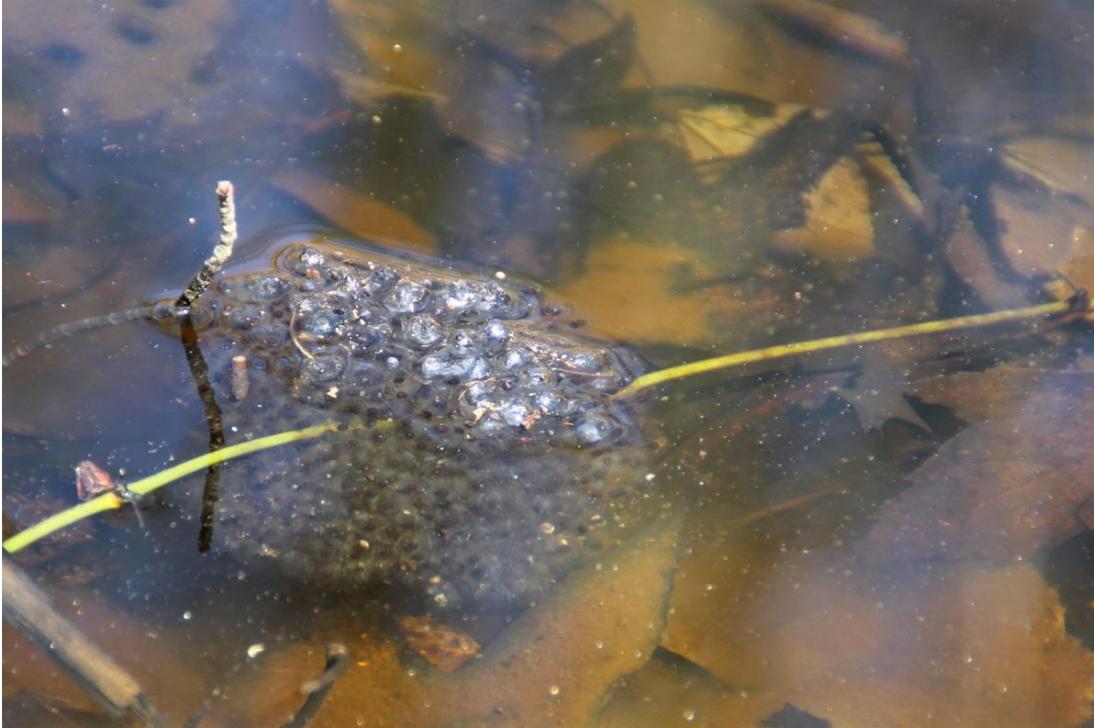
Wood frog eggs were abundant throughout the site, and were present in the tire-track depression as well as in the ditch and the marsh (photo 3.30-c). The presence of this obligate breeding species negated the need for further evaluation of the fauna, although two facultative vernal pool amphibians – the northern spring peeper and the southern leopard frog - were heard calling on the site. A spotted turtle was also observed on the bank of the ditched portion of the pool (photo 3.30-d).

Photo 3.30-c. Wood frog eggs were abundant on the site.

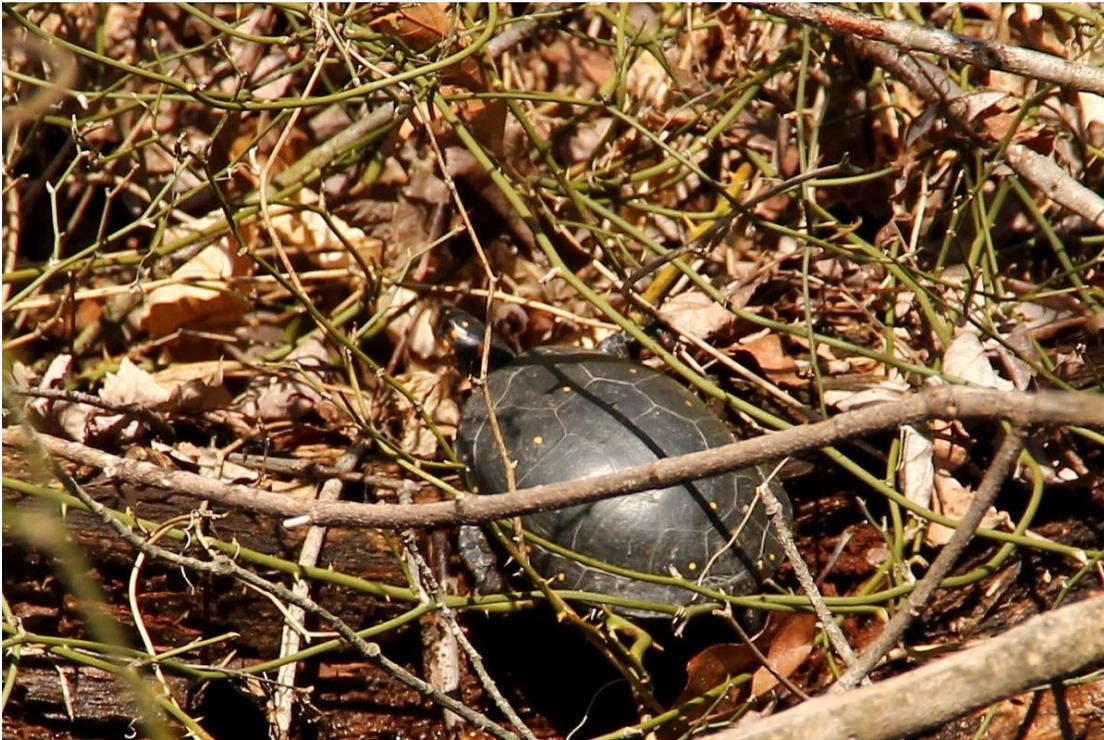
Photo 3.30-d. A spotted turtle was seen along the edge of ditched section.
