Groveville Fire Company  
Fire Engine #19  
4201 Crosswicks Hamilton Square Road  
Hamilton, NJ 08691

## Feasibility Study

December 7, 2017

## **Fire Station # 19, Groveville District 9 – Audit**

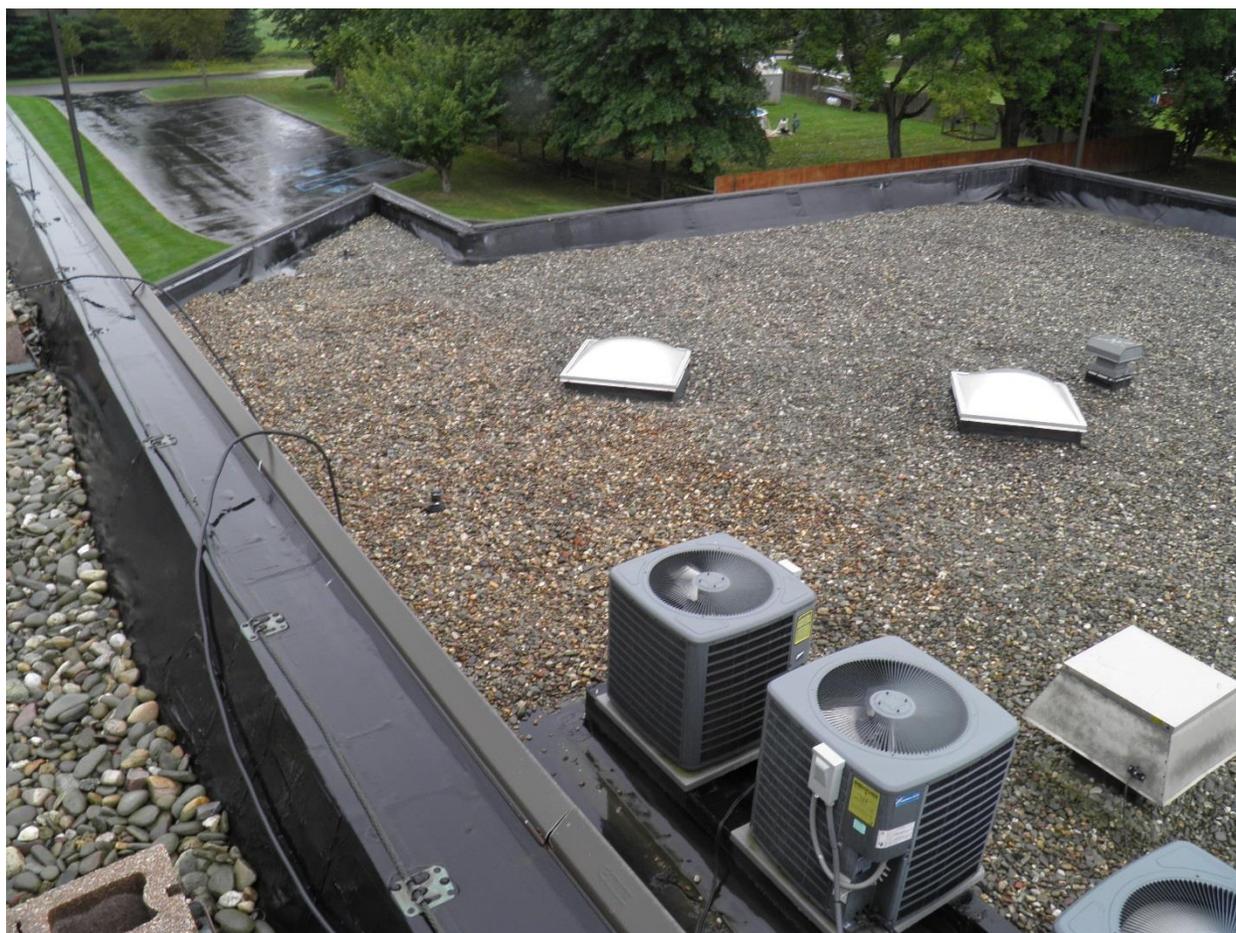
ROOF

- v. The precast concrete panel joint sealant material is alligating and oxidizing causing it to split open.
- B. Roofs
- i. An original single ply membrane roofing system with ballast is on all the roofs and all are in poor condition and require frequent maintenance to keep them water tight,
